# Asbestos Materials Refit survey and partial reinspection

## NW Sanderling

Shell Tankers Australia Pty Ltd

Reference: 754-PEREN324141

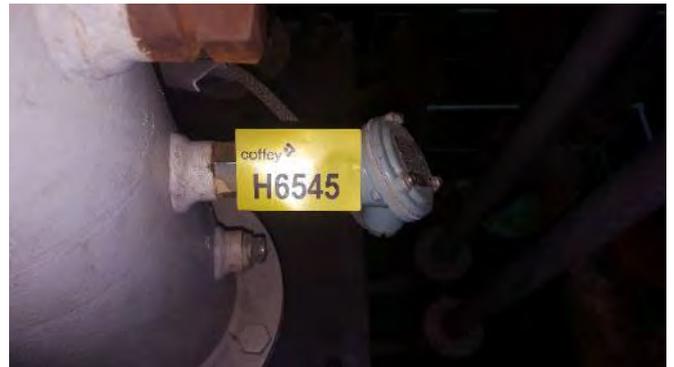
**Photo 4**

Tank Top/Lower Deck, Engine Room, Electrical Cable Conduit Above No.1 Atmos Drain Pump, Putty (Chrysotile)

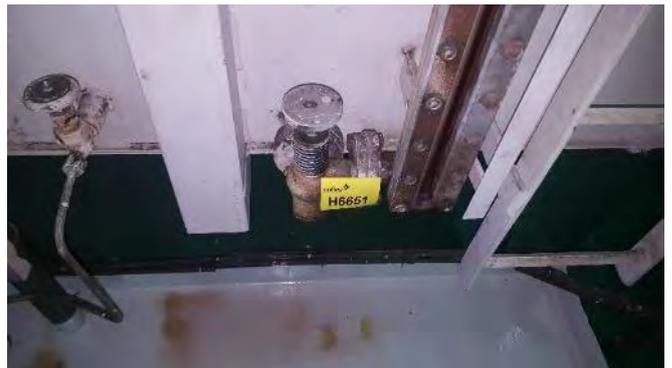
**Photo 29**  
H6650  
3rd Deck, Engine Room, Turbine Oil Gravity Tank Level Overflow Sight Glass, Gasket (Chrysotile)

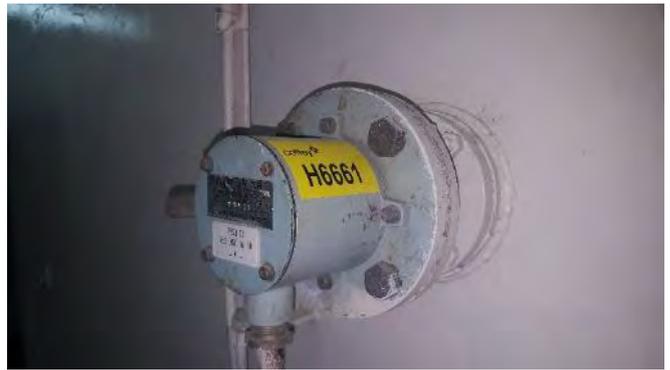
**Photo 31**  
H6657  
3rd Deck, Engine Room, Port Domestic F.W. Tank  
Low Level Switch Flange, Gasket (Chrysotile)

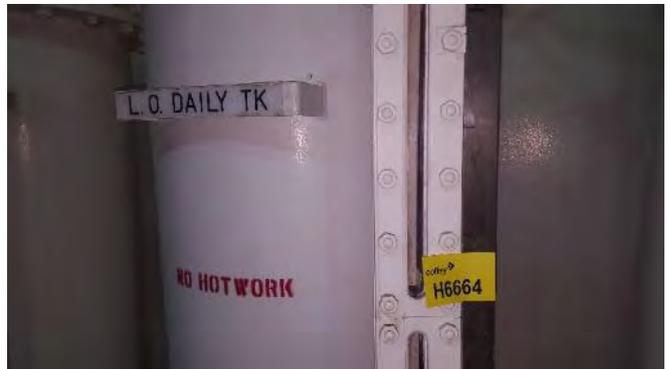
**Photo 33**  
H6663  
3rd Deck, Engine Room, Clean Oil Tank Level Sight Glass, Gasket  
(Chrysotile)

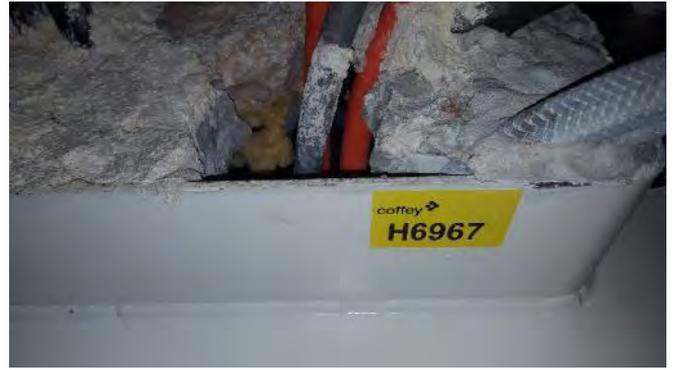
**Photo 139**  
G6966  
F Deck, Electric Cable Space, Starboard Bulkhead(Around Cables), Packing (White) (Chrysotile)

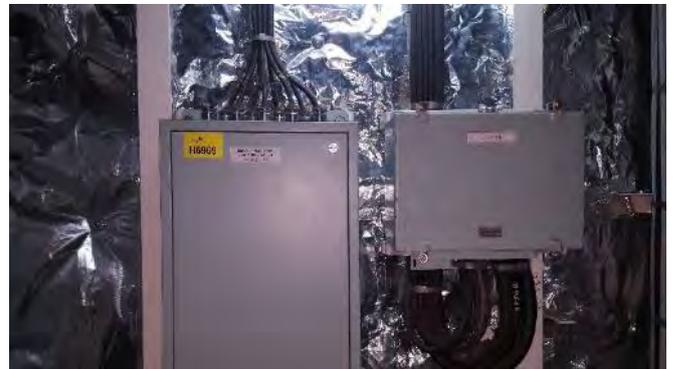
**Photo 141**  
H6968  
F Deck, Electric Cable Space, Below Inboard Deck Head, Debris & Dust (Chrysotile)

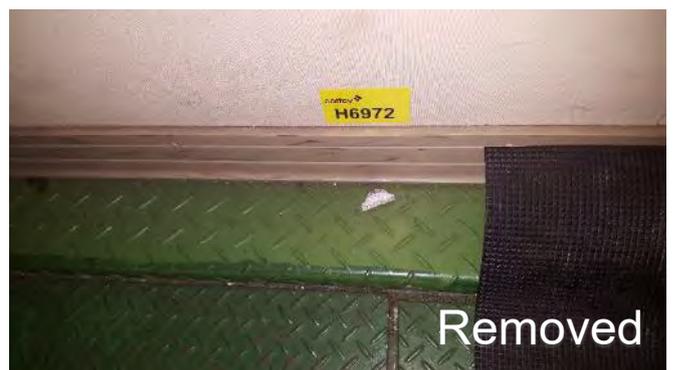
**Photo 143**  
H6971  
F Deck, Electrical Cable Trunking, Inboard Deck Head, Debris (Chrysotile)
