# Maritime Asbestos Materials Post Re-Fit Assessment

Post Re-Fit Survey - Northwest Sandpiper (IMO: 8913150)

Shell Tankers Australia Pty Ltd

**Report reference number: 754-PEREN310903**

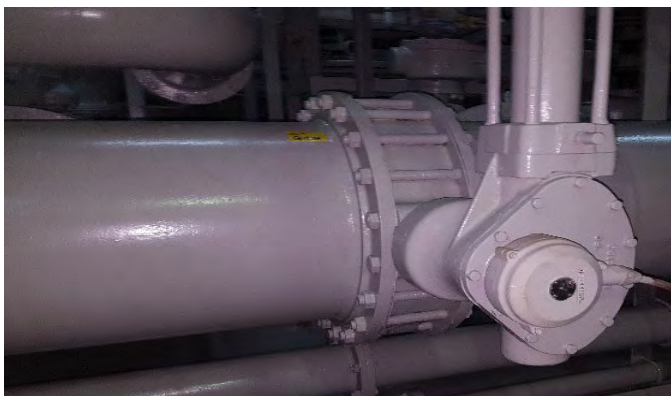
**Photo 1**

G6139  
Tank Top - Engine Room, To Forward VDJ Line Link to No.1 System Valve between 1 & 2 – Gasket (Blue) (UMF)

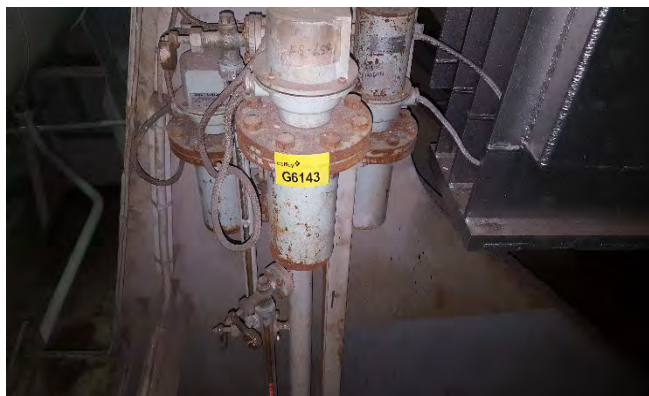
**Photo 2**

G6143  
Tank Top - Engine Room, Port Condenser Upper Float Transmitter to Flange – Gasket (Chrysotile)

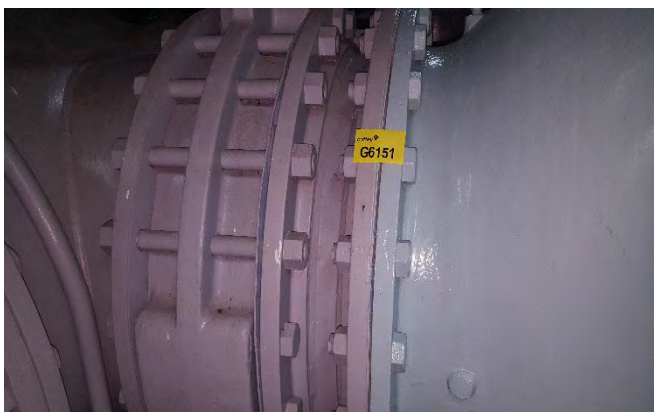
**Photo 5**

G6151  
Tank Top Engine Room, Auxiliary Circuit, PP Inlet Flange, Lower Walkway – Gasket (UMF)

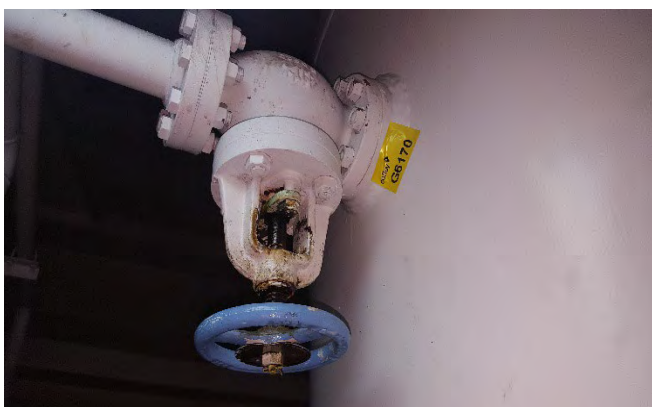
**Photo 11**  
G6170  
4<sup>th</sup> Deck Engine Room, FWD Port, General Service Air Receiver Inlet Valve, Flange – Gasket (UMF)

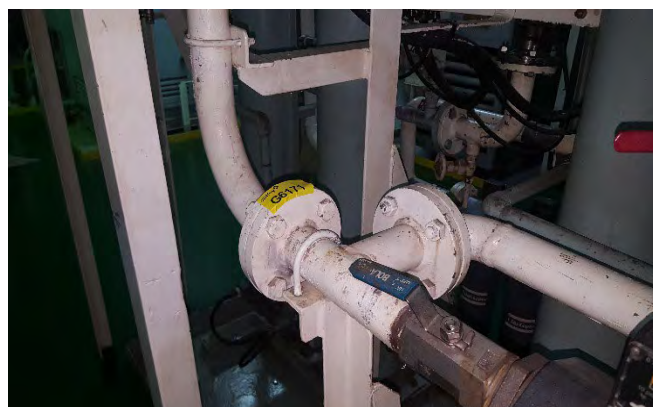
**Photo 12**  
G6171  
4<sup>th</sup> Deck - Engine Room, FWD Port, Atlas Air Filter, Flange – Gasket (UMF)

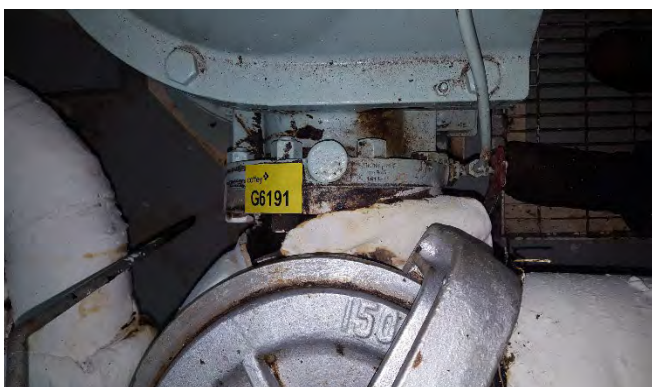
**Photo 17**  
G6191  
4<sup>th</sup> Deck Purifier Room, Heavy Fuel Oil, Transfer Pump, Inlet Flange – Gasket (UMF)

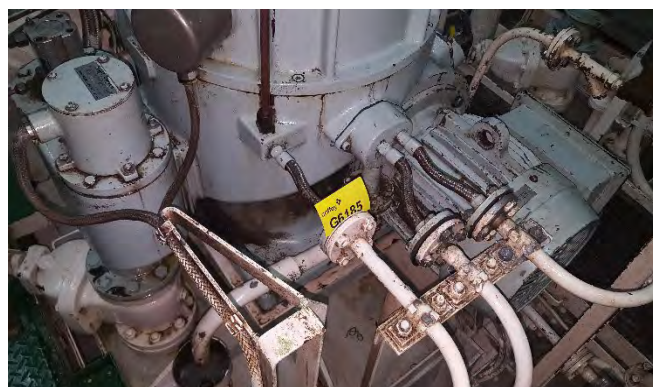
**Photo 18**  
G6185  
4<sup>th</sup> Deck - Purifier Room, Lube Oil Purifier No.2, Seal Water Valve – Gasket (UMF)

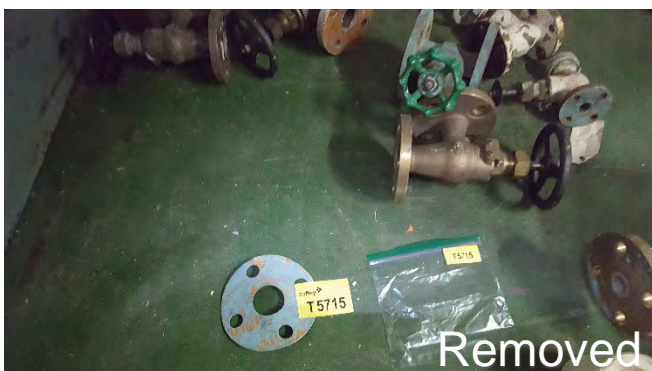
**Photo 23**  
T5715  
3<sup>rd</sup> Deck Workshop Mezzanine, Starboard, Fore, Stored Item – Gasket Loose (Orange Font, Blue Backing Valqua) (UMF)

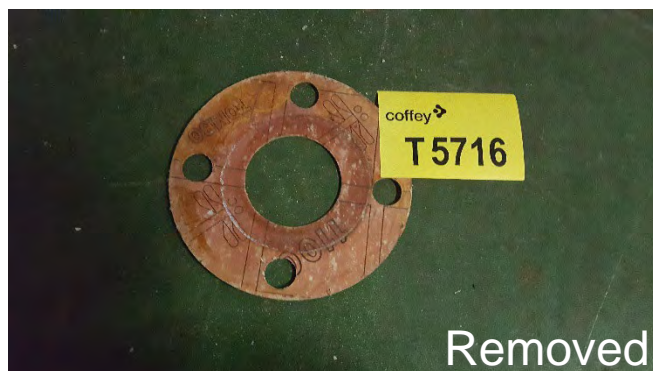
**Photo 24**  
T5716  
3<sup>rd</sup> Deck - Workshop Mezzanine, Starboard, Fore, Stored Item – Gasket Loose t (Pink, Black Font, Tombo 1100) (Chrysotile)

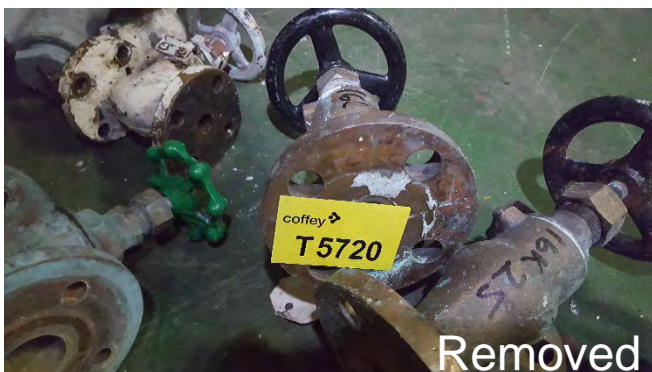
**Photo 25**  
T5722  
3rd Deck -Workshop Mezzanine, Starboard, Fore, Metal Box with Stored Items (Throughout) – Gasket Material (Pink/Grey) Adhered to Flange (Chrysotile)

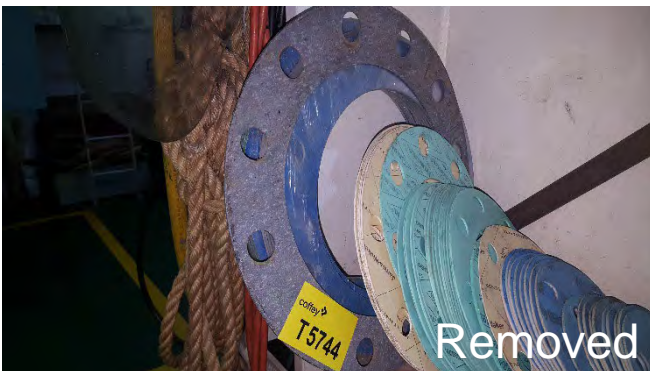
**Photo 35**  
T5744  
3rd Deck Workshop, Structural Column Between Grinder Electrical Box's – Gasket loose 'No Brand' (Black, White Flecks) (Chrysotile)

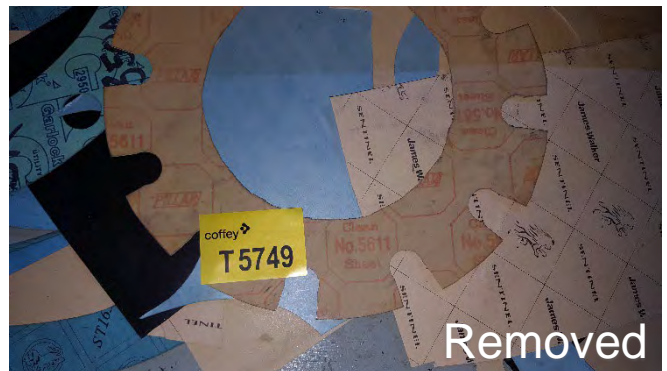
**Photo 36**  
T5749  
3rd Deck - Workshop, Bulkhead penetration insulation Draws, First Draw (Labelled Off-Cuts) - Gasket 'Pillar Clean Sheet No. 5611' (Orange Font, Beige Back) (Presumed Positive)

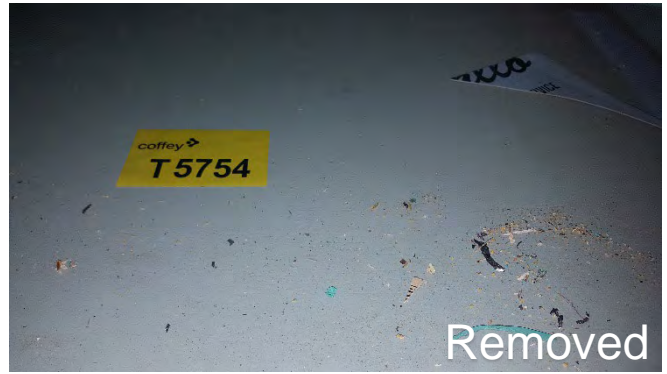
**Photo 38**  
T5754  
3rd Deck Workshop, Bulkhead penetration insulation Draws,  
Third Draw (Labelled 1.0 - 1.5mm) – Gasket Fragments,  
Debris and Dust (Chrysotile)

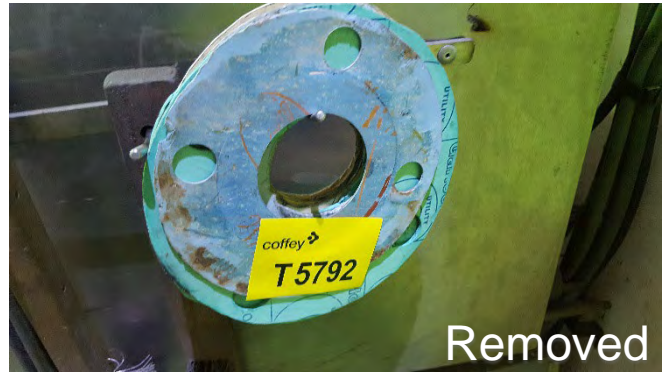
**Photo 44**  
T5792  
3rd Deck Workshop, Welders Bench – Loose Gasket 'Valqua' (Orange Font, Blue Backing) (UMF)

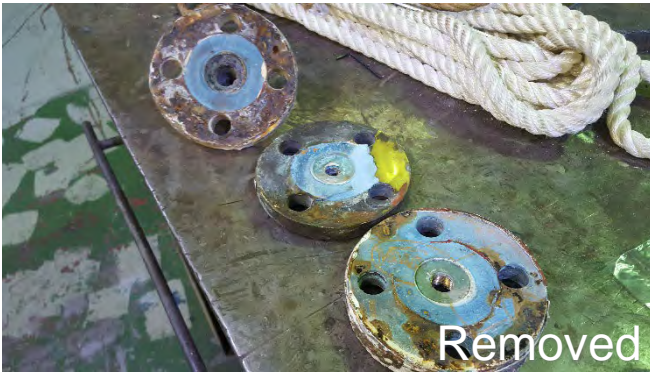
**Photo 45**  
Refer to T5792  
3rd Deck Workshop, Welders Bench – Loose Gasket 'Valqua' (Orange Font, Blue Backing) (UMF)

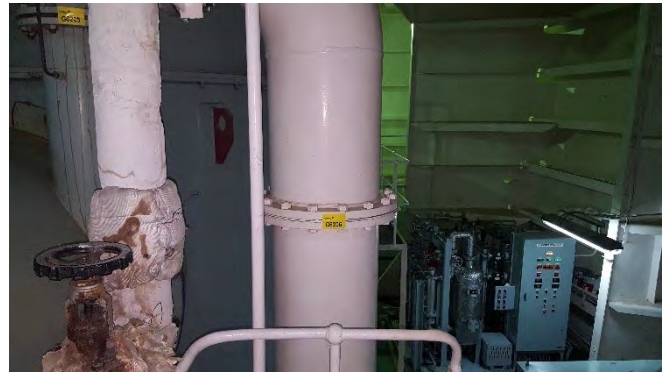
**Photo 46**  
G6206  
3rd Deck - IGG Room, Burner Outlet Manifold – Gasket (UMF)

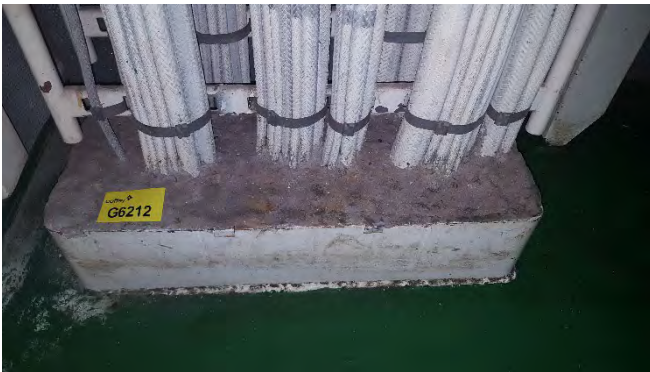
**Photo 47**  
G6212  
3rd Deck No.1 Diesel Alternator Room, Left of Inboard Door, Penetration – Bulkhead penetration insulation (Chrysotile)

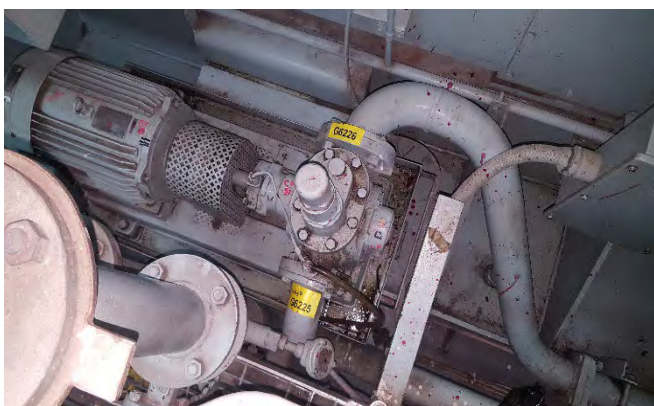
**Photo 53**  
G6225  
3rd Deck No.2 Diesel Alternator Room , Lube Oil Pump Discharge, Outlet Flange – Gasket (Chrysotile)

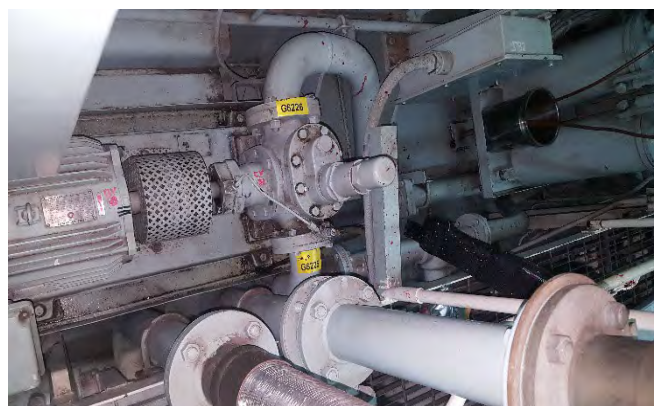
**Photo 54**  
G6226  
3rd Deck - No.2 Diesel Alternator Room , Lube Oil Pump Suction, Flange – Gasket (Chrysotile)

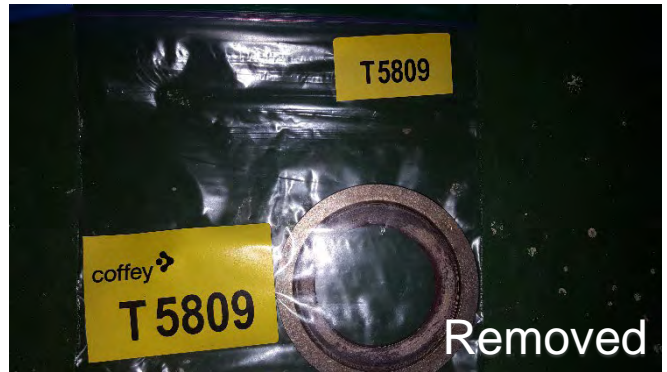
**Photo 70**  
T5809  
2nd Deck - Storage Area, Drawer CC1 (Labelled Spare Spiral Wound Gaskets) Throughout - Gasket Loose Spiral Wound Graphite/Cream Sealing Element, Valqua SHAS 304 (Chrysotile)

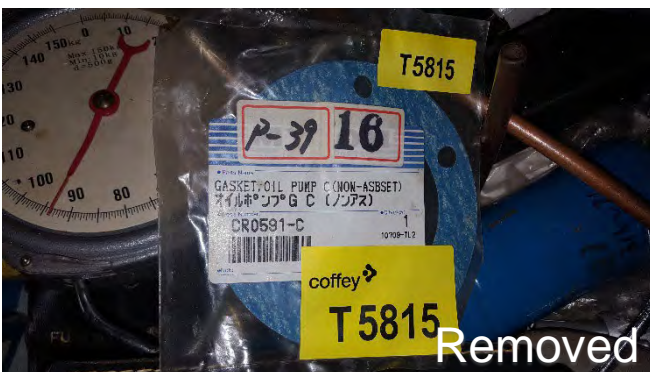
**Photo 71**  
T5815  
2nd Deck Storage Area, Drawer CC2 (Labelled Refrigerator Tools and Fittings) Gasket Loose 'YMcO' CR0591-C (Blue) (Chrysotile)

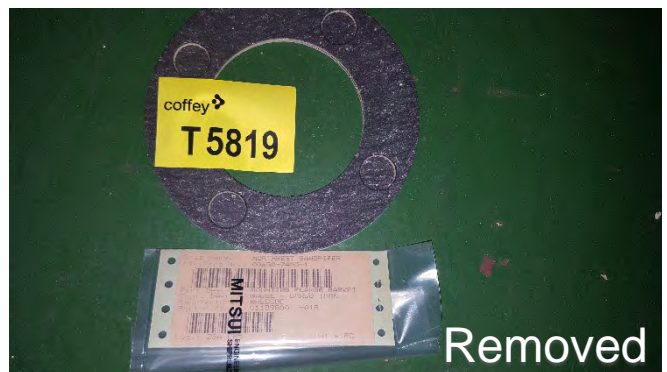
**Photo 72**  
T5819  
2nd Deck - Storage Area, Drawer CB5, (Labelled Cargo Tank Gauges) - Gasket Loose 'No Brand' Black with White Specks (Chrysotile)

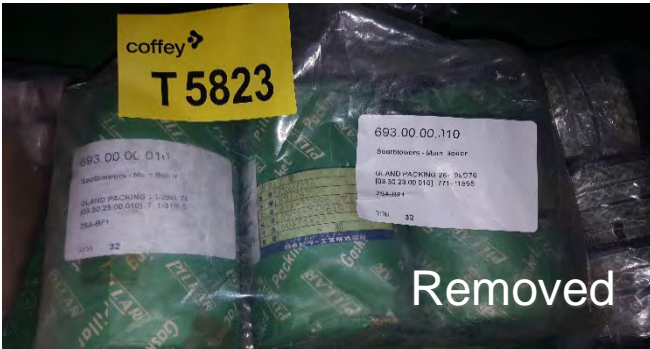
**Photo 73**  
T5823  
2nd Deck - Storage Area, Drawer BF1 (Labelled Main Boiler Sootblowers 693.00.00.110) – Bulkhead penetration insulation (Green) with Gasket (Black Font, Blue Backing) (Chrysotile)

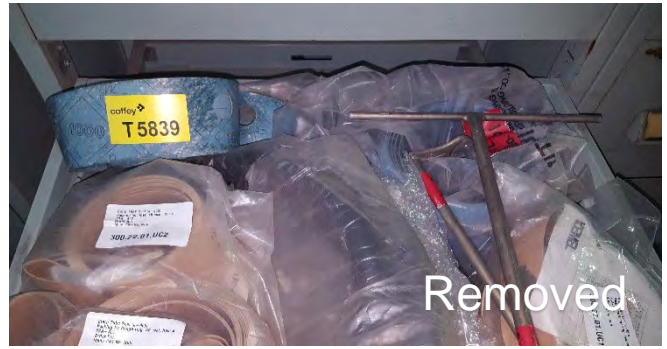
**Photo 74**  
T5839  
Storage Area, Drawer AL2, Stern Tube Seals - Gasket Loose t (Pink, Black Font, Tombo 1100) (Chrysotile)

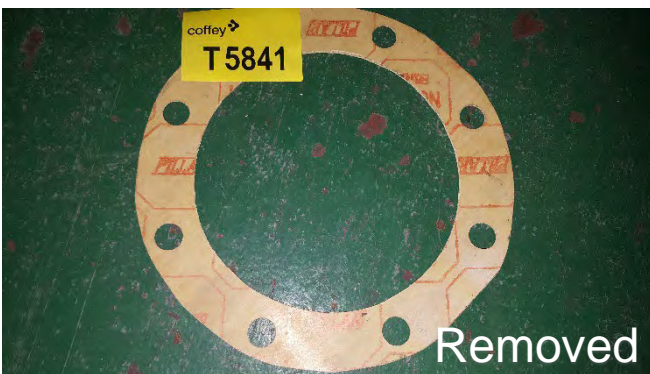
**Photo 75**  
T5841  
2nd Deck Storage Area, Drawer, AF2 – Gasket Loose 'Pillar Clean Sheet No. 5611' (Presumed Positive Sample)

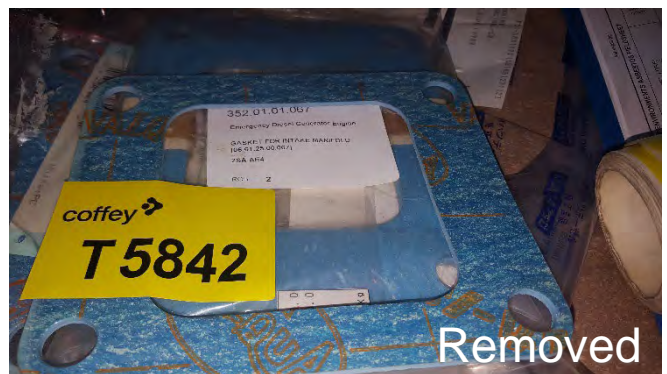
**Photo 76**  
T5842  
2nd Deck - Storage Area, Drawer, AE4 Emergency Generator - Gasket Loose 'Valqua' (Orange Font, Blue Backing) Japanese Symbols (UMF)

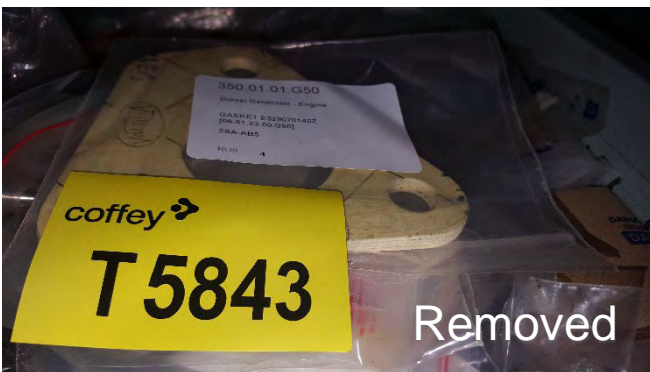
**Photo 77**  
T5843  
2nd Deck Storage Area, Drawer, AE5 Diesel Generator – Gasket Loose 'Valqua' (Beige Backing Black Print, 350.01.01.G50) (UMF)

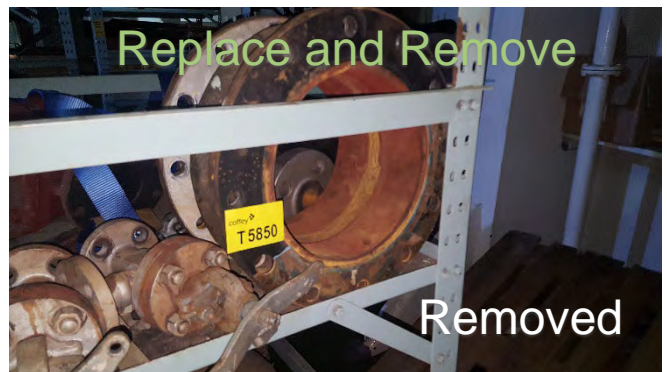
**Photo 78**  
T5850  
2nd Deck - Storage Area, Drawer, Shelf 1 from Fore – Gasket, Adhered to Redundant Winch Wheel, (Blue) (UMF)

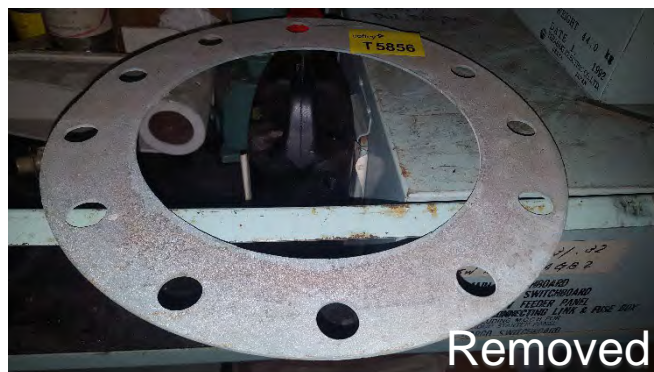
**Photo 80**  
 T5856  
 2nd Deck Storage Area 2nd Shelf from Fore - Gasket Loose (Blue) 'No Branding'

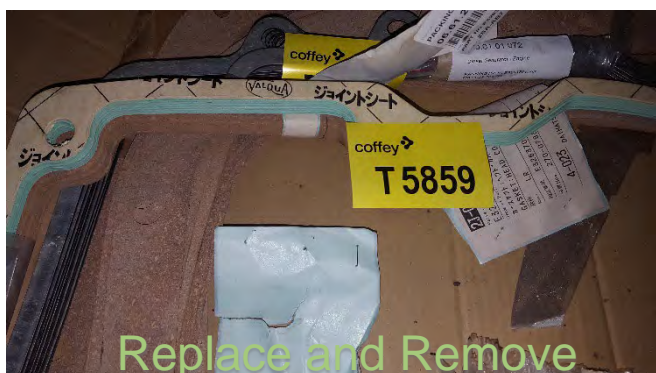
**Photo 81**  
 T5859  
 2nd Deck Storage Area, Above BD5 Cabinet – Gasket Loose 'Valqua' Black Font, Beige Background 350.01.01.072 (UMF)

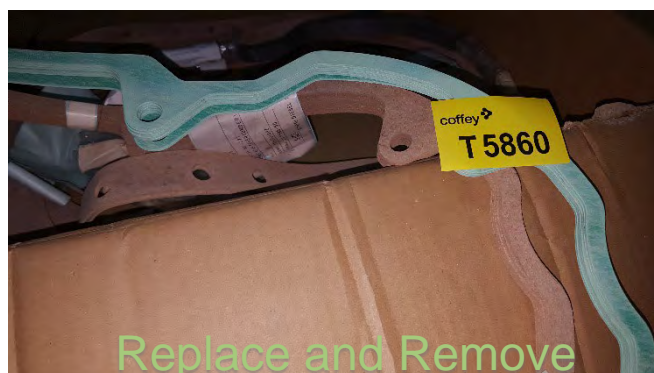
**Photo 82**  
 T5860  
 2nd Deck - Storage Area, Above BD5 Cabinet – Gasket Loose (No Brand) Green with Yellow Specks 350.01.01.073 (UMF)

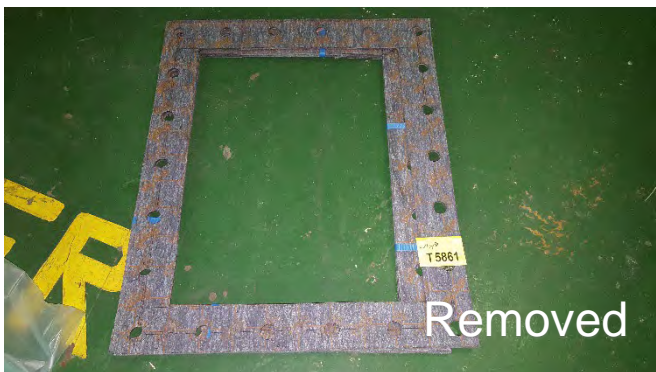
**Photo 83**  
 T5861  
 2nd Deck Storage Area, Contained for Removal – Gasket Loose 'Valqua 1755' (Orange Font with Black Backing and White Specks) (Chrysotile)

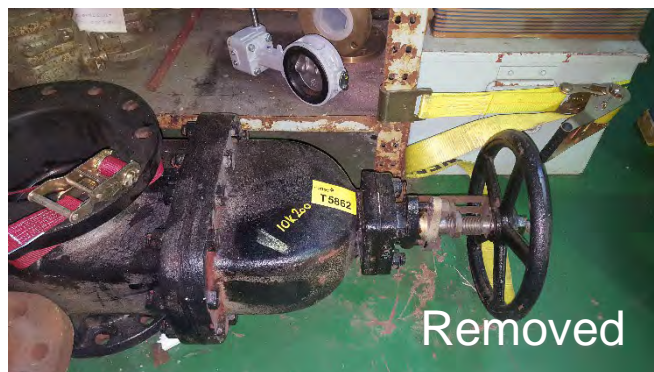
**Photo 84**  
 T5862  
 2nd Deck - Storage Area, Structural Column Adjacent 2nd Shelf from Fore – Gasket to Bonnet of Redundant Valve (Painted Black) (Chrysotile)

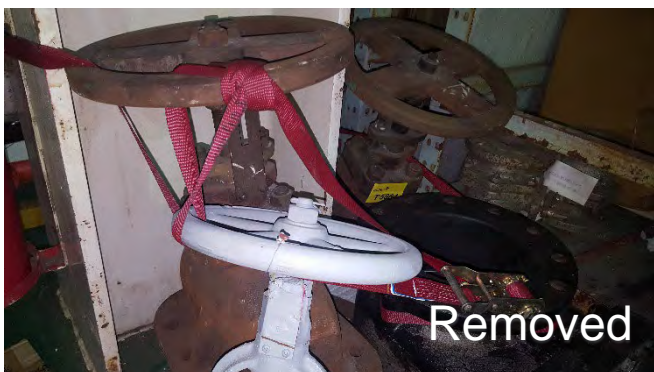
**Photo 85**  
T5864  
2nd Deck - Storage Area, Structural Column Adjacent 2nd Shelf from Fore – Gasket to Bonnet of x 2 Valves (Rusting) (Chrysotile)

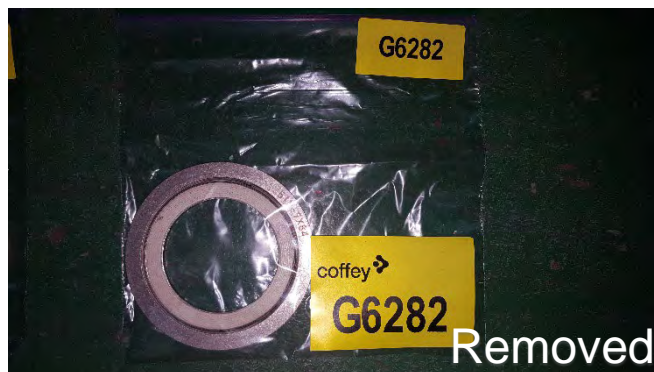
**Photo 86**  
G6282  
2nd Deck Storage Area, BF2 – Spiral Wound Gasket, Sealing Element (Cream)'Vortex 20x32x63 CT' (Chrysotile)

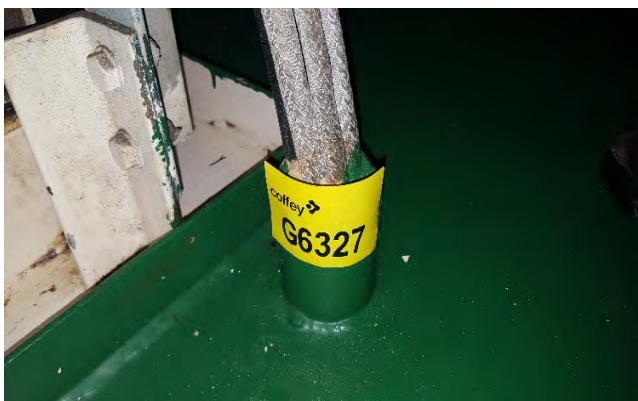
**Photo 97**  
G6327  
Upper Deck - Hydraulic Pump Unit Room (Ballast) Hydraulic Tank, Conduit Through Deck – Bulkhead penetration insulation (Presumed Positive) (Chrysotile)

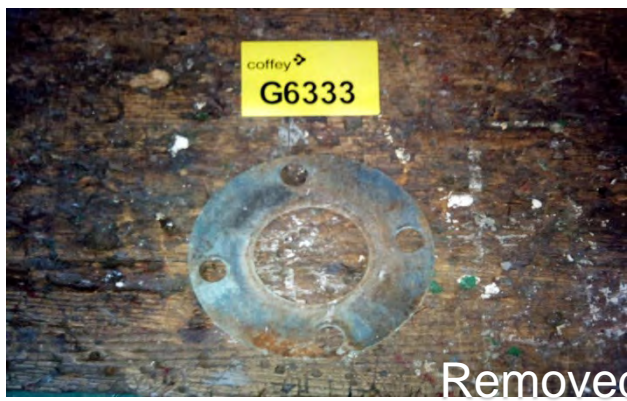
**Photo 98**  
G6333  
Upper Deck - External, Deck Workshop - Gasket Loose 'No Brand' (Blue) (UMF)

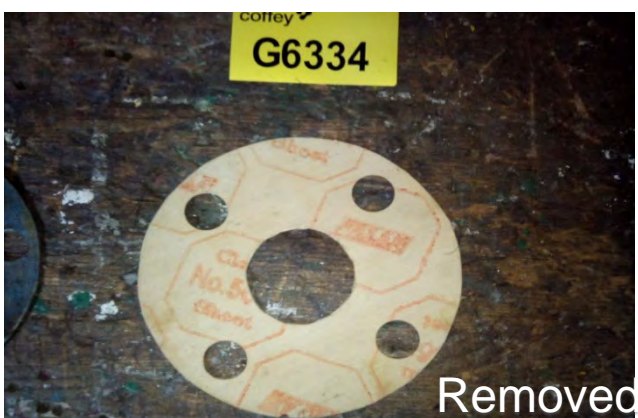
**Photo 99**  
G6334  
Upper Deck - External, Deck Workshop - Gasket Loose 'Pillar No. 5611' (Presumed Positive)(Chrysotile)

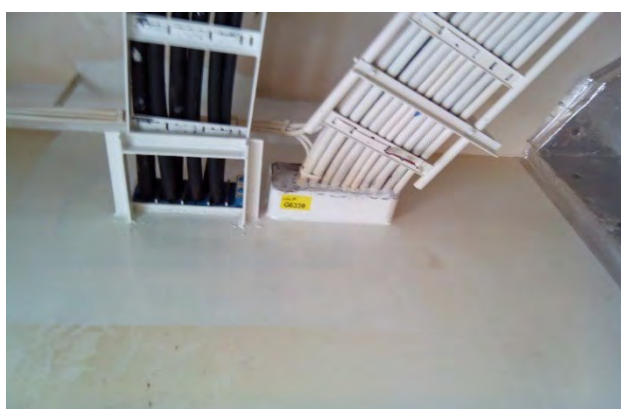
**Photo 100**  
G6339  
Upper Deck - Helicopter Rescue Equipment Store Penetration, – Bulkhead penetration insulation (Chrysotile)

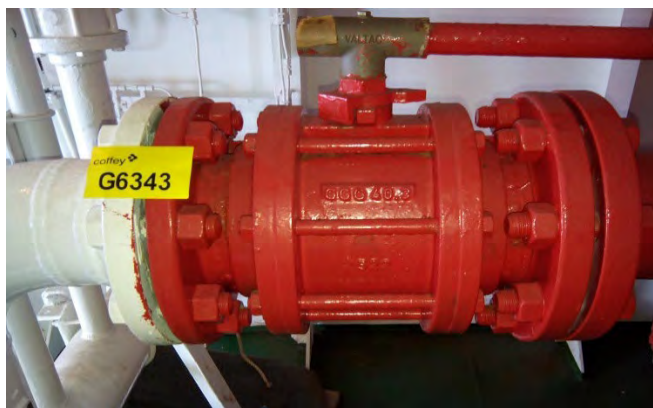
**Photo 103**  
G6343  
Upper Deck - Dry Chemical Unit Room, Aft, Outlet Storage, Under Manifold – Gasket (Chrysotile)

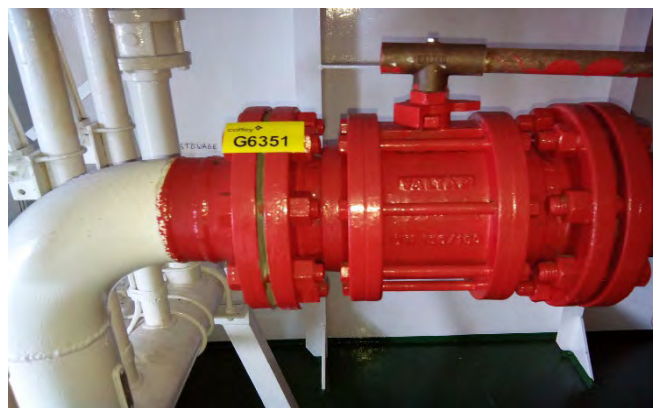
**Photo 104**  
G6351  
Upper Deck - Dry Chemical Unit Locker, Under Manifold - Gasket (Chrysotile)

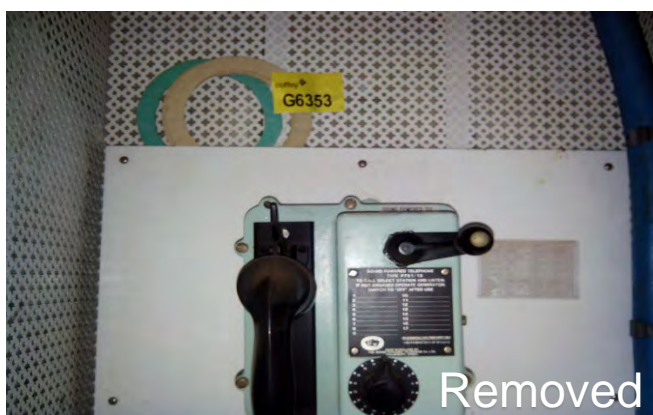
**Photo 105**  
G6353  
Upper Deck Cargo Motor Room, Telephone Booth – Gasket Loose 'Pillar Clean Sheet No. 5611' (Presumed Positive)(Chrysotile)

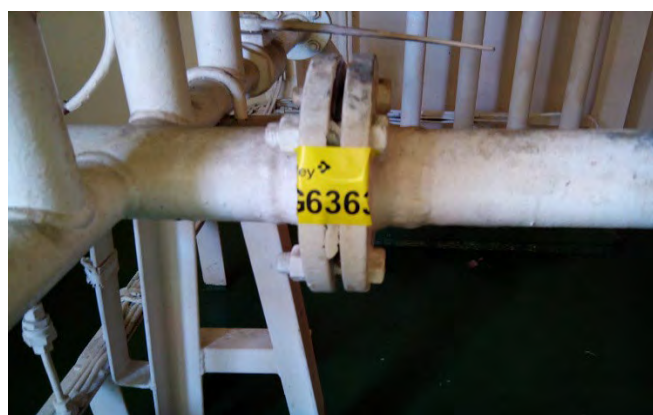
**Photo 106**  
G6363  
Upper Deck - External, Starboard Aft, Chemical Storage Tank Outlet - (Chrysotile)

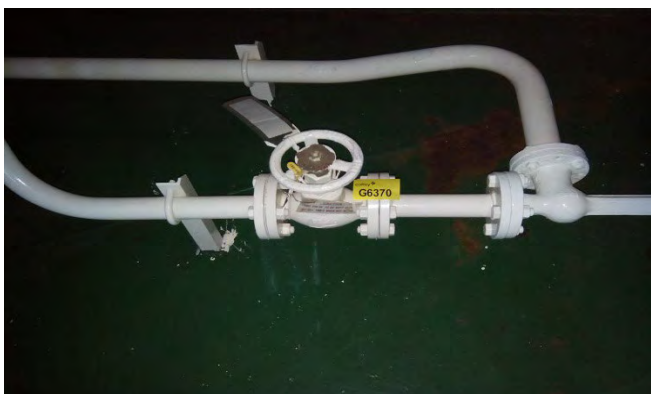
**Photo 109**  
G6370  
Upper Deck - Storage Area, Drawer, Shelf 1 from Fore 2, Adjacent Storage Column – Gasket (Pink) Adhered to Yellow Redundant Pump (Chrysotile)

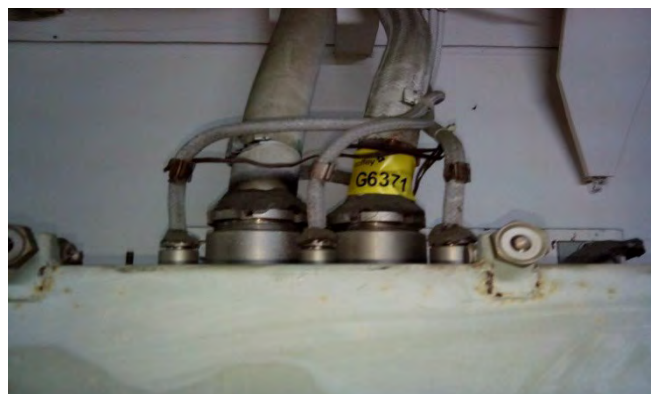
**Photo 110**  
G6371  
Upper Deck Forecastle/Bosun Store, No.2 Winch and Windlass Hydraulic Pump Power Cabinet Connection – Putty (Chrysotile)

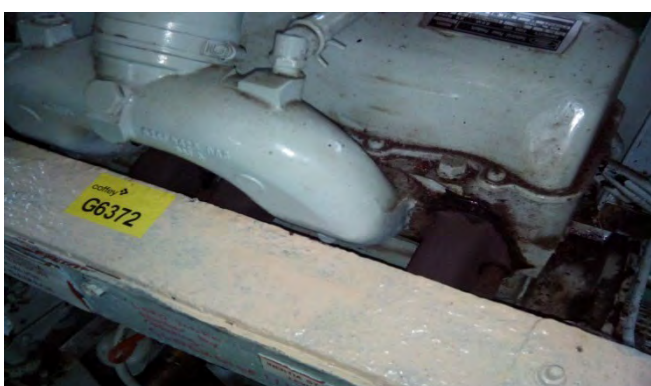
**Photo 111**  
G6372  
Upper Deck Forecastle/Bosun Store, Fire Pump Exhaust Manifold – Gasket (Chrysotile)

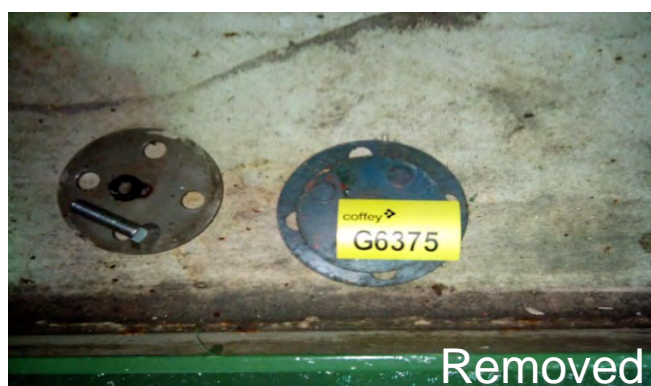
**Photo 112**  
G6375  
Upper Deck Forecastle/Bosun Store, to Storage Oil Tank Save - Gaskets Loose (UMF)

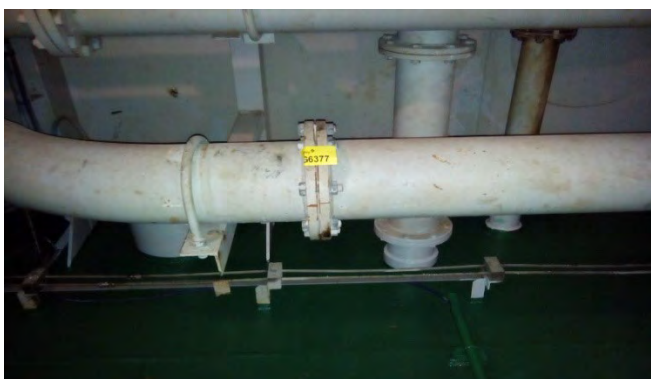
**Photo 113**  
G6377  
Upper Deck Pipe Passage Starboard, IG Pipe Flange (Aft) - Gasket (Chrysotile)

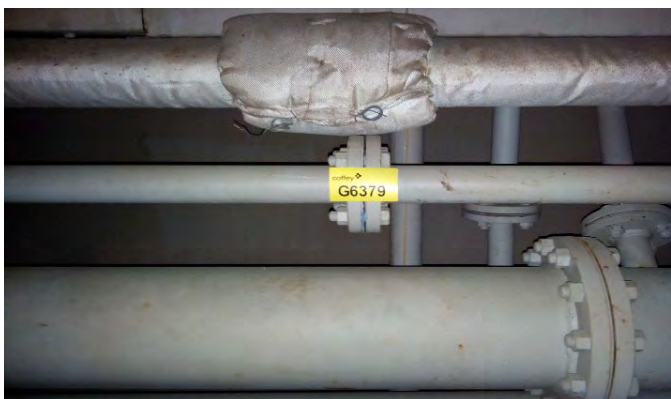
**Photo 115**  
G6379  
Upper Deck - Pipe Passage Starboard, Pipe Above Bunker Line 'A' - Gasket (UMF)

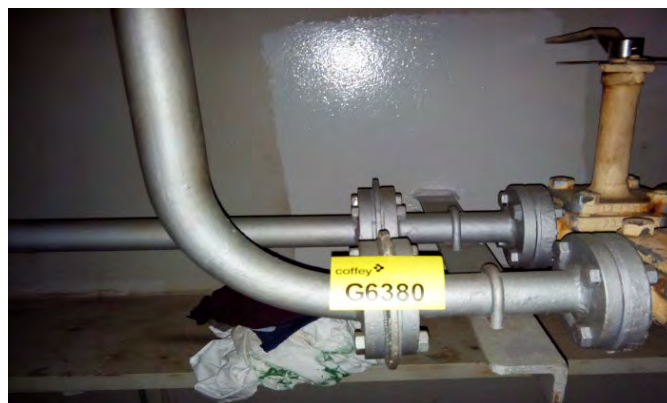
**Photo 116**  
G6380  
Upper Deck Pipe Passage Starboard, Valve to Sampling Line) - Gasket (UMF)

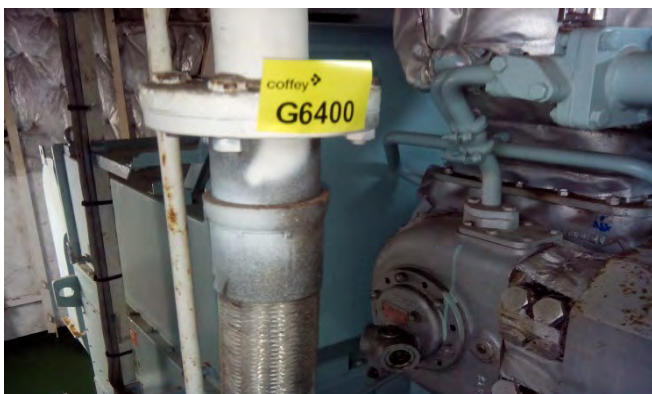
**Photo 121**  
G6400  
Upper Deck - Emergency Generator Room, Sump Vent, Flexible Hose Flange – Gasket (UMF)

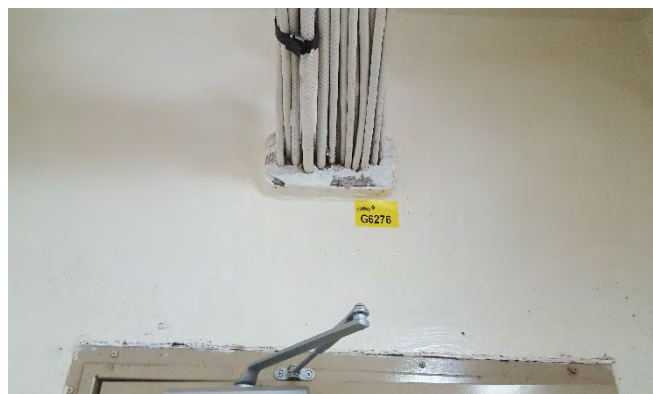
**Photo 122**  
G6276  
A Deck - Waste Storage Room, Bulkhead Above Entrance Door - Gasket (Chrysotile)

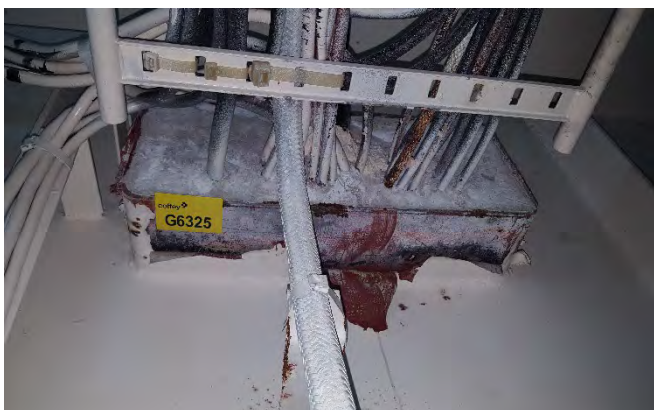
**Photo 127**  
**G6325**  
A Deck - Electrical Cable Room, Conduit Through Bulkhead – Bulkhead penetration insulation (Chrysotile)

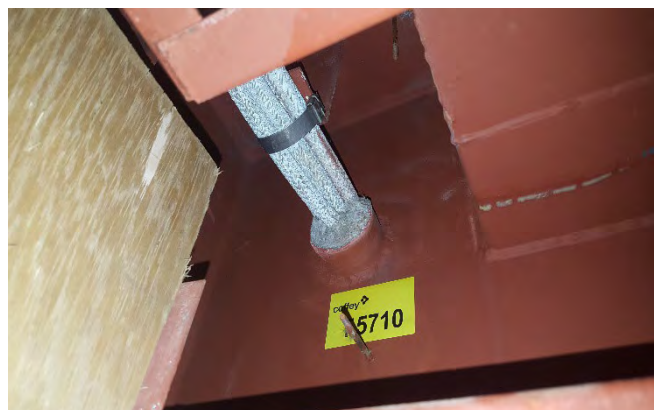
**Photo 128**  
**T5710**  
B Deck - Sauna, Conduit Penetrations (Throughout) – Bulkhead penetration insulation (Chrysotile)

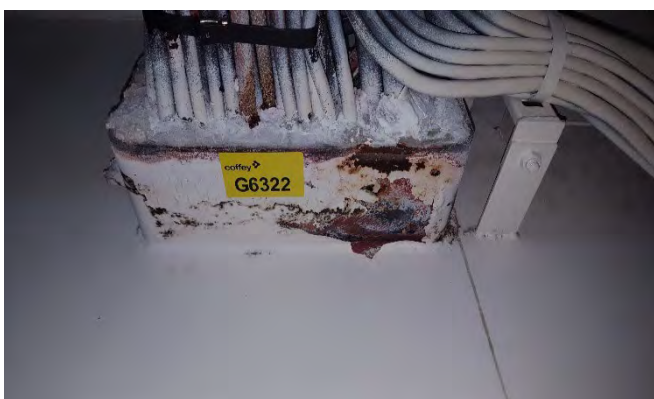
**Photo 129**  
**G6322**  
B Deck - Electrical Cable Trunk Room, Cables through Bulkhead – Bulkhead penetration insulation (Chrysotile)

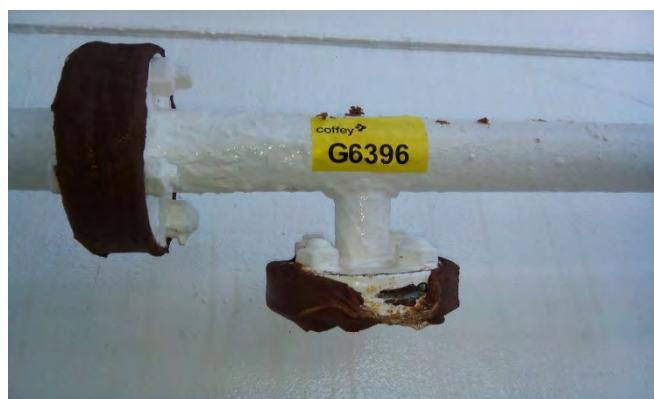
**Photo 130**  
**G6396**  
C Deck - External, Port Stairs, Deluge System, Flange Joint-Gasket (UMF)

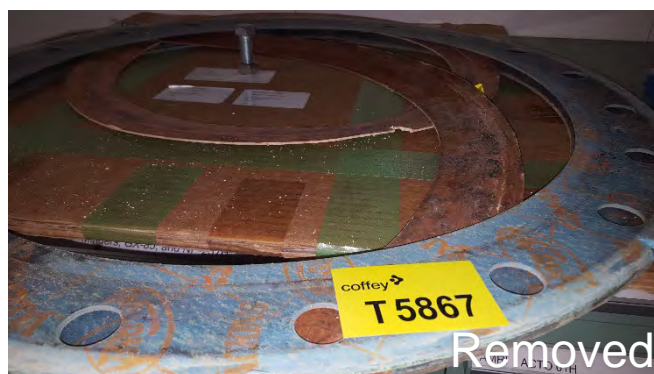
**Photo 132**  
**T5867**  
F Deck - No.2 Equipment Room, Aft Wall - Gasket Loose 'Valqua' (UMF)

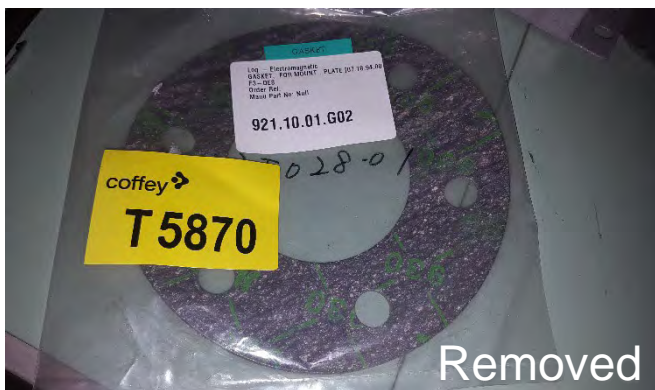
**Photo 133**  
 T5870  
 F Deck - No.2 Equipment Room, Drawer DE8 – Gasket  
 Loose 'Valqua 930' Electro-Magnetic Mount 921.10.01.G02  
 (Chrysotile)

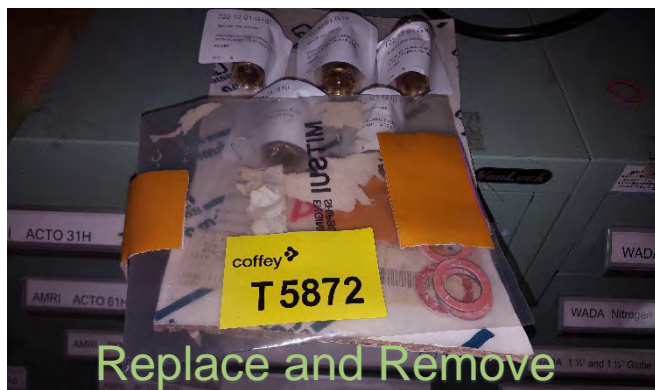
**Photo 134**  
 T5872  
 F Deck - No.2 Equipment Room, Drawer DB4 - Gasket  
 Loose, Boil Off Valve Bulkhead penetration insulation Gland  
 (Orange) (Chrysotile)

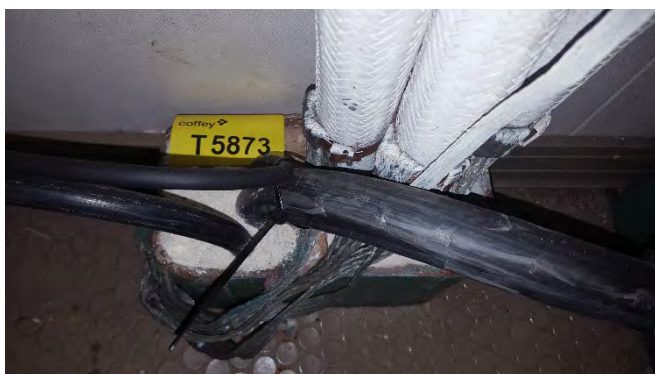
**Photo 135**  
 T5873  
 F Deck No.2 Equipment Room, Bulkhead penetration  
 insulation (Off-White, Soft) (Presumed Positive) (Chrysotile)

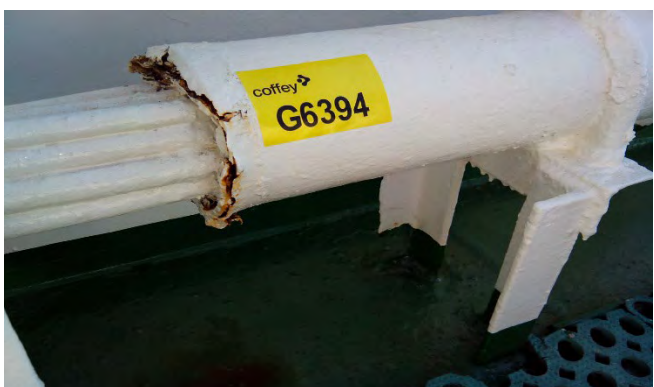
**Photo 141**  
G6394  
Nav. Bridge Starboard Bridge Wing – Bulkhead penetration insulation (Presumed Positive) (Chrysotile)

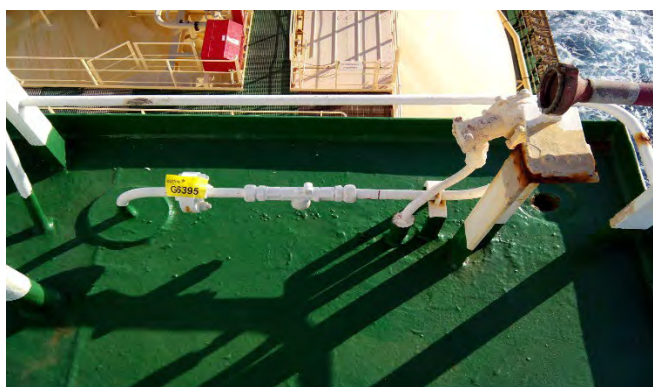
**Photo 142**  
G6395  
Nav. Bridge External, Monkey Island, Air Horn, Starboard Side – Gasket (UMF)

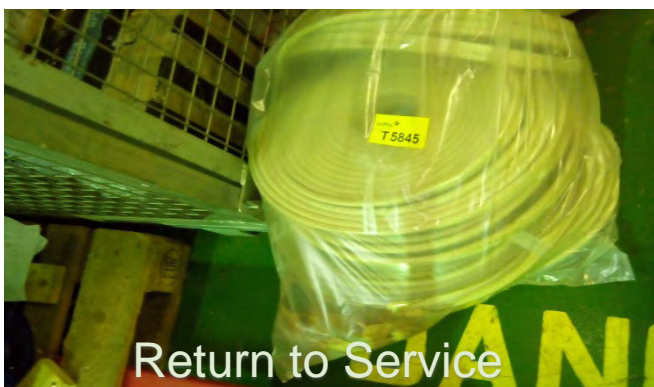
**Photo 143**  
T5845  
2nd Deck Storage Area, Contained for Reassurance, Return to Area Above Cabinets 'BF' & 'BE'– Boiler Lagging 680.01.01.G14 (No Asbestos Detected)

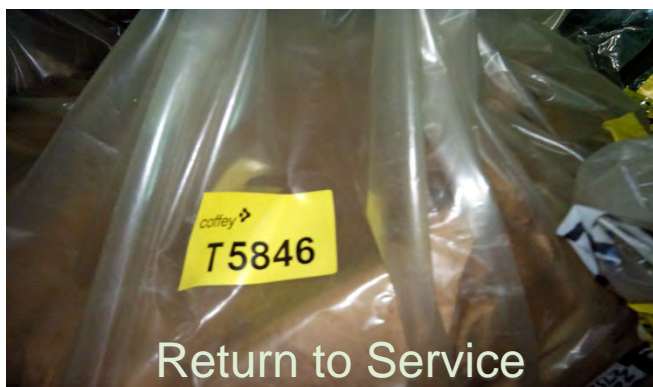
**Photo 144**  
T5846  
2nd Deck Storage Area, Contained for Reassurance, Return to Area Above Cabinets 'BF' & 'BE'– Boiler Lagging 680.01.01.G14 (No Asbestos Detected)

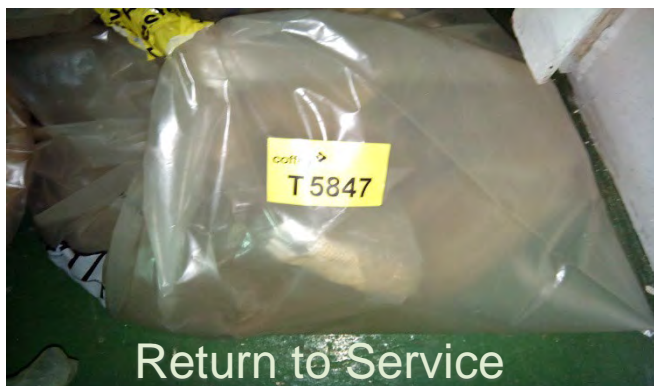
**Photo 145**  
T5847  
2nd Deck, Storage Area, Contained for Reassurance, Return to Area Above Cabinets 'BF' & 'BE'– Boiler Lagging 680.01.01.G14 (No Asbestos Detected)

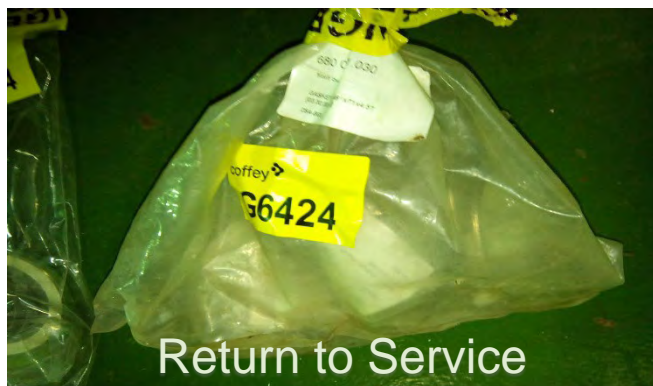
**Photo 146**  
G6424  
2nd Deck Storage Area, Contained for Reassurance Return to Drawer BG3, Gasket, Gasket (Ring) [680.01.01.030 (No Asbestos Detected)

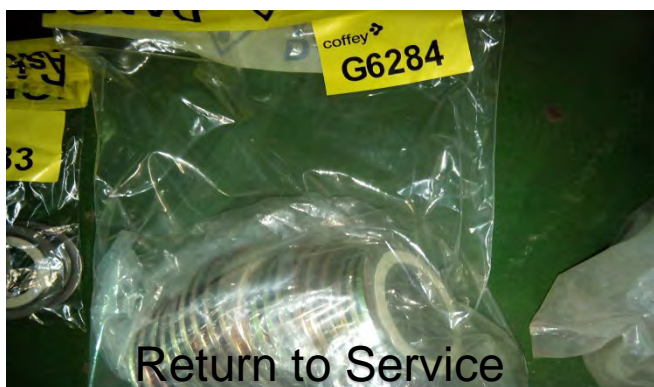
**Photo 147**  
G6284  
2nd Deck, Storage Area, Contained for Reassurance Return to Area BF2 Labelled (Main Boiler Instruments) Spiral Wound Gasket, Sealing Element (White) 'Valqua VN D-20K-40 CT' (No Asbestos Detected)

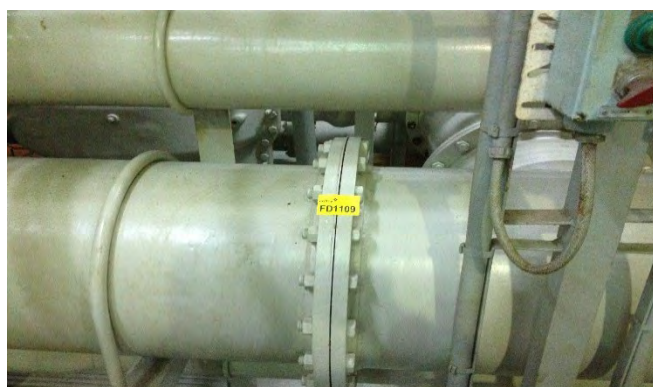
**Photo 148**  
FD1109  
Lower Deck, Seawater Cooling System Pipework Valves - Gasket (UMF)
