Asbestos Materials Refit survey and partial reinspection

NW Snipe

Shell Tankers Australia Pty Ltd

Report reference number: 754-PEREN324142

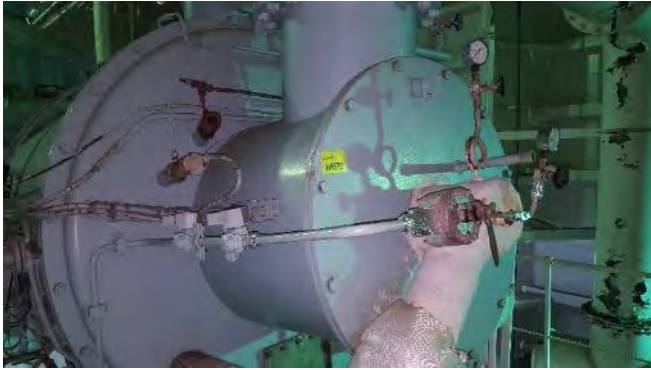
Photo 36
H6667
3rd Deck, IGG Room, HFO Tank Steam Heating Valve Flange,
Gasket (Chrysotile)

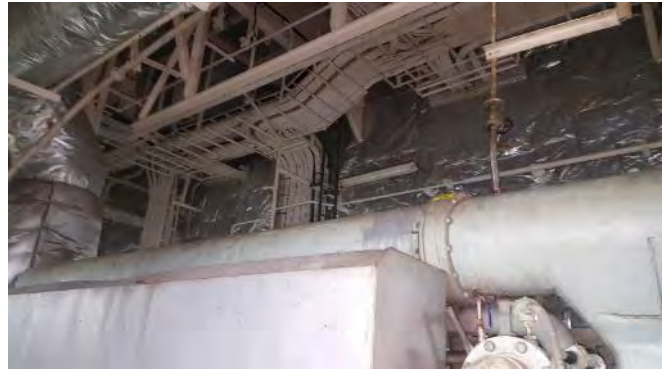
Photo 49
H6684
3rd Deck, No.2 Diesel Generator Room, Temperature Sensor - Charge Air Cooler, Gasket (Chrysotile)

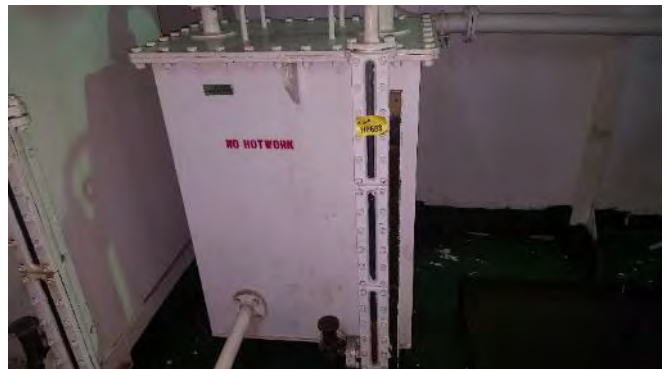
Photo 51
H6687
3rd Deck, Steering Flat, Transfer Oil Tank Level Gauge Glass, Gasket (Chrysotile)

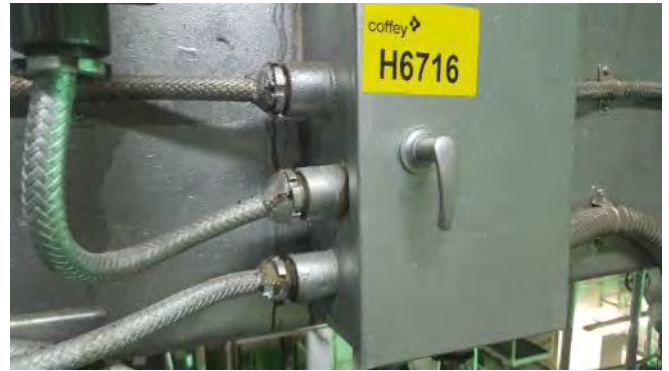
Photo 61
H6714
2nd Deck, Engine Room, Starboard Boiler No.1 Retractable Soot Blower Power Junction Box, Putty (Chrysotile)

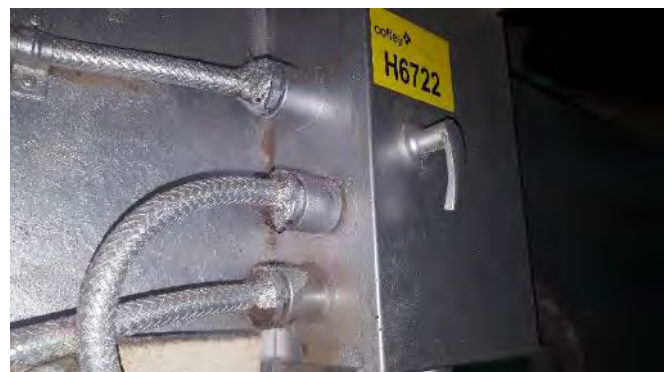
Photo 63
H6721
3rd Deck, Engine Room, Port Boiler No.1 Retractable Soot Blower Power Junction Box, Putty (Chrysotile)

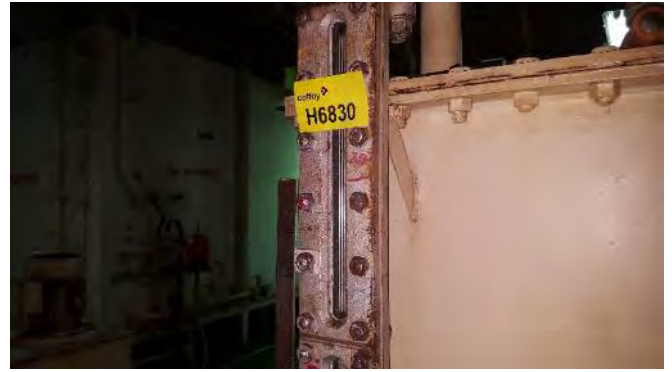
G6823

Upper Deck, Engine Room, Main C.C.S F.W. Expansion Tank Low Level Switch, Gasket (Chrysotile)

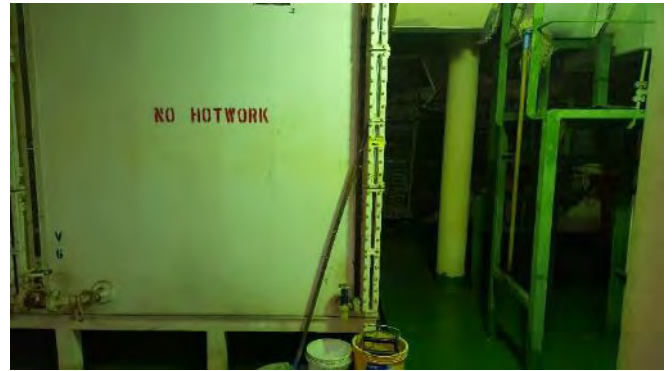
G6831

Upper Deck, Fo'c'sle/Bosons Store, No.3 Winch & Windlass Starter Box, Putty (Chrysotile)

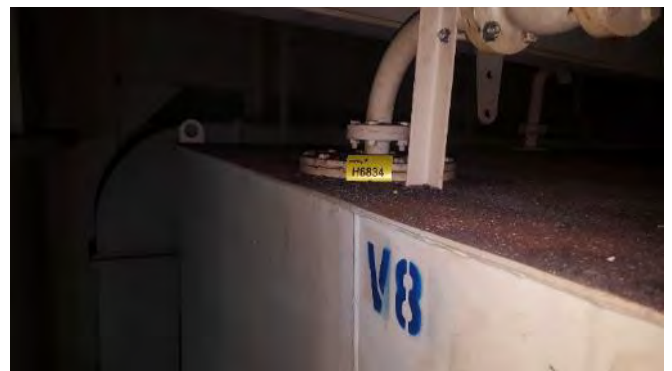
G6833

Upper Deck, Fo'c'sle/Bosons Store, Storage Oil Tank Sight Glass, Gasket (Chrysotile)

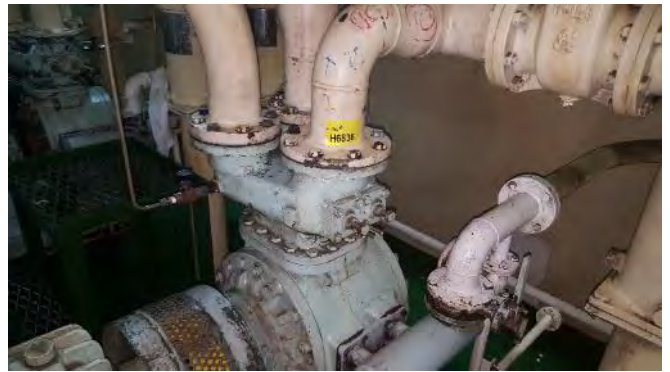
Photo 109
G6835
Upper Deck, Fo'c'sle/Bosons Store, Pipework to Transfer Oil Tank, Gasket (Chrysotile)

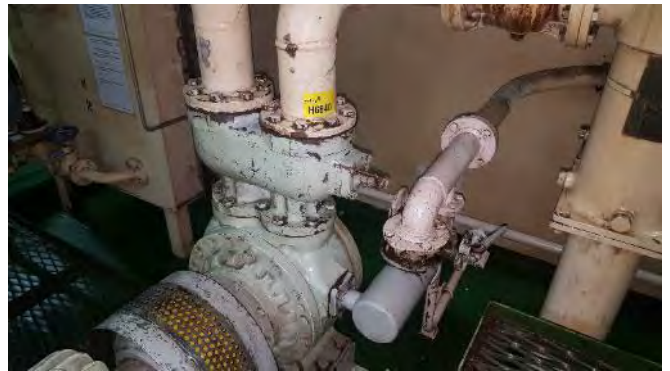
Photo 111
G6839
Upper Deck, Fo'c'sle/Bosons Store, Hydraulic Pump No.3 Suction Flange, Gasket (Chrysotile)

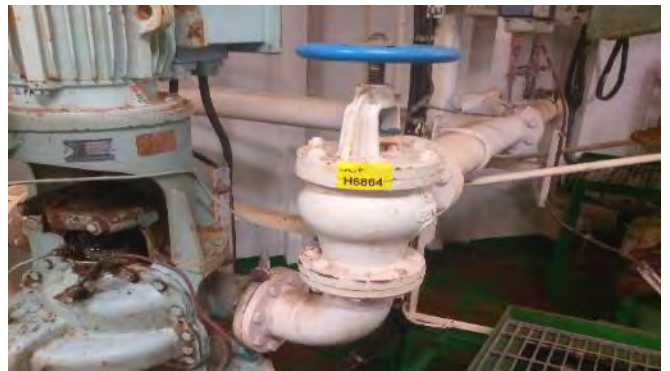
Photo 113
G6841
Upper Deck, Fo'c'sle/Bosons Store, Hydraulic Pump No.4 Suction Flange, Gasket (Chrysotile)

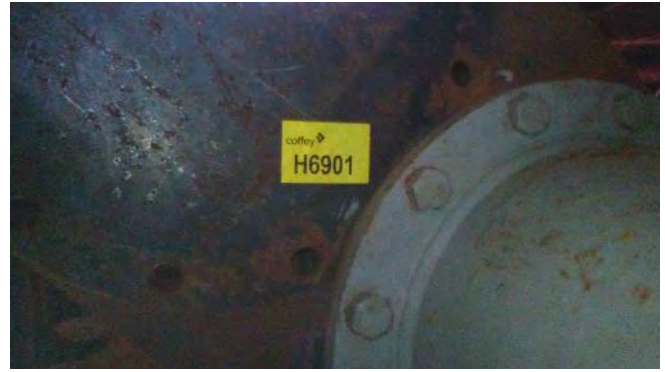
Photo 127
H6900
Upper Deck, Port Passage, Spectacle Piece Port Frame 65,
Gasket (UMF)

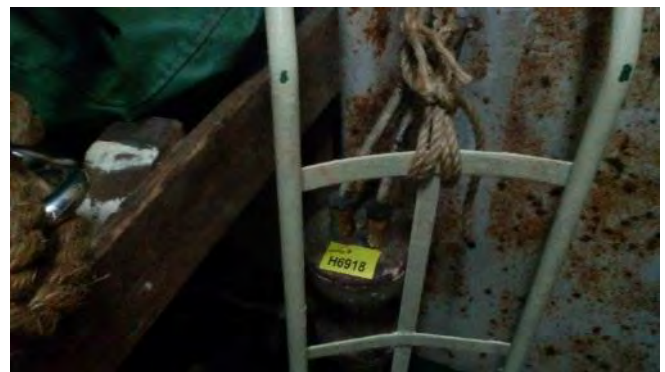
Photo 131
H6917
Upper Deck, Shipwright Store, Port Side Aft Through FWD
Bulkhead, Packing (Chrysotile)

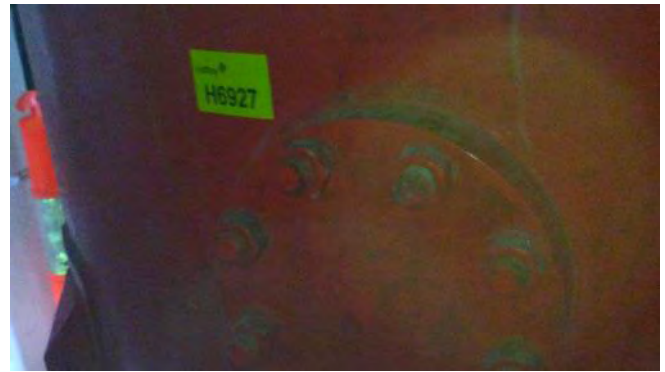
Photo 133
H6920
Upper Deck, No.3 Dry Chemical Powder Room Vessel Pipework Outlet Flange to Manifold, Gasket

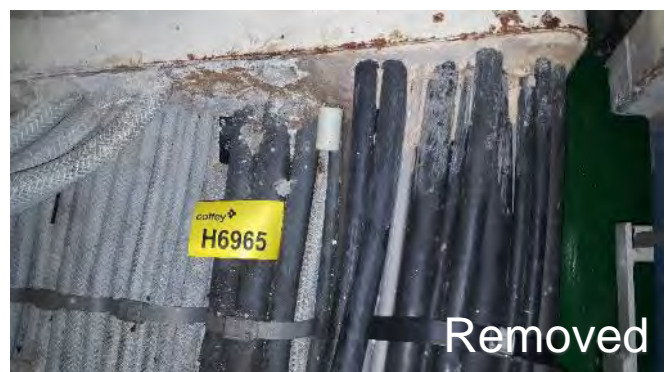
Photo 137
H6963
Nav. Bridge, Cable Trunk Room (CRYOS) Deck Penetration, Packing (Chrysotile)

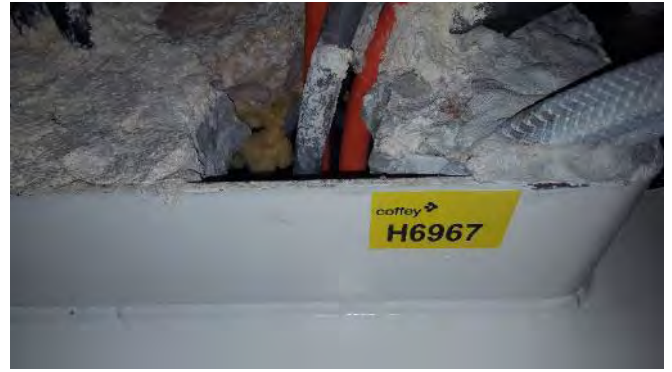
Photo 139
G6966
F Deck, Electric Cable Space, Starboard Bulkhead(Around Cables), Packing (White) (Chrysotile)

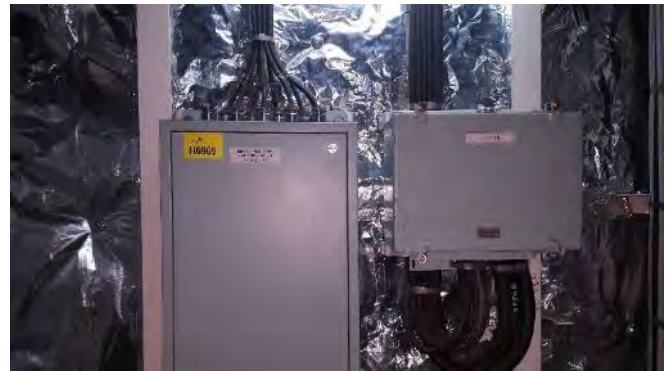
Photo 141
H6968
F Deck, Electric Cable Space, Below Inboard Deck Head, Debris & Dust (Chrysotile)

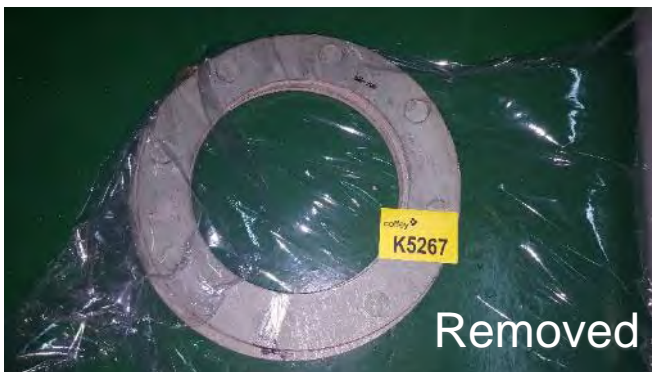
Photo 166

2nd Deck, 2SA, BJ2, Gaskets Loose (Various Sizes of Graphite Material) (Chrysotile)

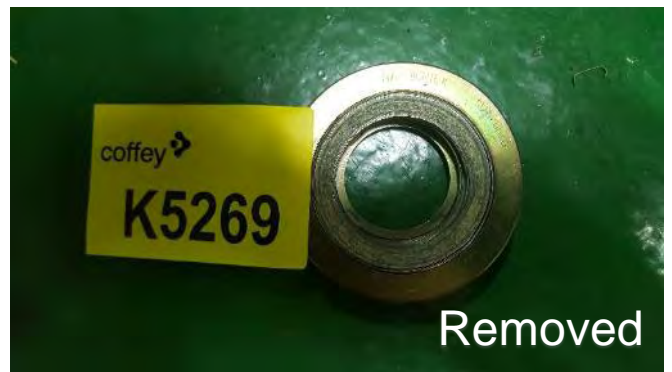
Photo 167

2nd Deck, 2SA, BJ2, Gaskets Loose (Green with White Speckles 5K200A) (Chrysotile)

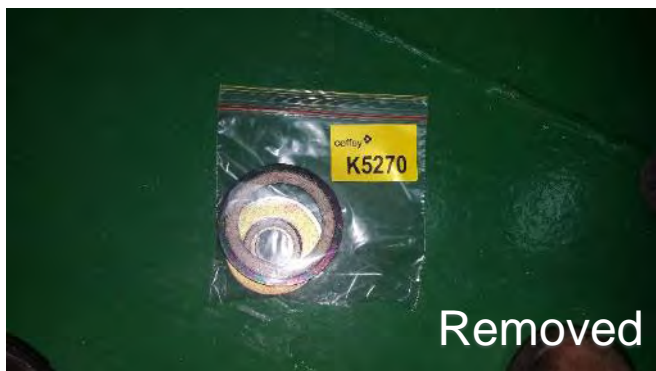
Photo 168

2nd Deck, 2SA, BJ2, Spiral Wound Loose Gaskets Vortex C20 K25,D 20K 25 (Chrysotile)

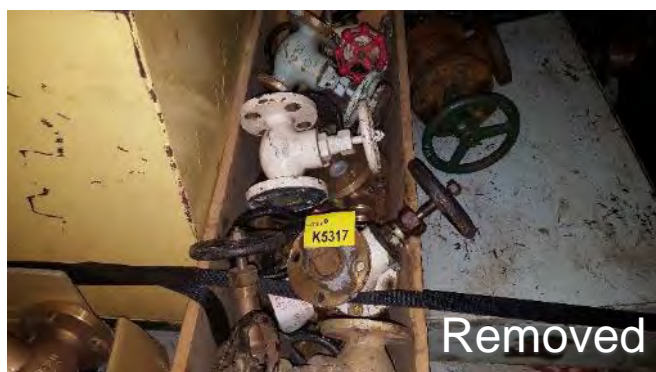
Photo 179

2nd Deck, Workshop Loft, Small Grey Metal Box Beneath Black Crate Containing Brass Valves, Gasket (Bonnet) (Chrysotile)

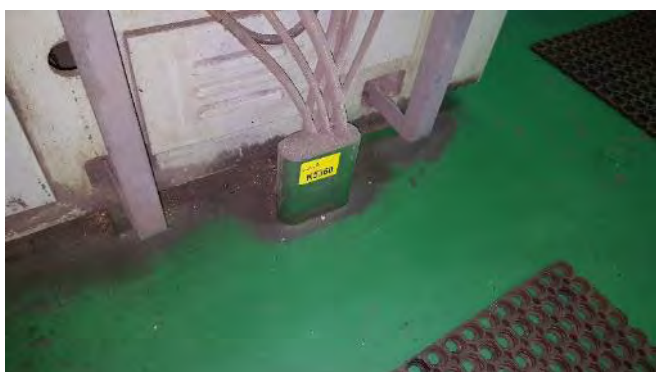
3rd Deck, Workshop, ARC Welder Connection Box Power Inlet (Welding Booth), Putty (Chrysotile)
