Asbestos Materials Refit survey and partial reinspection

NW Stormpetrel

Shell Tankers Australia Pty Ltd

Report reference number: 754-PEREN324141

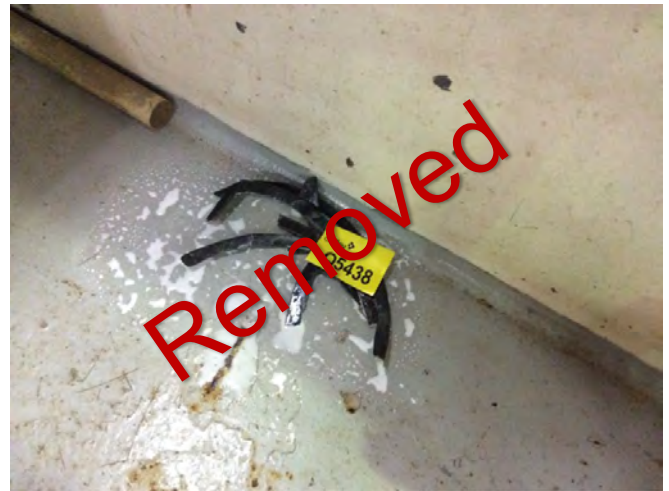
Photo 2

Tank top engine room - fwd VPJ 44 Ballast v/v flange (original gasket)

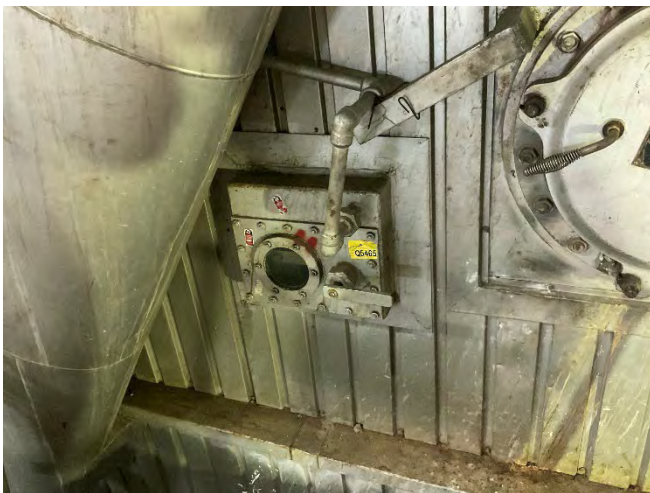
Photo 3

Tank top - fwd port under 1 ballast P/P suction
Loose remnant Gasket (Tombo 1500) under 1 ballast P/P suction

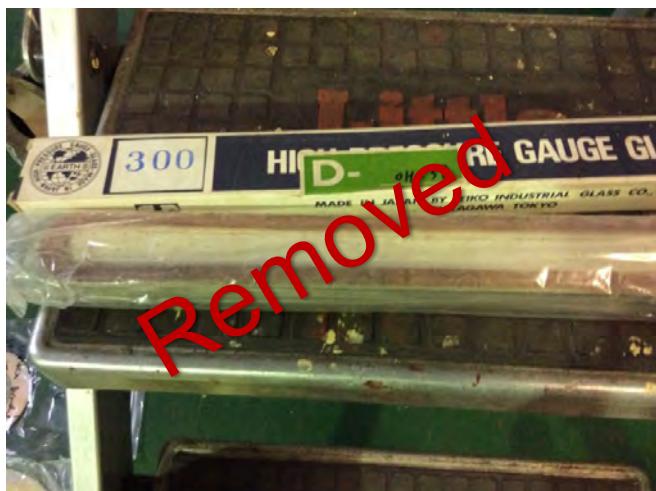
Photo 28
Q5200
2nd deck - 2sa - cc3 drawer

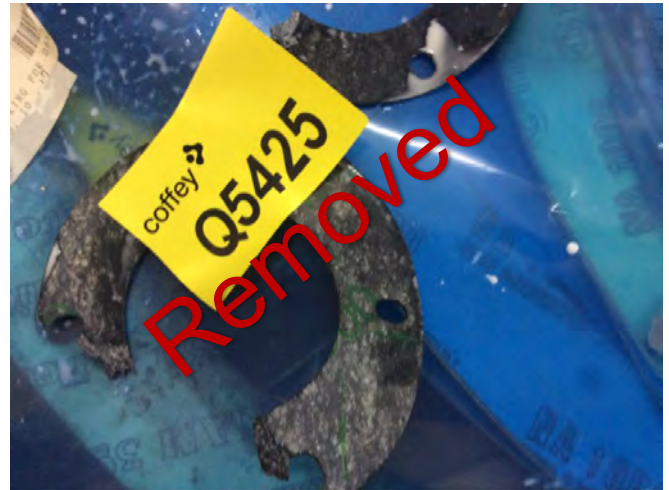
Photo 33
Q5371
Focsle Store -Starboard Aft - Hyd Oil Fuel Tank Return Glass
Gasket to hyd oil tank return glass gasket

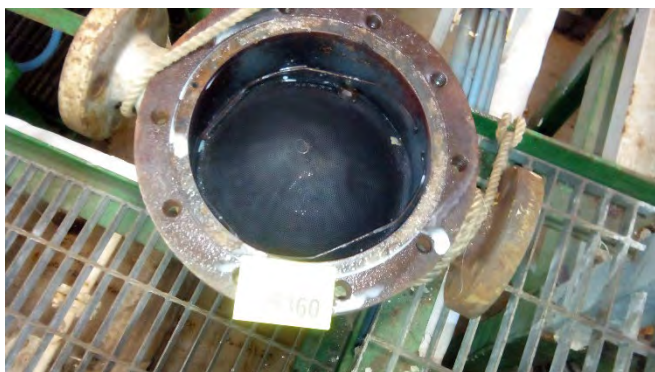
Photo 36
Q5360
CMR - lower old strainer between LD comps
lower old strainer between LD comps gasket

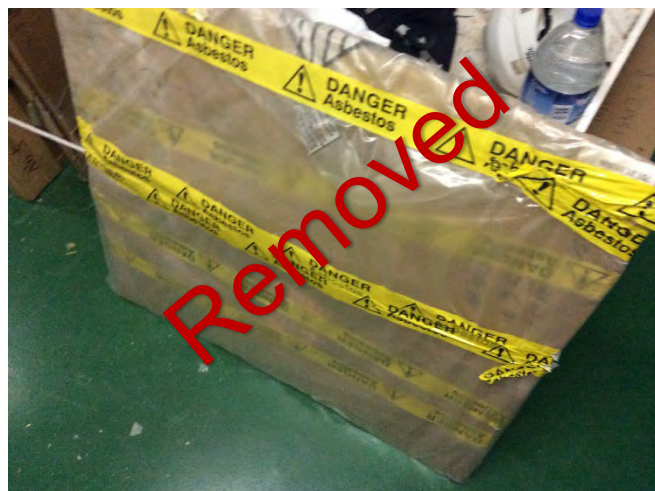
Photo 37
Q5360
CMR - lower old strainer between LD comps
lower old strainer between LD comps gasket (remnant Gasket)

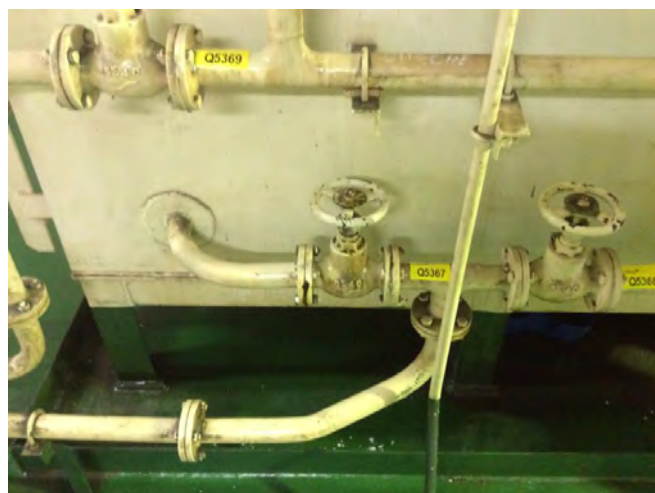
Photo 39
Q5366
Focsle store -starboard Aft - hyd oil store tk outlet
Gasket to hyd oil store tk outlet

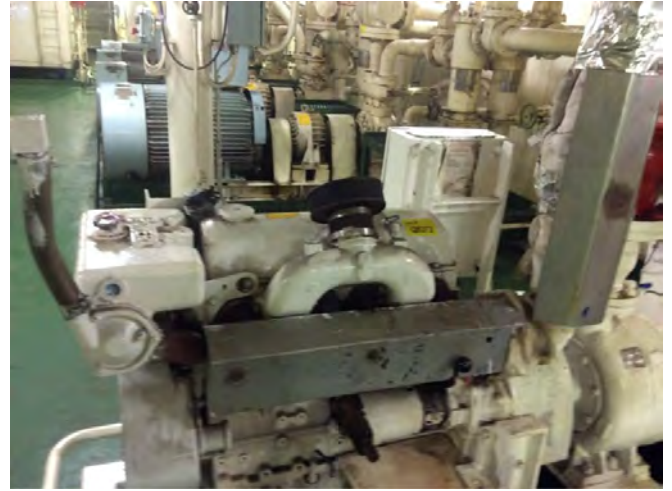
Photo 41
Q5369
Focsle store -starboard Aft - hyd trans P/P suction
Gasket to hyd trans P/P suction

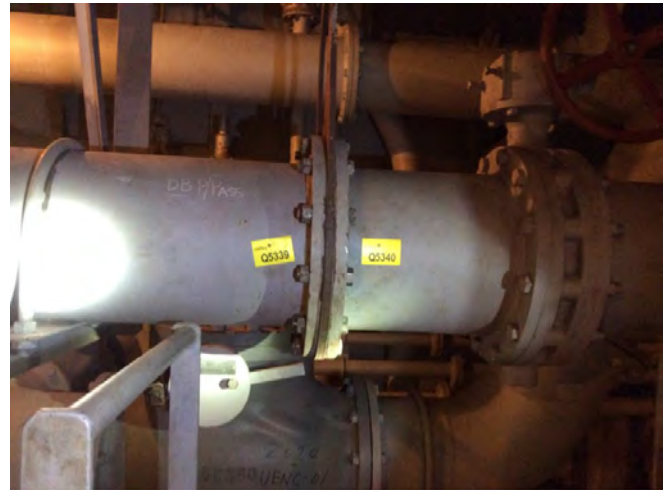
Photo 43
Q5339
Port UDPP- IG 2 Dbpp
Spectacle piece downstream Gasket

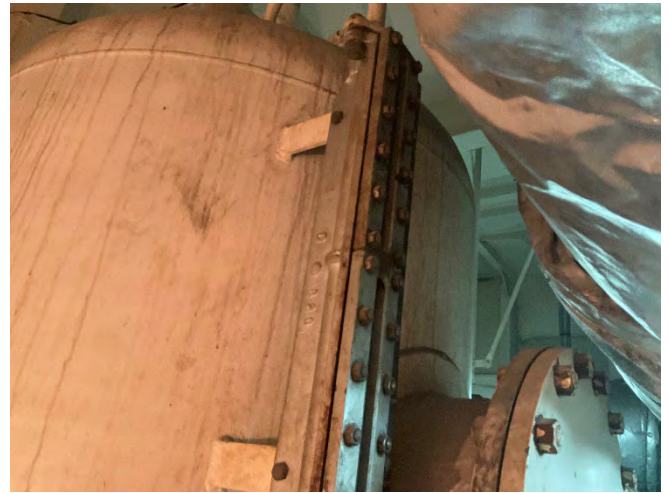
Photo 45
Q5341
Port UDPP IG to ebpp Valve Gasket

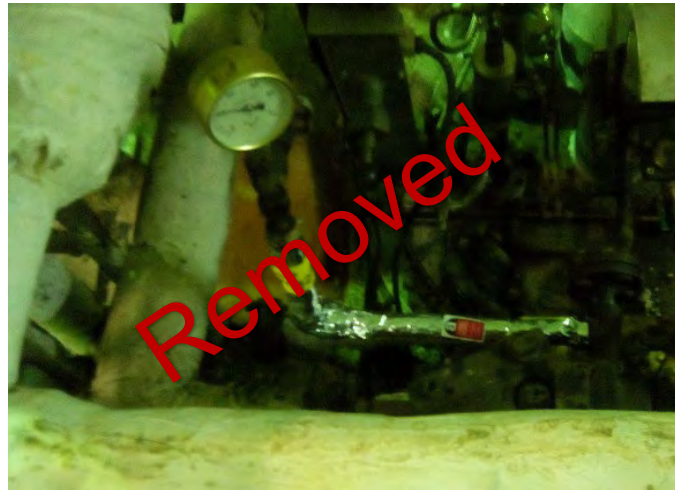
Photo 57
FD5239
2nd Deck, Engine Room, No.2 Boiler Drum Safety Valve, Aft, Woven Rope (Chrysotile)

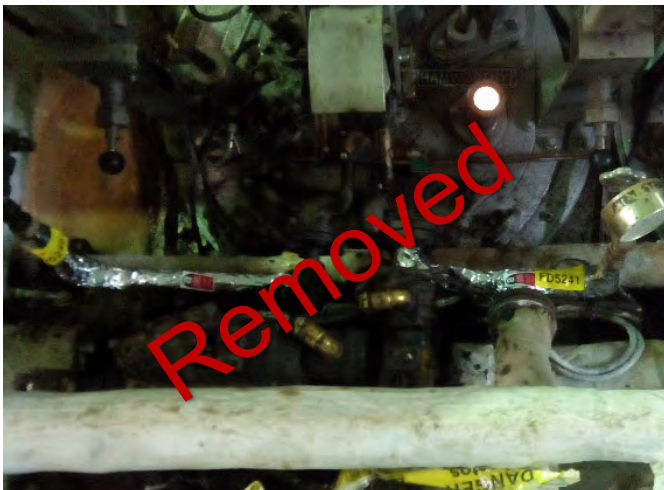
Photo 58
FD5240
2nd Deck, Engine Room, No.1 Boiler, No.1 Burner F.O. Gauge Line, Woven Rope (Chrysotile)

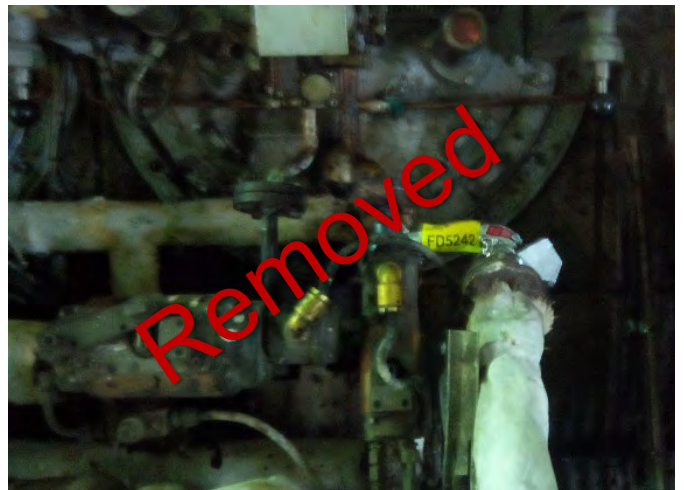
Photo 59
FD5241
2nd Deck, Engine Room, No.1 Boiler, No.1 Burner ATM, Steam Line, Woven Rope (Chrysotile)

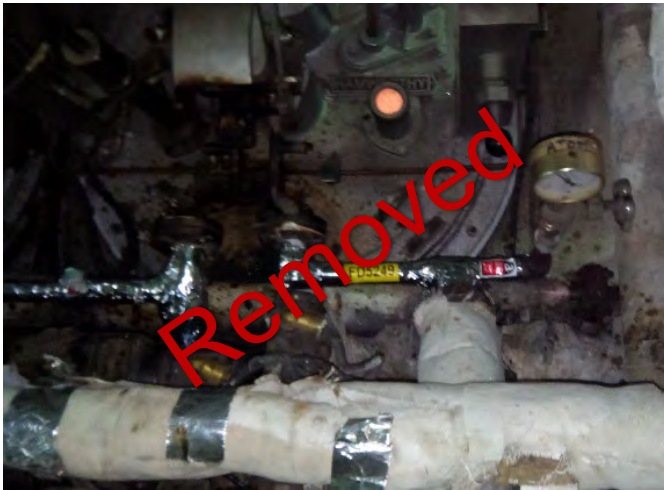
Photo 60
FD5242
2nd Deck, Engine Room, No.1 Boiler, No.2 Burner ATM, Steam Line, Woven Rope (Chrysotile)

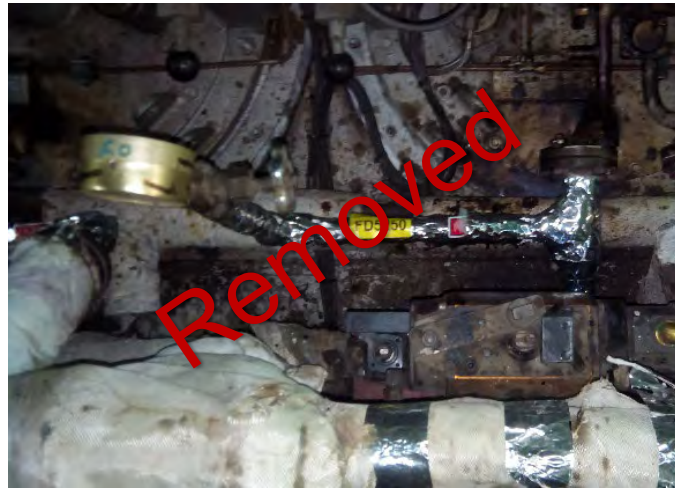
Photo 61
FD5249
2nd Deck, Engine Room, No.2 Boiler, No.1 Burner ATM,
Steam Line, Woven Rope (Chrysotile)

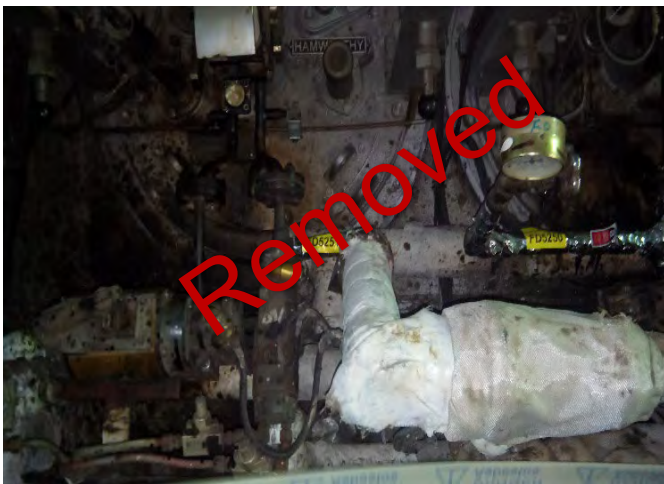
Photo 62
FD5250
2nd Deck, Engine Room, No.2 Boiler, No.1 Burner F.O.
Supply Line, Woven Rope (Chrysotile)

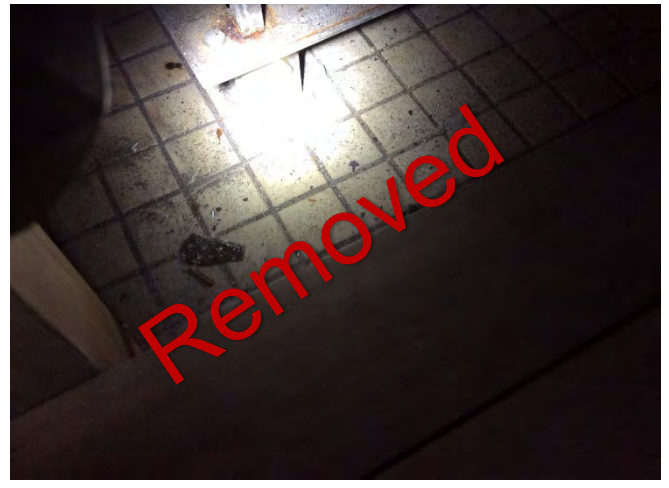
Photo 67
Q5052
2nd Deck, Sauna, Fibre Cement Debris (Chrysotile)

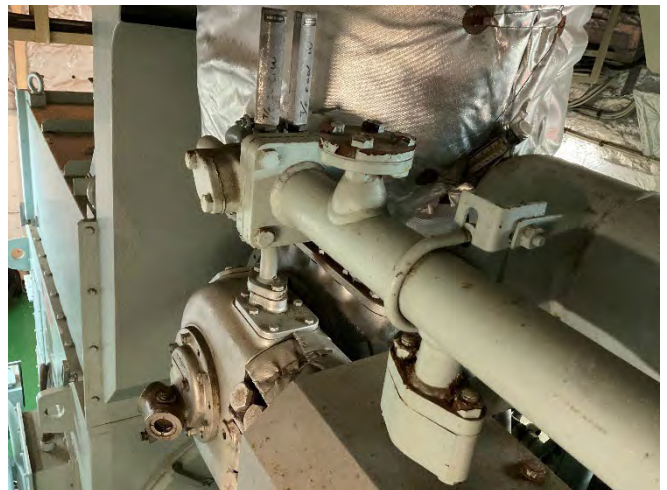
ZA21820

A Deck Incinerator Room - Gasket to new pipe joint (Chrysotile)
