LIFEBOAT DRILL SAFETY ISSUE 2009

1 AIMPE LIFEBOAT DRILL POLICY: for davit-launch & freefall-launch lifeboats

LIFEBOATS

4. Don't Rely on Stainless Steel; some grades may rot!

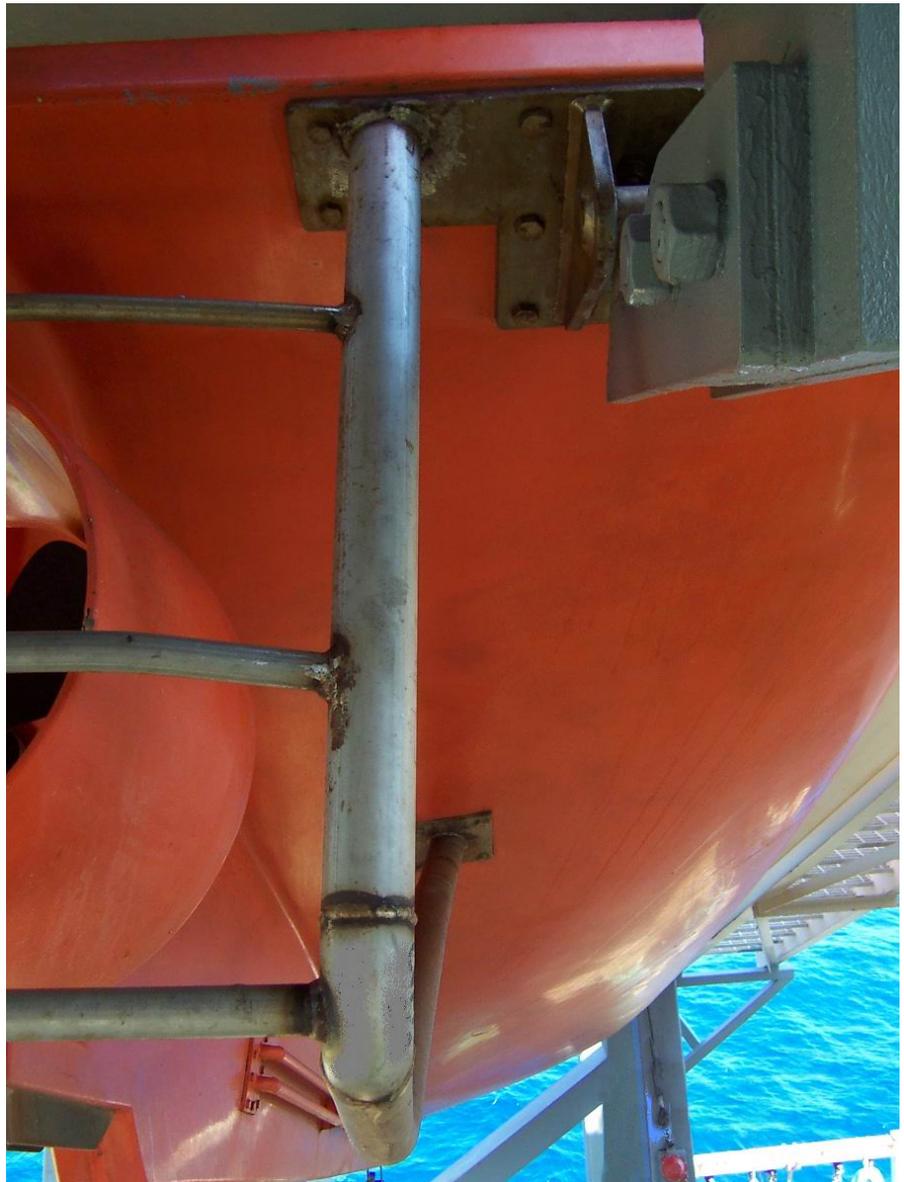
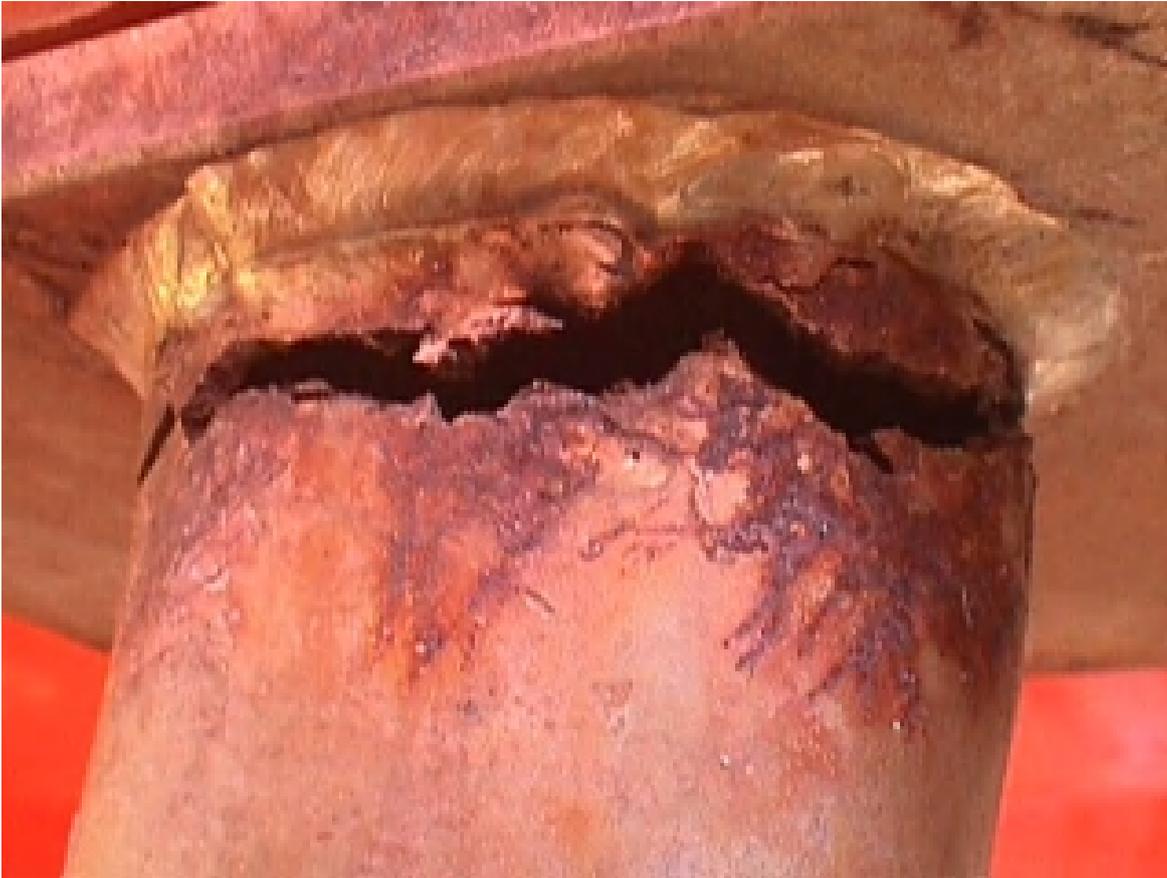
Experience gained in the Timor Sea and off the Pilbara coast has reached an unequivocal conclusion that 304 / 302 grade (Austenitic) stainless fasteners suffer from CSCC under normal service conditions on deck due to the high ambient temperatures and solar radiation which often raises metal temperatures above 70 Deg C. These fasteners are identified by head markings as per the attached spreadsheet.

The insidious thing about this failure mechanism is **that there is no prior warning**, so NDT of parts will often show no defects.

Cracks can propagate to full material thickness within a few weeks. The first warning is usually a bolt head missing or found on the deck or alternatively sheared heads when trying to disassemble components.

See attached spreadsheet, summary and photos of lifeboat propeller guard.

AIMPE members have found A4 or 316L to be suitable for most bolting applications, however this material is totally unsuitable for warm stagnant seawater applications (particularly piping) due to extremely rapid pitting corrosion to full material thickness within about a month. (exacerbated by the presence of hydrogen sulphide from microbial action or sour crudes.)

Woodside has a total ban on the use of 302 / 304 grade of stainless steels, except for "special duty" such as in superheated steam service (ASTM - Grade B8) or in submerged pump applications where temperatures do not rise above seawater temp.
