# Maritime Asbestos Materials Post Re-Fit Assessment

Post Re-Fit Survey - Northwest Sandpiper (IMO: 8913150)

Shell Tankers Australia Pty Ltd

**Report reference number: 754-PEREN310903**

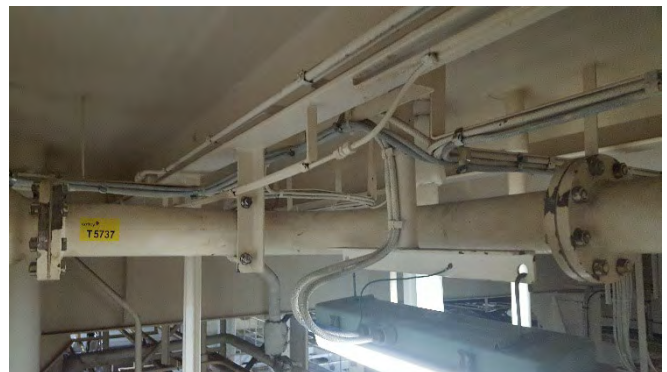
**Photo 33**  
T5737  
3rd Deck Workshop Mezzanine, Starboard, Fore, Diesel Oil Inlet (3 Way Valve) – Gasket (White) (Chrysotile)

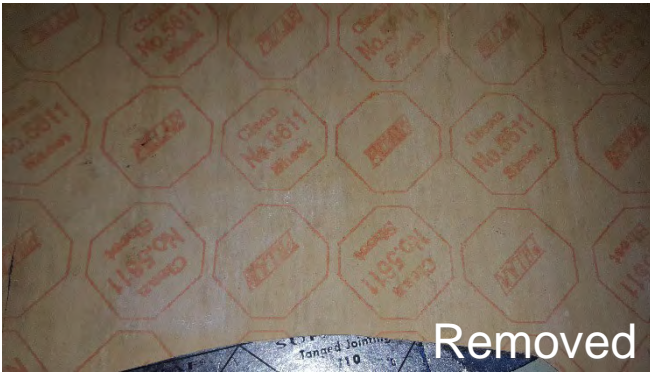
**Photo 36**  
T5749  
3rd Deck - Workshop, Bulkhead penetration insulation Draws, First Draw (Labelled Off-Cuts) - Gasket 'Pillar Clean Sheet No. 5611' (Orange Font, Beige Back) (Presumed Positive)

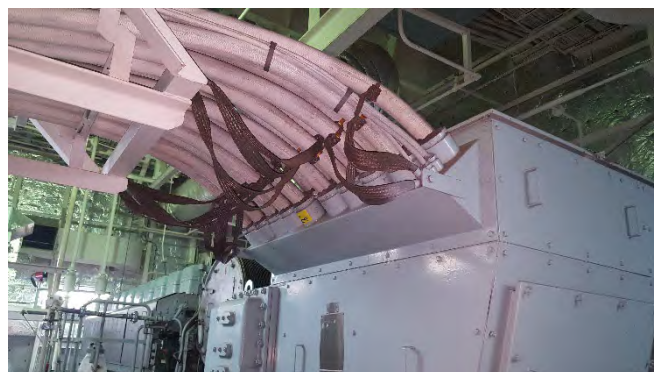
**Photo 49**  
G6215  
3rd Deck - No.1 Diesel Alternator Room , Lube Oil Cover, End Cover FWD – Gasket (UMF)

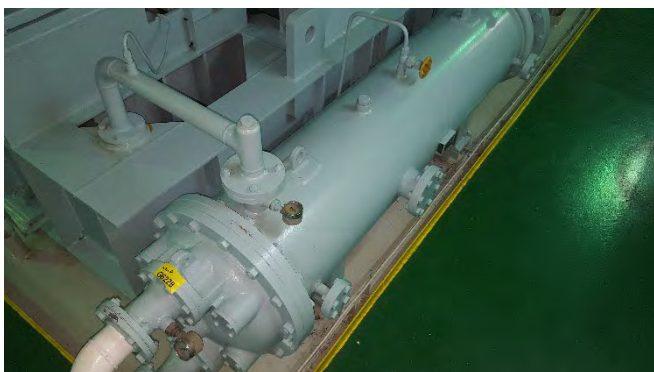
**Photo 54**  
G6226  
3rd Deck - No.2 Diesel Alternator Room , Lube Oil Pump Suction, Flange – Gasket (Chrysotile)

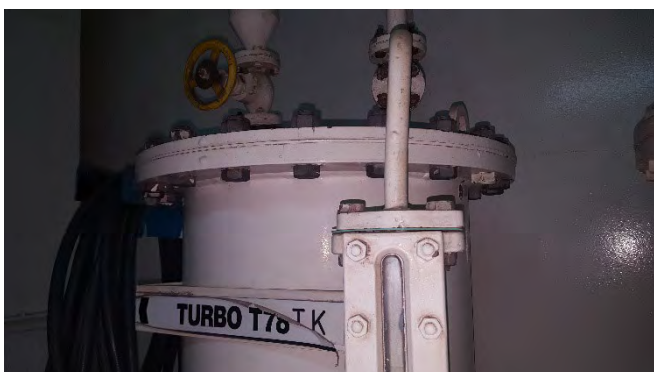
**Photo 64**  
G6290  
3rd Deck Engine Room, Turbine, Lube Oil Gravity Tank Level Sight Glass Flange – Gasket (Chrysotile)

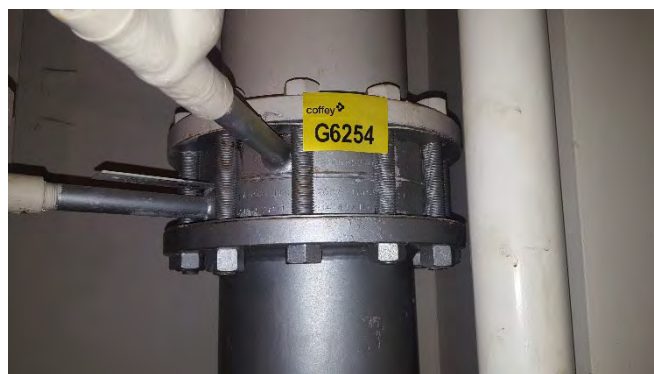
**Photo 89**  
G6254  
2nd Deck Steam Isolation Valve to Cargo Machinery Room – Lagging (Chrysotile)

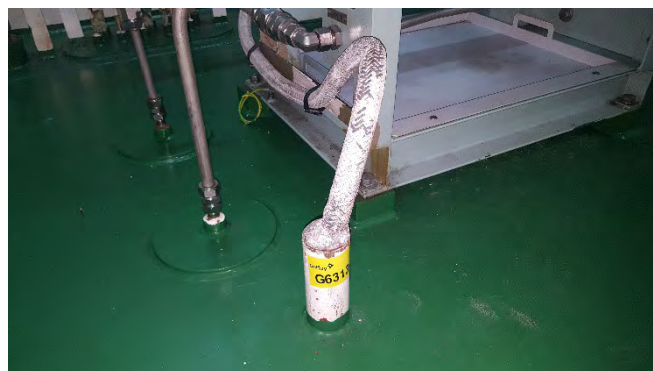
**Photo 93**  
G6311  
2nd Deck Chemical Locker, Boiler, Chemical Dosing Tank, Low Level Switch – Putty (Soft) (Presumed Positive)

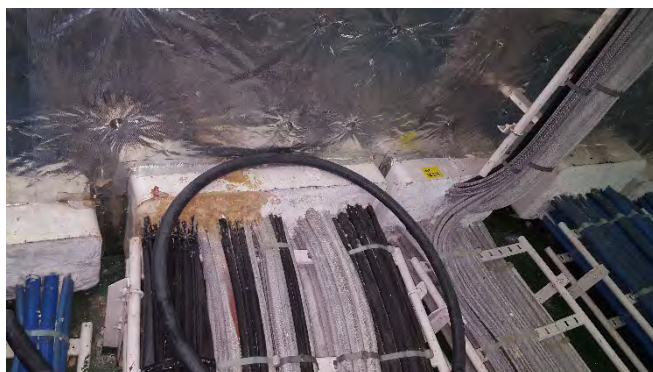
**Photo 140**  
G6319  
F Deck Electrical Cable Space, Starboard, Cables Through Bulk Head - Bulkhead penetration insulation (Chrysotile)

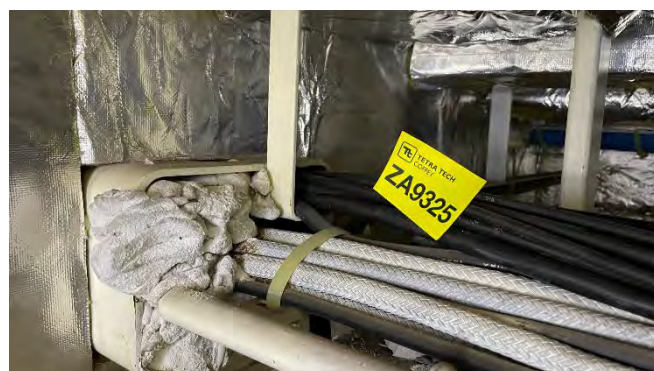
**Photo 202**  
ZA9325  
Bulkhead cable penetration putty material G deck electrical cable trunk room – Aft (Chrysotile)

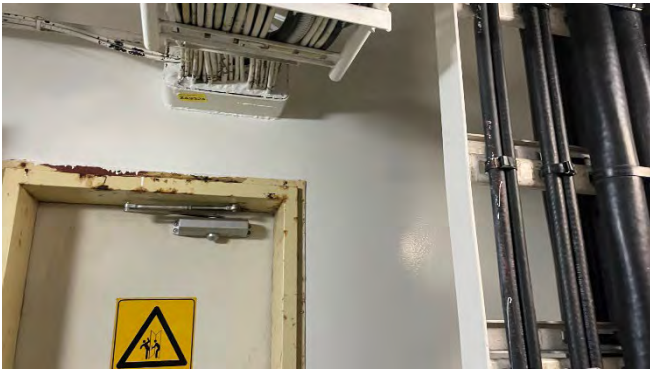
**Photo 203**  
ZA9324  
Void spaces in deck head, C deck fwd cross alley way (Chrysotile)

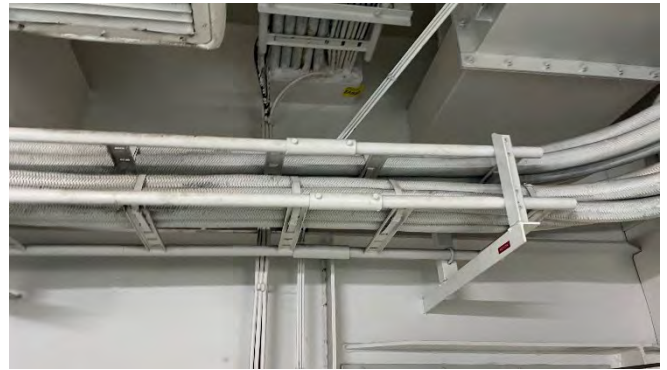
**Photo 204**  
ZA9322  
Bulkhead cable penetration putty material, Upper deck electrical cable trunk room (Chrysotile)

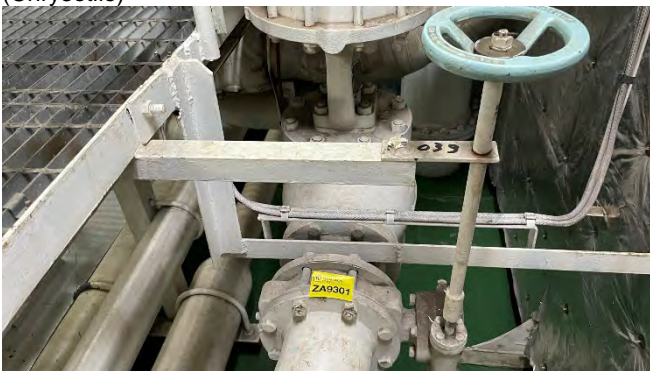
**Photo 205**  
ZA9301  
E/R DG Room 1, Cooling system inlet (Chrysotile)

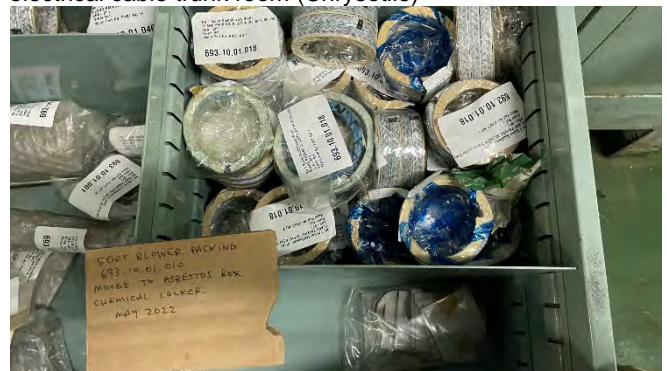
**Photo 206**  
ZA9300  
Stores - BF1, Soot blower packing - Port 639.10.01.018 (Chrysotile)
