Asbestos Materials Refit survey and partial reinspection

NW Snipe

Shell Tankers Australia Pty Ltd

Report reference number: 754-PEREN324142

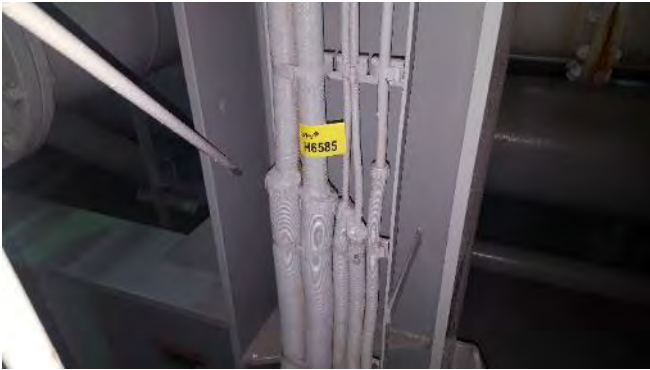
Photo 13
H6585
Tank Top/Lower Deck, Engine Room, Between
No.1 & No.2 Main C.C.S Cooling S.W. Pumps, Putty (Chrysotile)

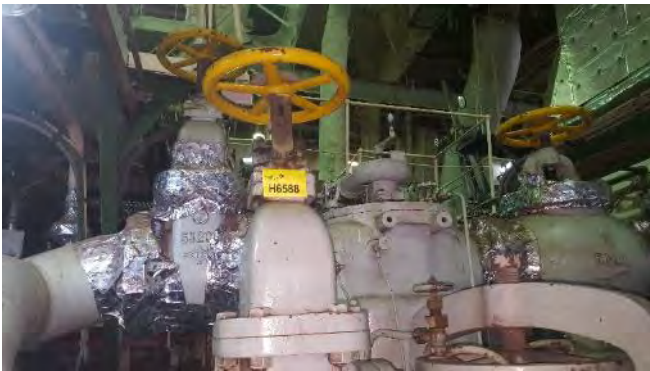
Photo 15
H6588
Tank Top/Lower Deck, Engine Room, Main L.O. Filter Bypass Valve,
Gasket (Chrysotile)

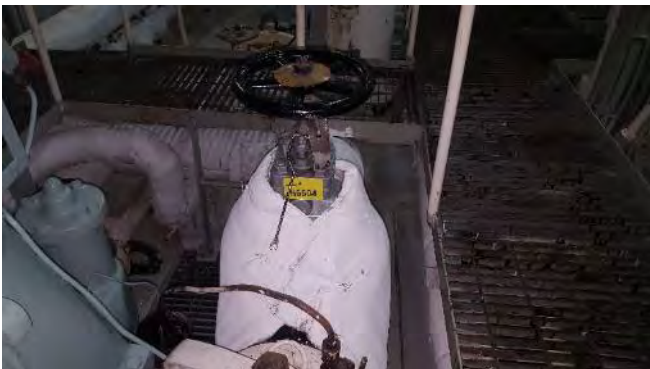
Photo 17
H6604
4th Deck, Purifier Room, HFO Transfer Pump Cross Connection
Valve Bonnet, Gasket (Chrysotile)

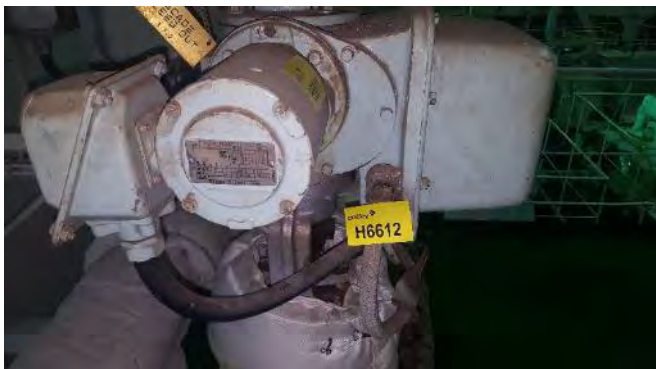
Photo 19
H6612
4th Deck, Engine Room, No.2 Cascade Controller
Conduit, Putty (Chrysotile)

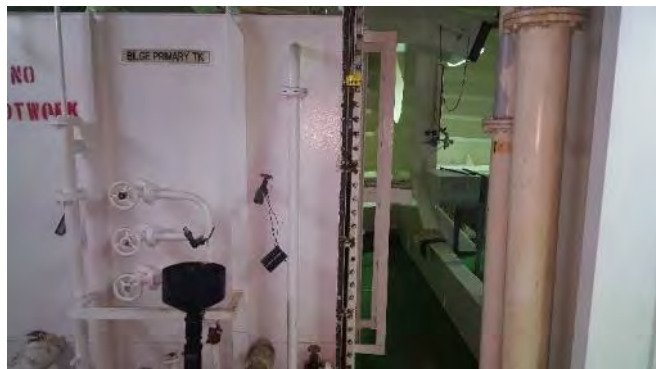
Photo 20
H6617
4th Deck, Engine Room, Bilge Primary Tank Level
Indicator, Sight Glass, Gasket (Chrysotile)

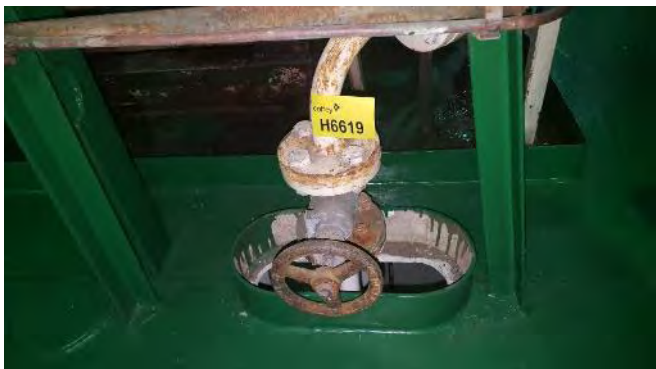
Photo 21
H6619
4th Deck, Engine Room, Electric Lighting EL7 Conduit, Putty
(Chrysotile)

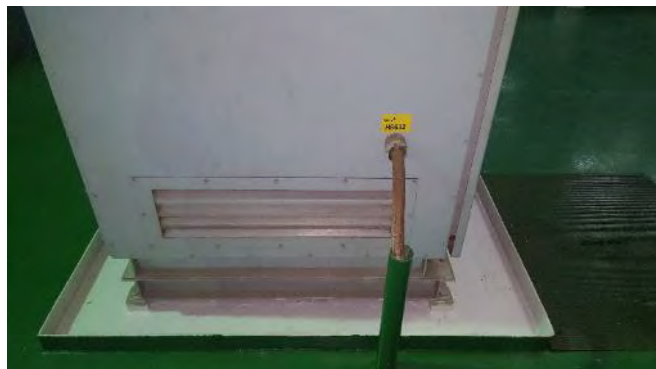
Photo 22
H6632
4th Deck, Engine Room, Hychlorinator Power, Inlet, Putty
(Chrysotile)

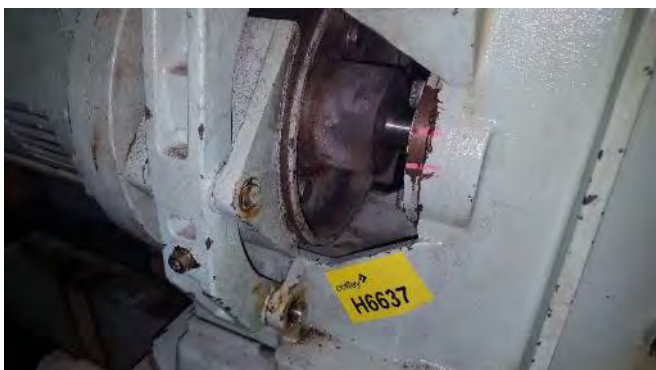
Photo 23
H6637
3rd Deck, Lift Motor Room, Braking System Friction Material,
Lining (Chrysotile)

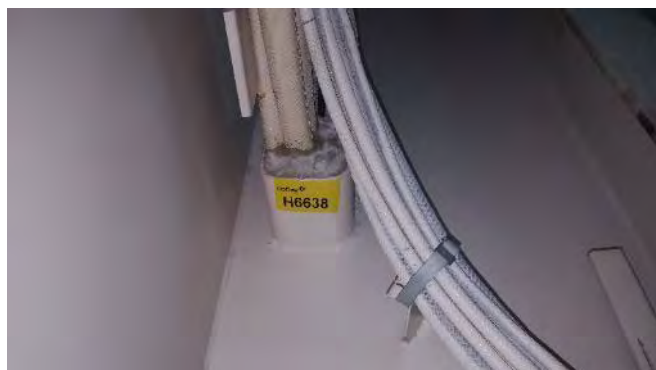
Photo 24
H6638
3rd Deck, Lift Motor Room, Penetration, Packing (Chrysotile)

It is recommended to prevent inadvertent exposure to workers that the packing materials be removed prior to scheduled maintenance, or refurbishment, using appropriate localised control measures in accordance with Shell AMP, relevant legislation, Standards and Guidance Materials.

- HSE Safety Alert to communicate risk of exposure during routine maintenance and new installation thru penetrations.
- Labelling of penetrations to warn of potential hazard.
- Complete a risk assessment and develop a management plan prior to removal of the ACM.

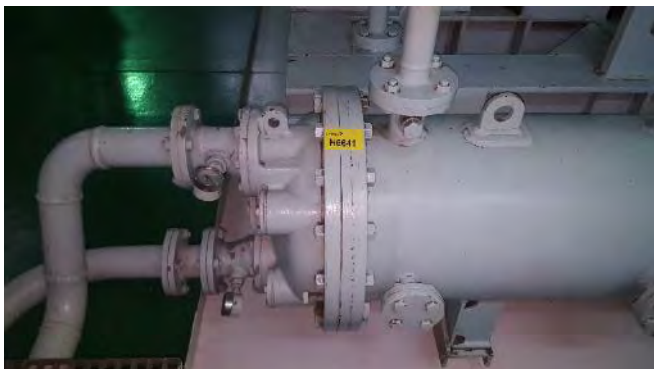
Photo 25
H6641
3rd Deck, Engine Room, Diesel Alternator L.O. Cooler End Cover, Gasket (Chrysotile)

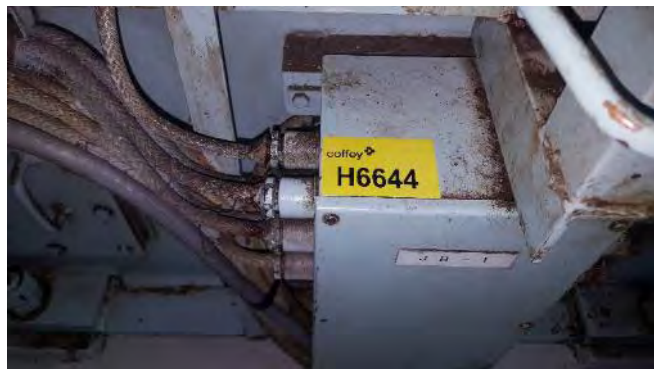
Photo 26
H6644
3rd Deck, Engine Room, Diesel Alternator Junction Box JB-1, Putty (Chrysotile)

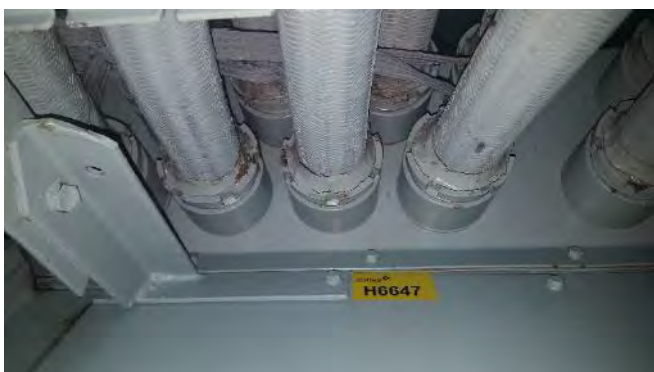
Photo 27
H6647
3rd Deck, Engine Room, Diesel Alternator Electrical (x16) Cables Outlet, Putty (Chrysotile)

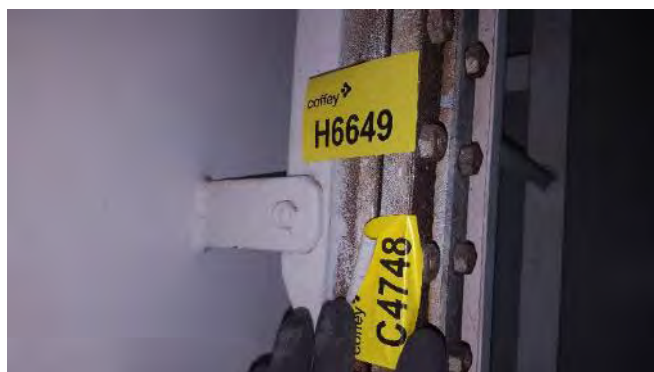
Photo 28
H6649
3rd Deck, Engine Room, Turbine Oil Gravity Tank Level Sight Glass, Gasket (Chrysotile)

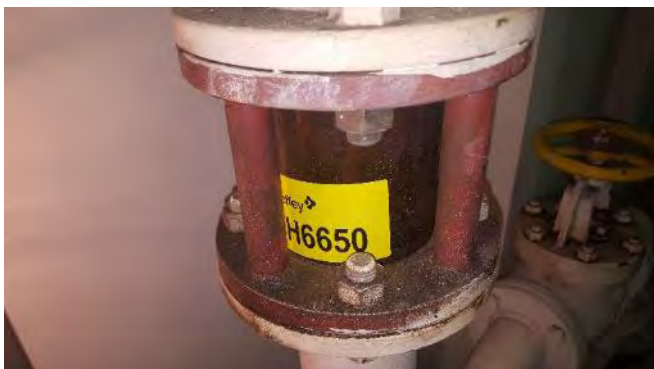
Photo 29
H6650
3rd Deck, Engine Room, Turbine Oil Gravity Tank Level Overflow Sight Glass, Gasket (Chrysotile)

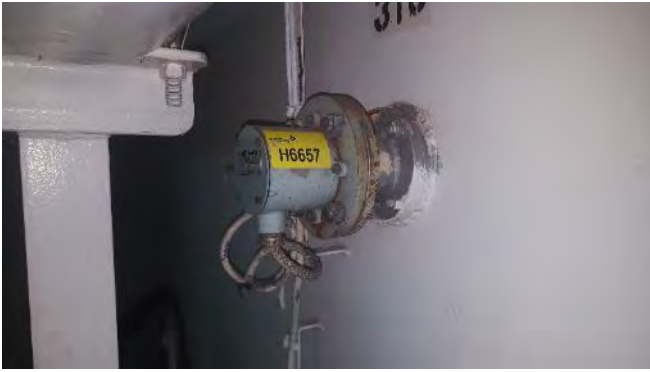
Photo 31
H6657
3rd Deck, Engine Room, Port Domestic F.W. Tank
Low Level Switch Flange, Gasket (Chrysotile)

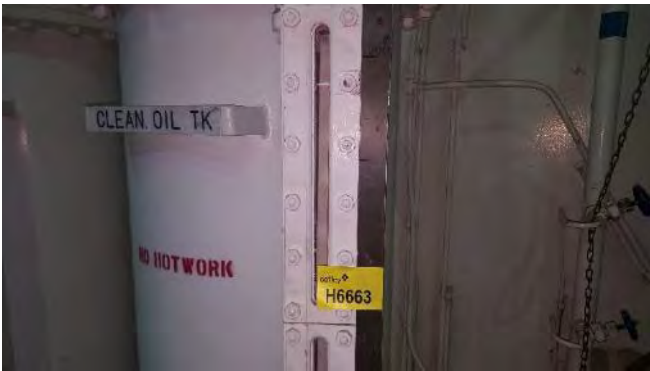
Photo 33
H6663
3rd Deck, Engine Room, Clean Oil Tank Level Sight Glass, Gasket
(Chrysotile)

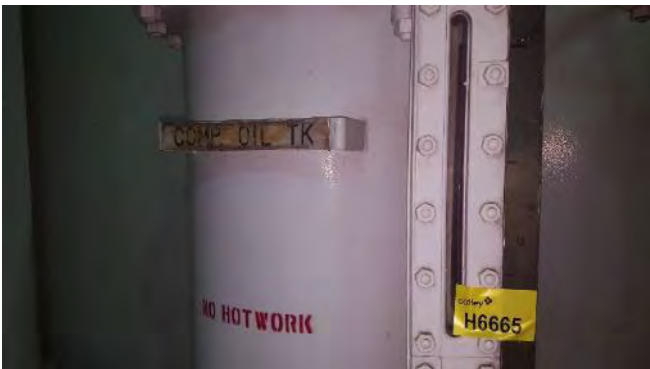
Photo 35
H6665
3rd Deck, Engine Room, Compressor Oil Tank Level Sight Glass,
Gasket (Chrysotile)

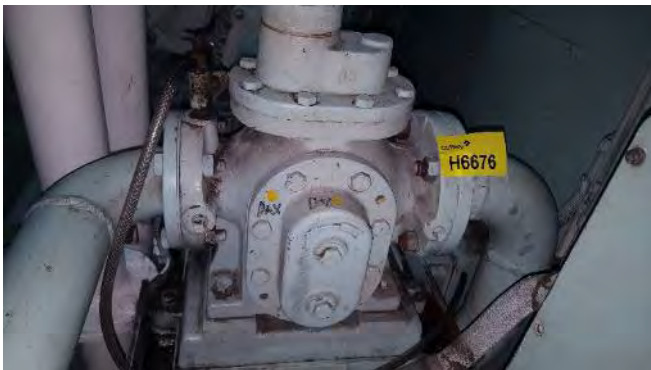
Photo 39
H6676
3rd Deck, No.1 Diesel Generator Room, L.O. Priming Pump Outlet Flange, Gasket (Chrysotile)

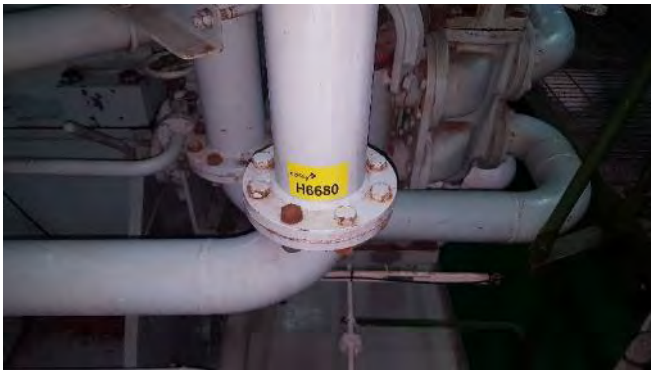
Photo 41
H6680
3rd Deck, No.1 Diesel Generator Room, Cooling Water Line - L.O. Cooler Inlet Flange, Gasket (Chrysotile)

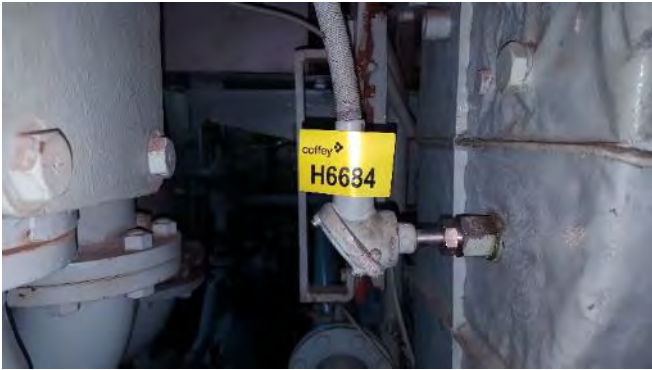
Photo 49
H6684
3rd Deck, No.2 Diesel Generator Room, Temperature Sensor - Charge Air Cooler, Gasket (Chrysotile)

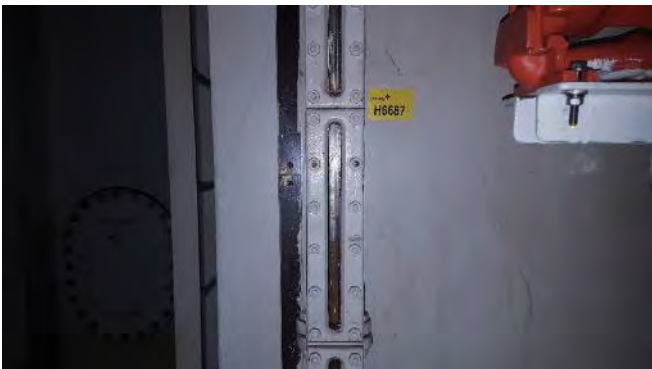
Photo 51
H6687
3rd Deck, Steering Flat, Transfer Oil Tank Level Gauge Glass, Gasket (Chrysotile)

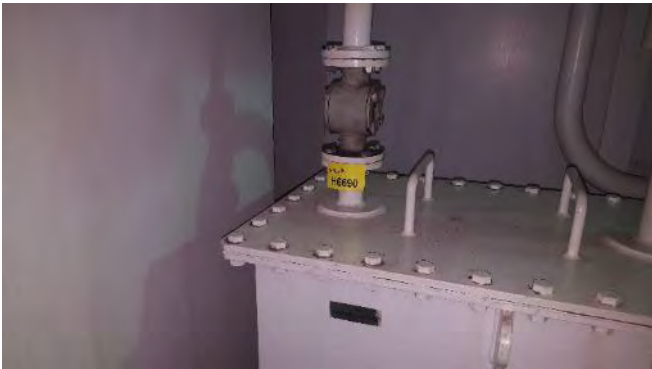
Photo 53
G6690
3rd Deck, Steering Flat, Overflow Tank Filling Glass Flange, Gasket (Chrysotile)

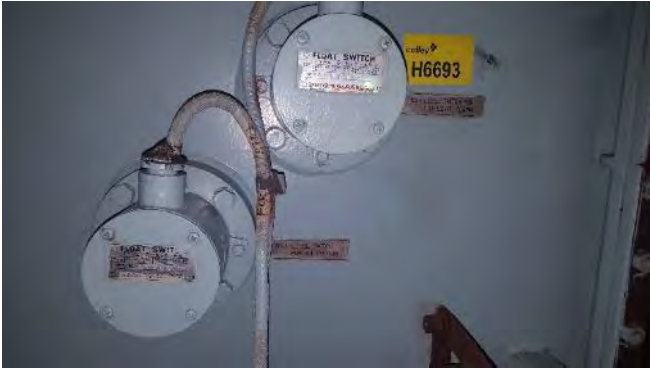
Photo 55
G6693
3rd Deck, Steering Flat, Starboard Header Tank Level Switch, Gasket (Chrysotile)

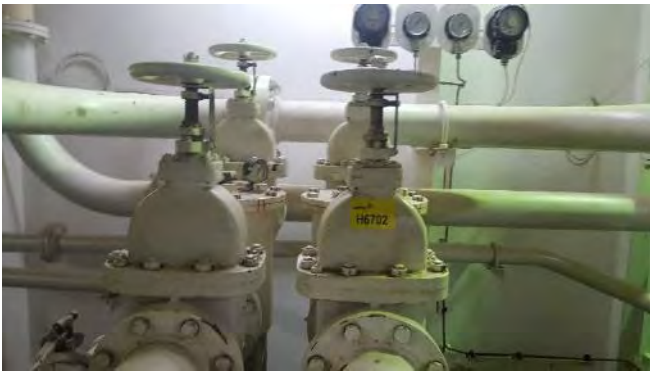
Photo 57
H6702
3rd Deck, Steering Flat, Hydraulic Valve Bonnet, Gasket (Chrysotile)

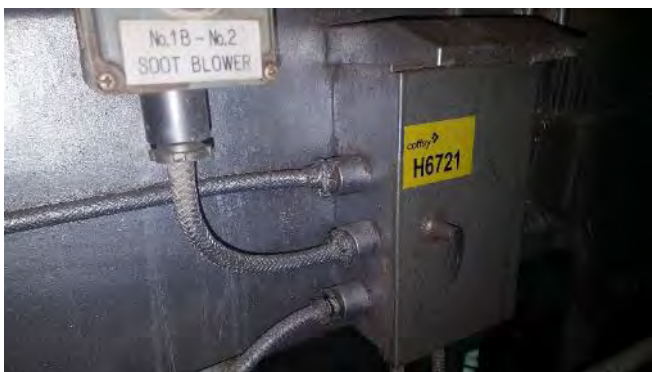
Photo 63
H6721
3rd Deck, Engine Room, Port Boiler No.1 Retractable Soot Blower Power Junction Box, Putty (Chrysotile)

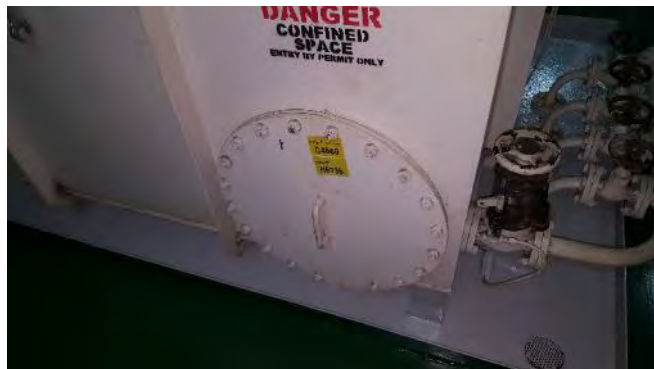
Photo 68
H6735
2nd Deck, Port, Fuel Oil Additive Tank Manhole Cover, Gasket (Chrysotile)

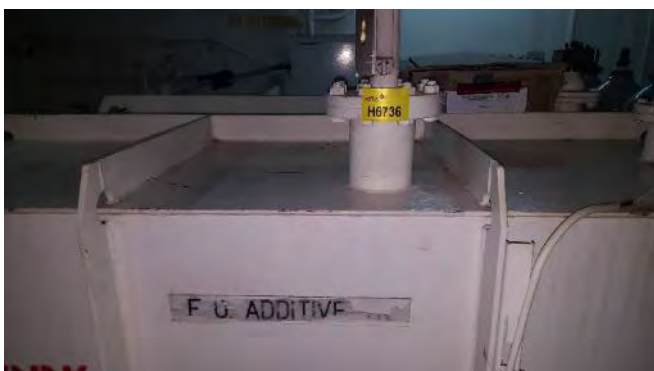
Photo 69
H6736
2nd Deck, Port, Fuel Oil Additive Tank Sight Level Gauge, Gasket (Chrysotile)

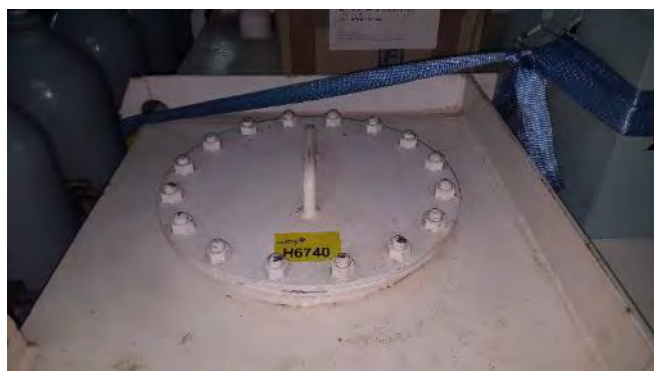
Photo 70
H6740
2nd Deck, Port, Fuel Oil Additive Tank Manhole Cover (Top), Gasket (Chrysotile)

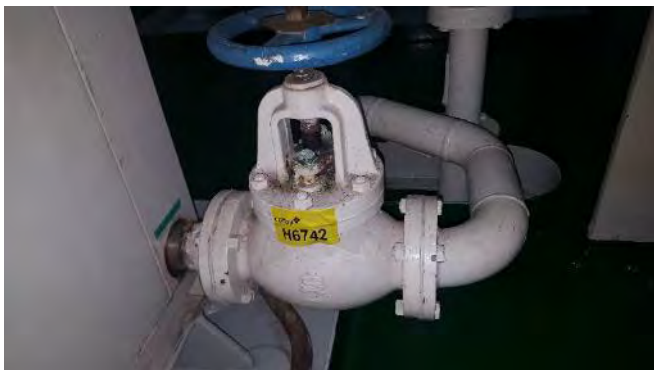
Photo 71
H6742
2nd Deck, Port, Package Cooler Inlet Valve Flange, Gasket (Chrysotile)

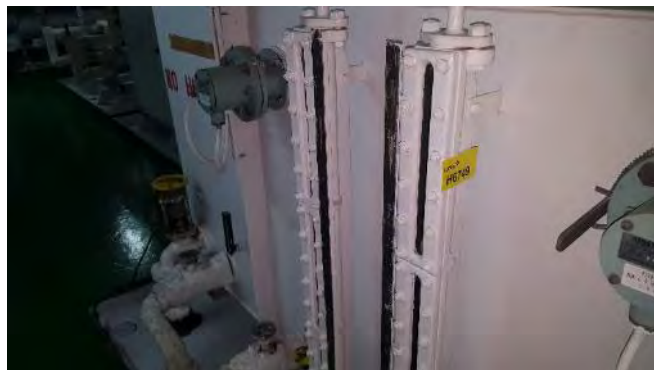
Photo 72
H6749
2nd Deck, Starboard, Aux. L.O. Purifying Tank (Small) & Aux L.O. Renovation Tank Sight Level Gauge, Gasket (Chrysotile)

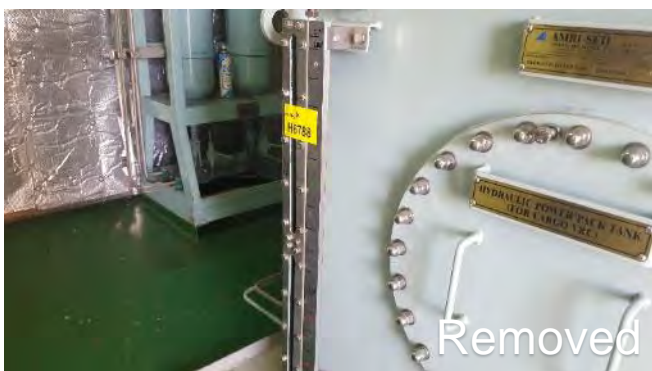
Photo 92
 G6787
 Upper Deck, Hydraulic Room, Ballast Power Pack Level Sight Glass, Gasket (Chrysotile)

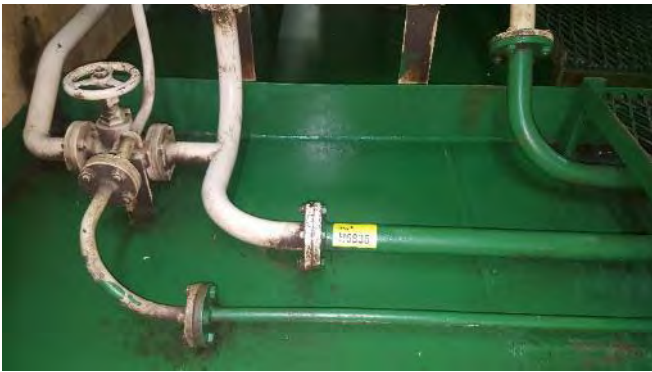
G6834

Upper Deck, Fo'c'sle/Bosons Store, Transfer Oil Tank Inlet/Inspection Plate, Gasket (Chrysotile)

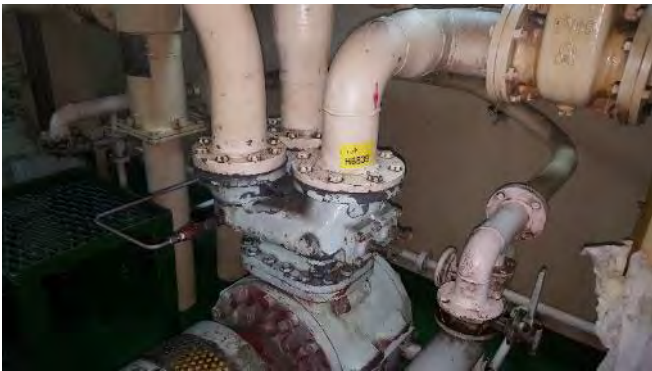
Photo 110
G6838
Upper Deck, Fo'c'sle/Bosons Store, Hydraulic Pump No.2 Suction Flange, Gasket (Chrysotile)

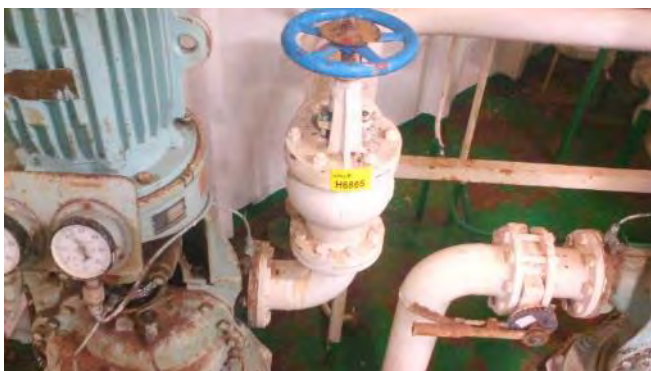
Photo 114
G6864
Upper Deck, Cargo Motor Room, No.1 Freshwater Pump Discharge Valve Casing, Gasket (Chrysotile)
