Asbestos Materials Refit survey and partial reinspection

NW Stormpetrel

Shell Tankers Australia Pty Ltd

Report reference number: 754-PEREN324141

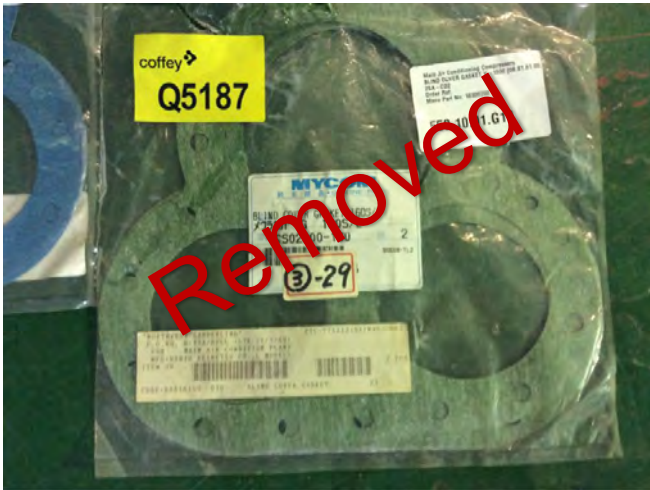
Photo 25
Q5187
2nd deck - 2sa - cd1 drawer
Main air con blind cover Gasket - green -
550.10.01.g10

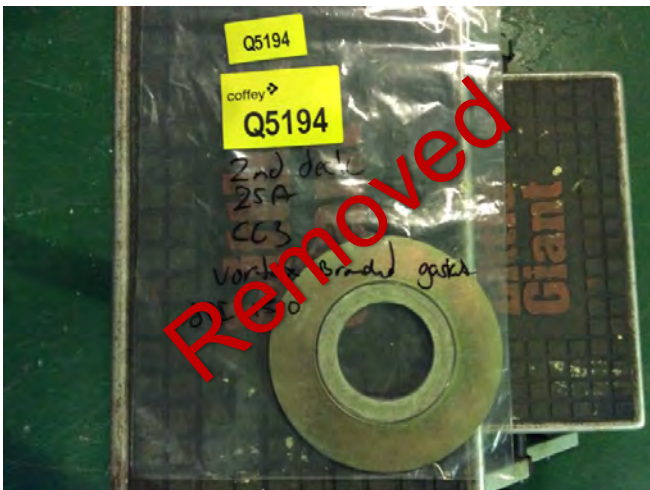
Photo 27
Q5194
2nd deck - 2sa - cc3 drawer
Vortex branded Gasket - no product code

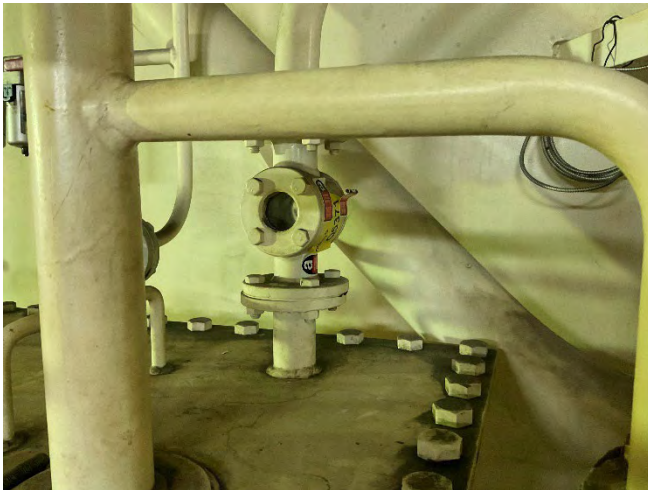
Photo 33
Q5371
Focsle Store -Starboard Aft - Hyd Oil Fuel Tank Return Glass
Gasket to hyd oil tank return glass gasket

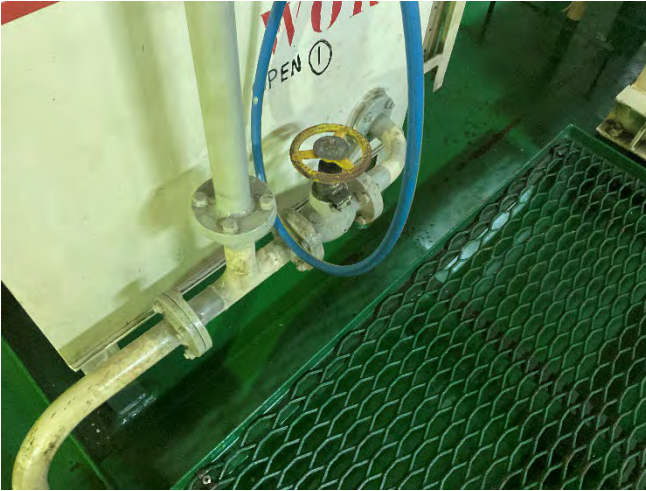
Photo 41
Q5369
Focsle store -starboard Aft - hyd trans P/P suction
Gasket to hyd trans P/P suction

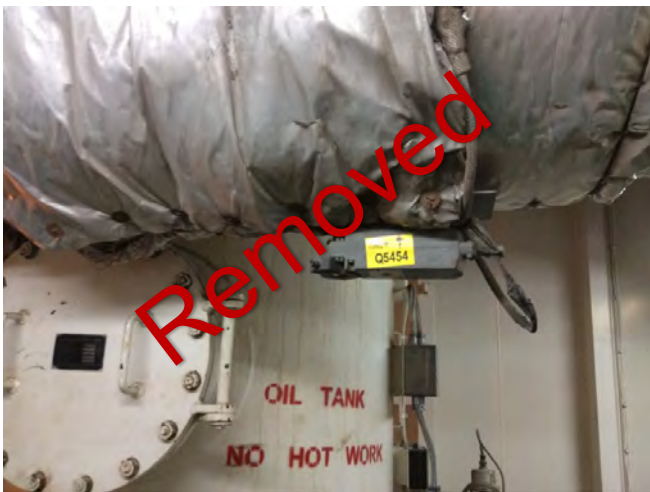
Photo 47
Q5454
A Deck – Incinerator Room – Incinerator Flue
Incinerator Flue At Damper Inlet gasket

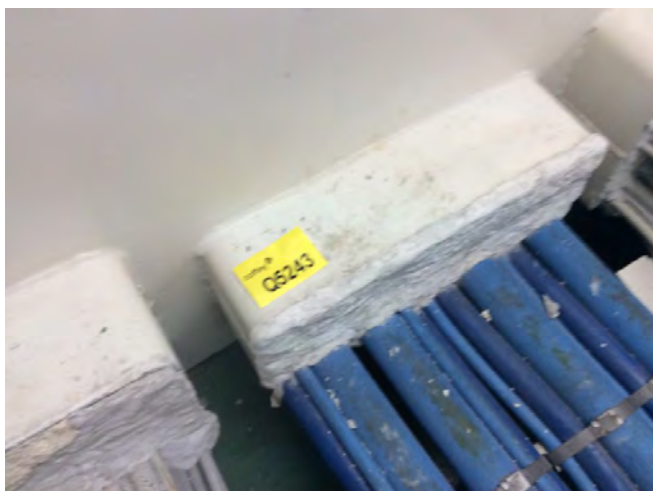
Photo 49
Q5243
F deck - cable locker
Cable penetration insulation

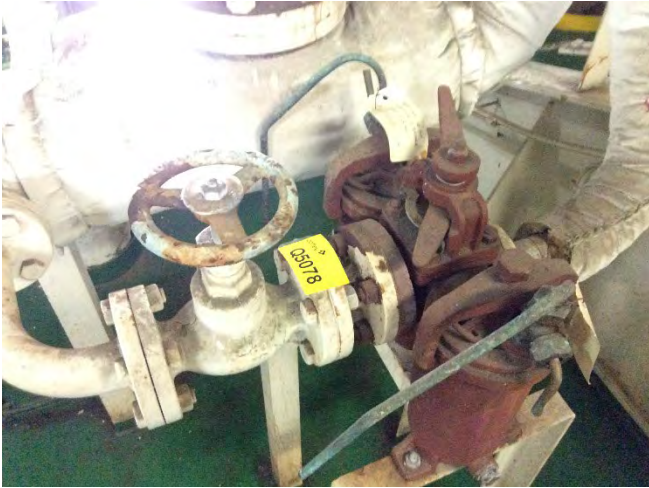
Photo 65
Q5078
4th Deck – Main Engine Room – Grease Extractor, Gasket (Chrysotile)

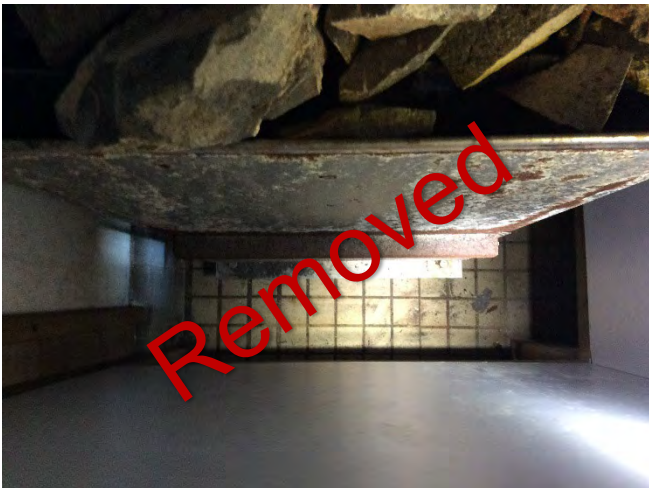
Photo 67
Q5052
2nd Deck, Sauna, Fibre Cement Debris (Chrysotile)

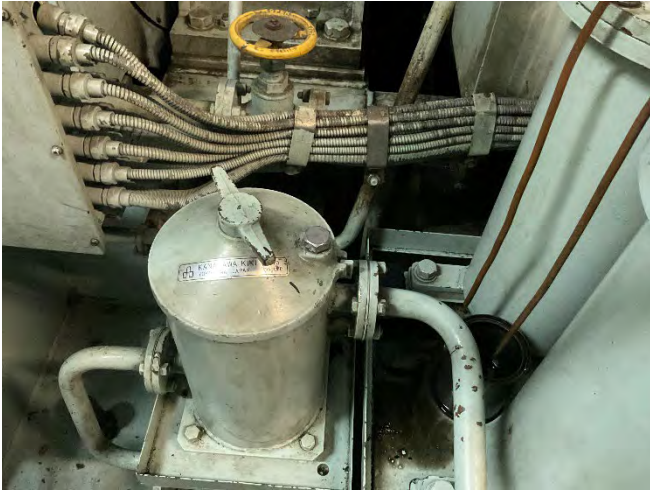
Photo 93
ZA21825
3rd Deck Lube oil system to Generator 2 Gasket
Adjacent walkway Port Side (Chrysotile)
