# Asbestos Materials Refit survey and partial reinspection

## NW Sanderling

Shell Tankers Australia Pty Ltd

Reference: 754-PEREN324141

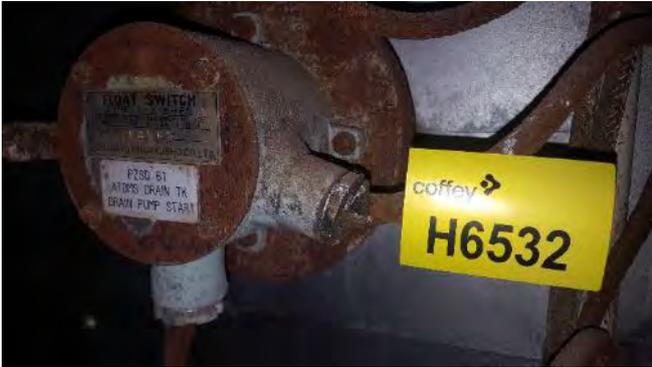
**Photo 1**

H6532

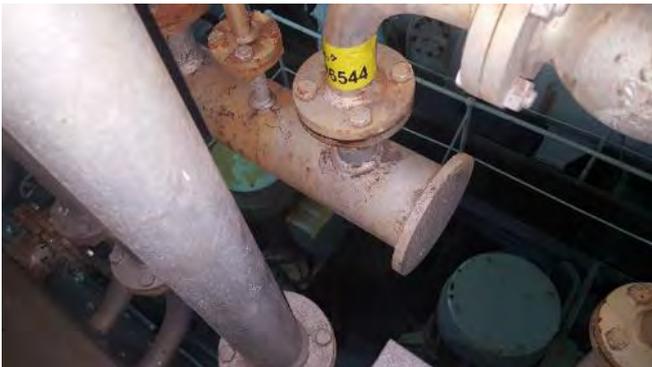
**Photo 3**

H6544

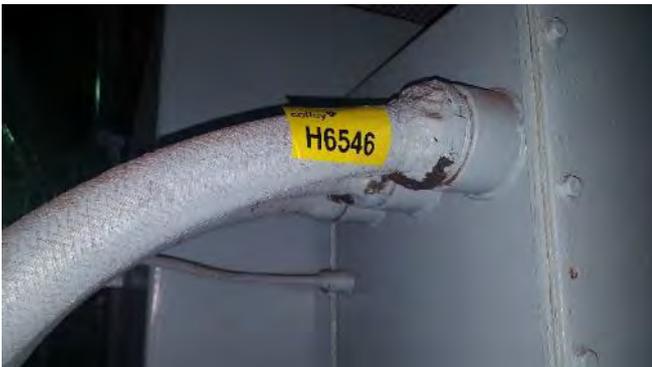
**Photo 5**

H6546

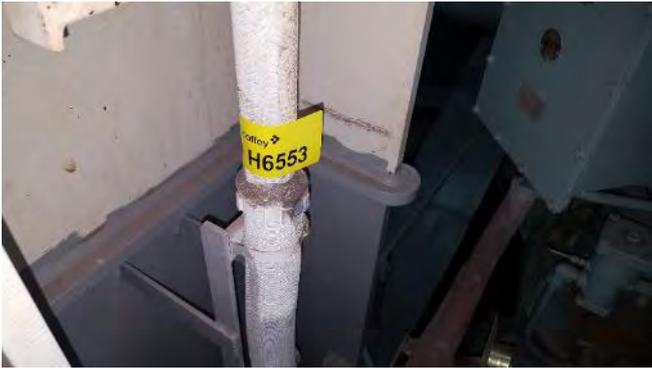
**Photo 7**  
H6553  
Tank Top/Lower Deck, Engine Room, Bilge and General Service Pump – Conduit, Putty (Chrysotile)

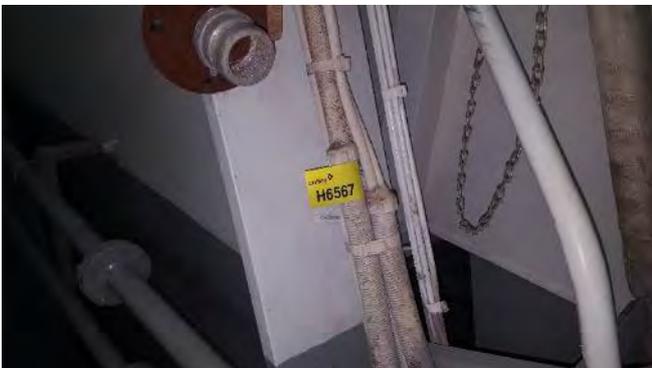
**Photo 9**  
H6567  
Tank Top/Lower Deck, Engine Room, Bilge Pump Conduit, Putty (Chrysotile)

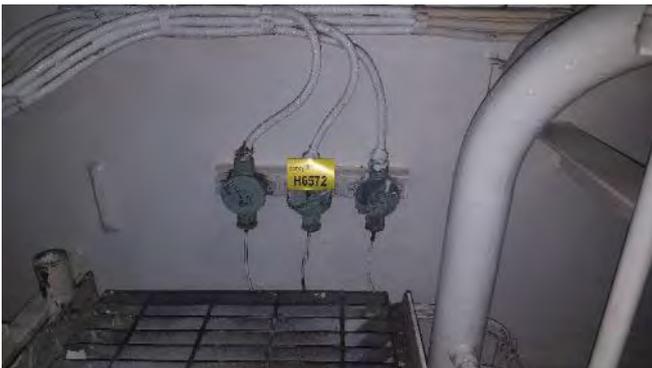
**Photo 11**  
H6572  
Tank Top/Lower Deck, Engine Room, Junction Box - Aft Bulkhead, Putty (Chrysotile)

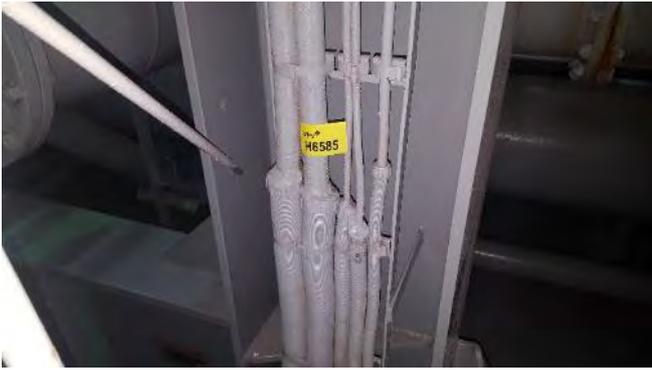
**Photo 13**  
H6585  
Tank Top/Lower Deck, Engine Room, Between  
No.1 & No.2 Main C.C.S Cooling S.W. Pumps, Putty (Chrysotile)

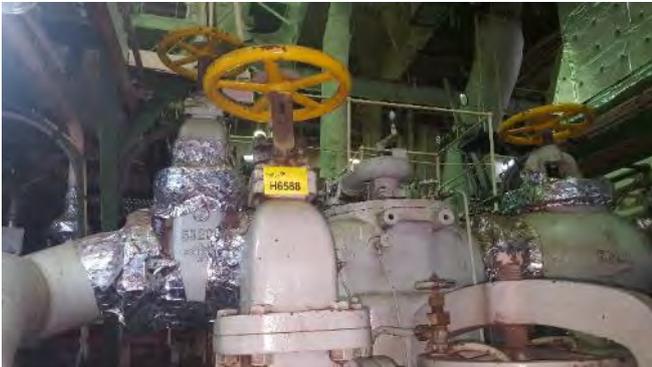
**Photo 15**  
H6588  
Tank Top/Lower Deck, Engine Room, Main L.O. Filter Bypass Valve,  
Gasket (Chrysotile)

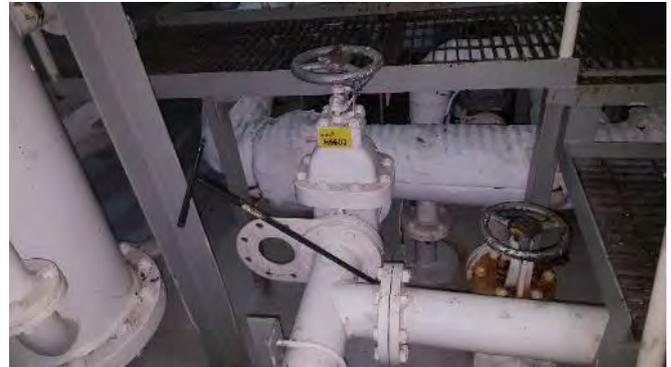
**Photo 16**  
H6603  
4th Deck, Purifier Room, D.O. Transfer Pump Cross Connection  
Valve Bonnet, Gasket (Chrysotile)

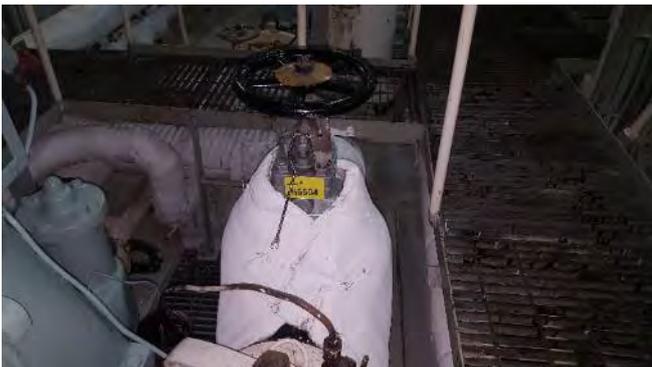
**Photo 17**  
H6604  
4th Deck, Purifier Room, HFO Transfer Pump Cross Connection  
Valve Bonnet, Gasket (Chrysotile)

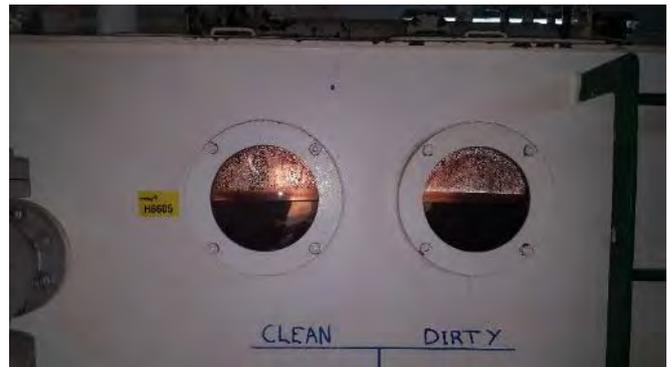
**Photo 18**  
H6605  
4th Deck, Engine Room, Hotwell/Observation Tank Viewing Glass  
Gasket (Chrysotile)

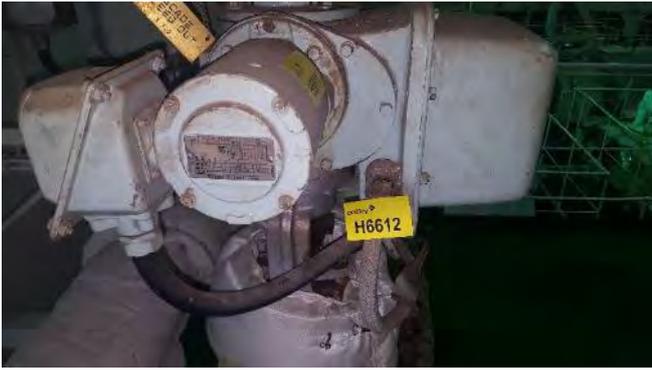
**Photo 19**  
H6612  
4th Deck, Engine Room, No.2 Cascade Controller  
Conduit, Putty (Chrysotile)

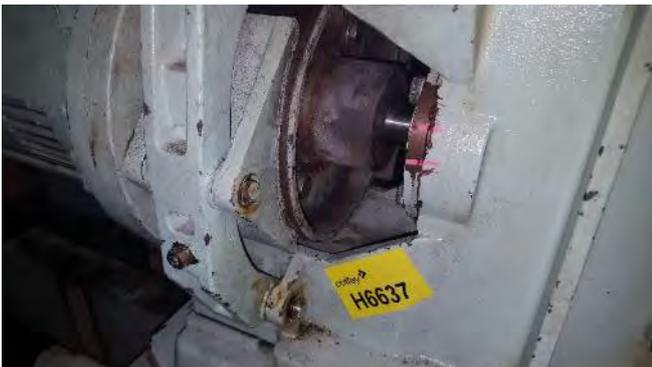
**Photo 23**  
H6637  
3rd Deck, Lift Motor Room, Braking System Friction Material,  
Lining (Chrysotile)

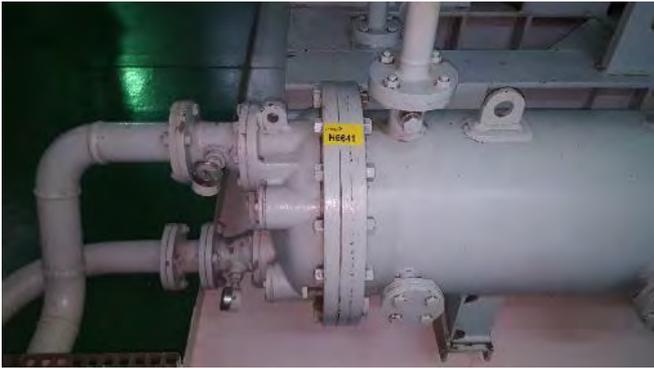
**Photo 25**  
H6641  
3rd Deck, Engine Room, Diesel Alternator L.O. Cooler End Cover, Gasket (Chrysotile)

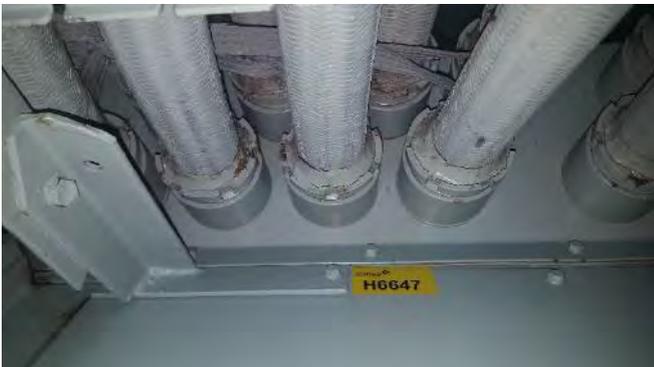
**Photo 27**  
H6647  
3rd Deck, Engine Room, Diesel Alternator Electrical (x16) Cables Outlet, Putty (Chrysotile)

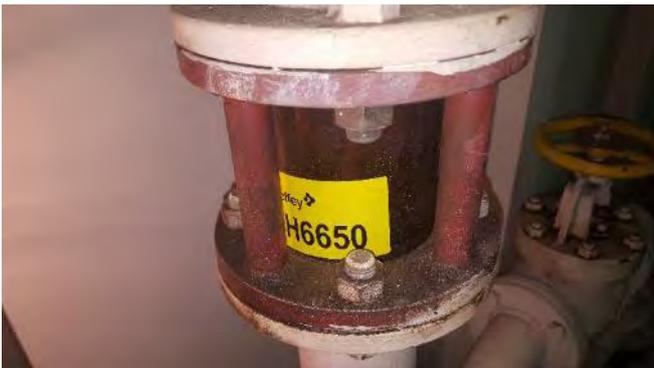
**Photo 29**  
H6650  
3rd Deck, Engine Room, Turbine Oil Gravity Tank Level Overflow Sight Glass, Gasket (Chrysotile)

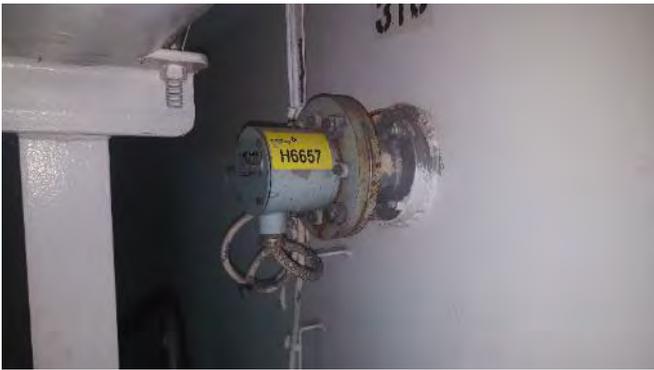
**Photo 31**  
H6657  
3rd Deck, Engine Room, Port Domestic F.W. Tank  
Low Level Switch Flange, Gasket (Chrysotile)

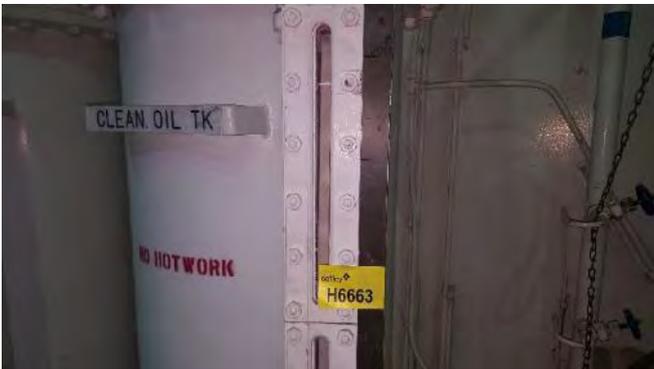
**Photo 33**  
H6663  
3rd Deck, Engine Room, Clean Oil Tank Level Sight Glass, Gasket  
(Chrysotile)

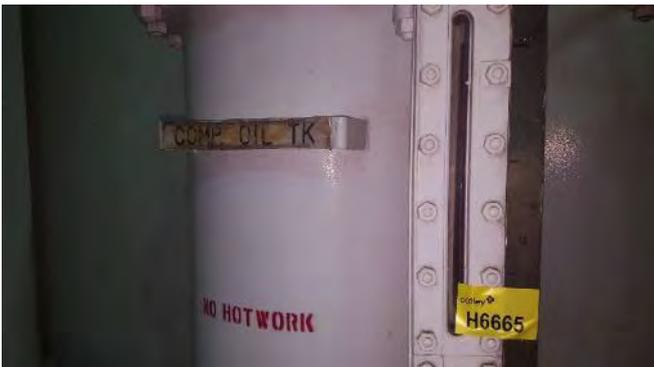
**Photo 35**  
H6665  
3rd Deck, Engine Room, Compressor Oil Tank Level Sight Glass,  
Gasket (Chrysotile)

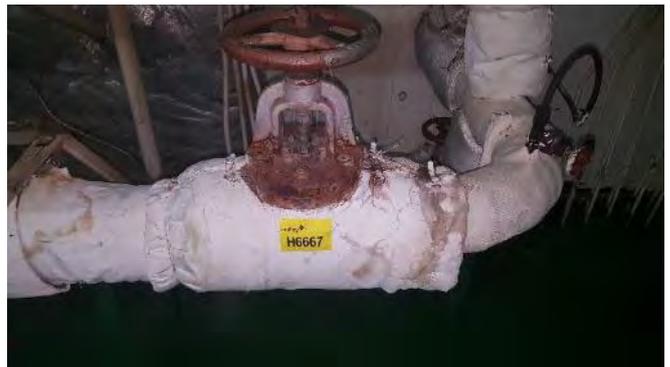
**Photo 36**  
H6667  
3rd Deck, IGG Room, HFO Tank Steam Heating Valve Flange,  
Gasket (Chrysotile)

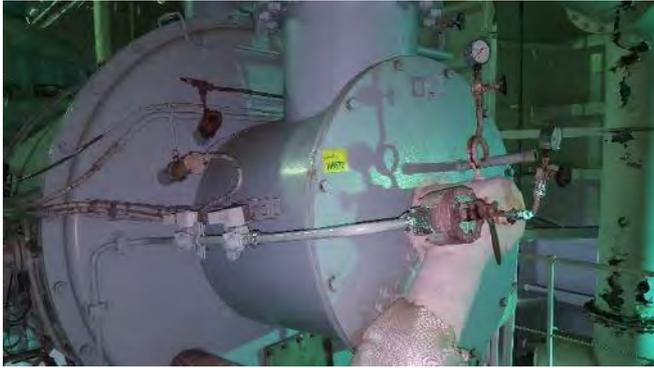
**Photo 37**  
H6673  
3rd Deck, IGG Room, Burner End Cover, Gasket (Chrysotile)

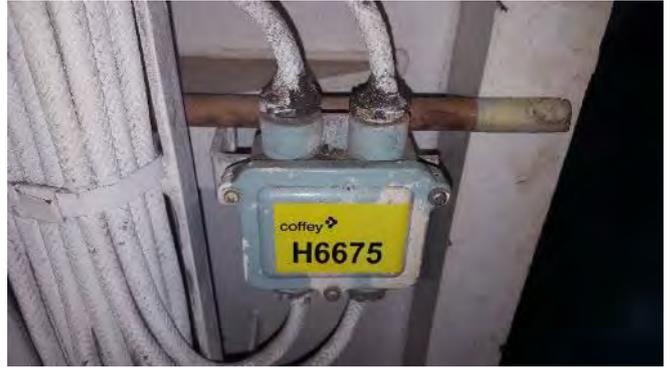
**Photo 38**  
H6675  
3rd Deck, IGG Room, Junction Box Adj. Door, Putty (Chrysotile)

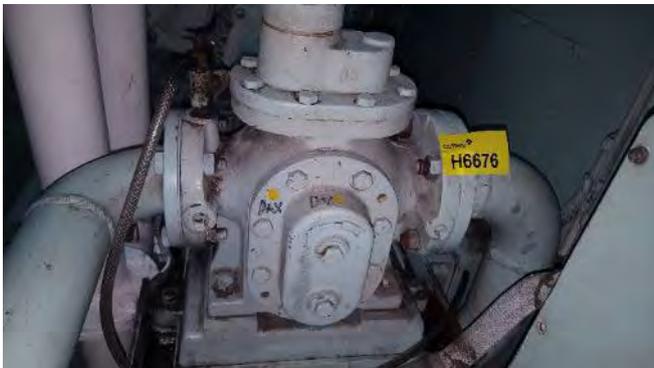
**Photo 39**  
H6676  
3rd Deck, No.1 Diesel Generator Room, L.O. Priming Pump Outlet Flange, Gasket (Chrysotile)

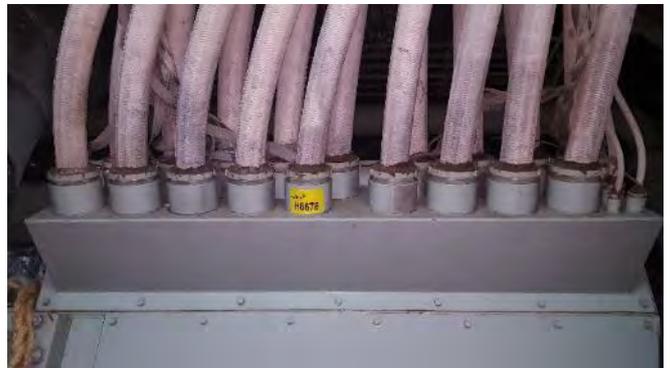
**Photo 40**  
H6678  
3rd Deck, No.1 Diesel Generator Room, Power Cables from Alternator, Putty (Chrysotile)

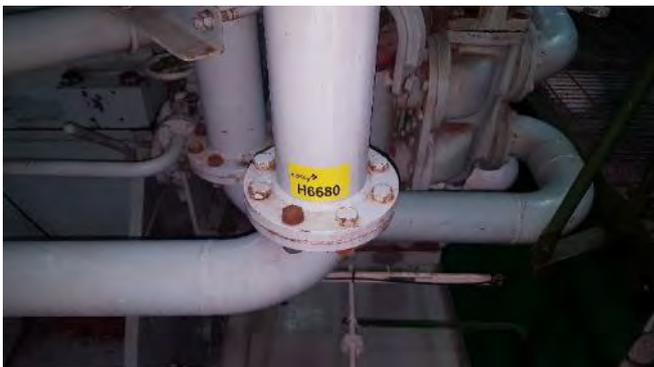
**Photo 41**  
H6680  
3rd Deck, No.1 Diesel Generator Room, Cooling Water Line - L.O. Cooler Inlet Flange, Gasket (Chrysotile)

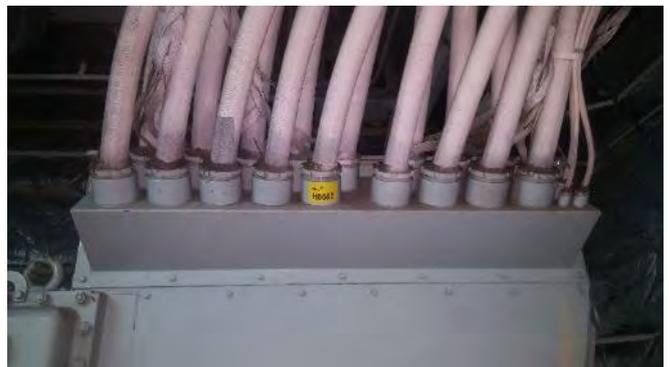
**Photo 42**  
H6682  
3rd Deck, No.2 Diesel Generator Room, Power Cables from Alternator, Putty (Chrysotile)

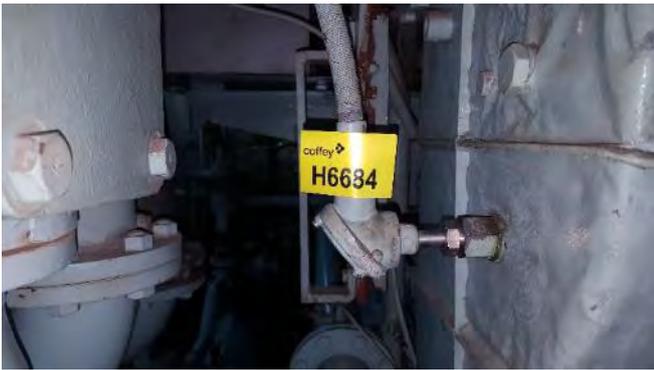
**Photo 49**  
H6684  
3rd Deck, No.2 Diesel Generator Room, Temperature Sensor - Charge Air Cooler, Gasket (Chrysotile)

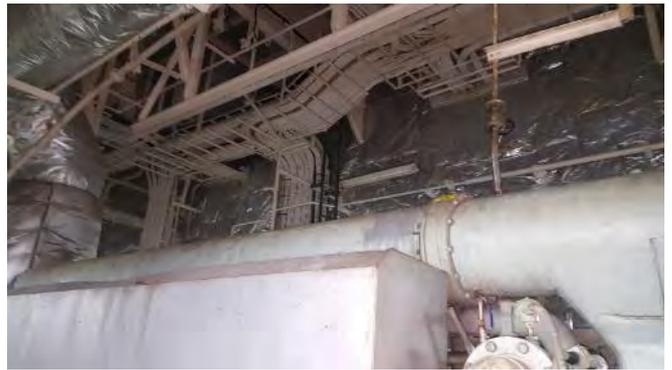
**Photo 50**  
H6685  
3rd Deck, No.2 Diesel Generator Room, Exhaust Gasket at Charge Air Cooler, Gasket (Chrysotile)

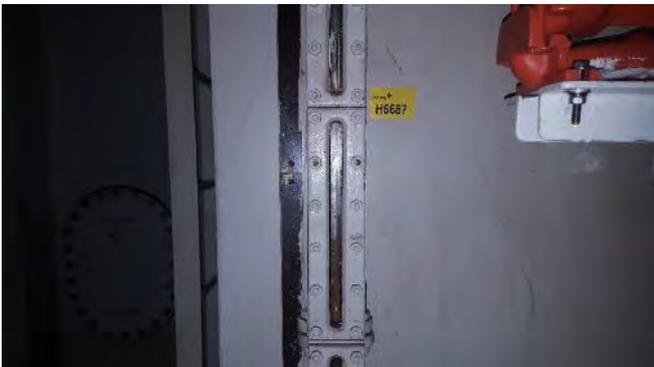
**Photo 51**  
H6687  
3rd Deck, Steering Flat, Transfer Oil Tank Level Gauge Glass, Gasket (Chrysotile)

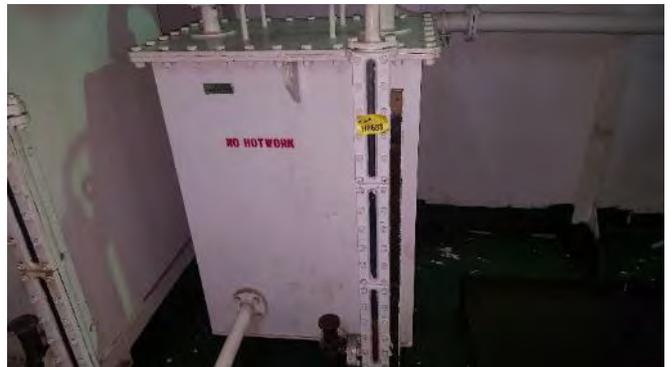
**Photo 52**  
G6688  
3rd Deck, Steering Flat, Overflow Tank Level Gauge Glass, Gasket (Chrysotile)

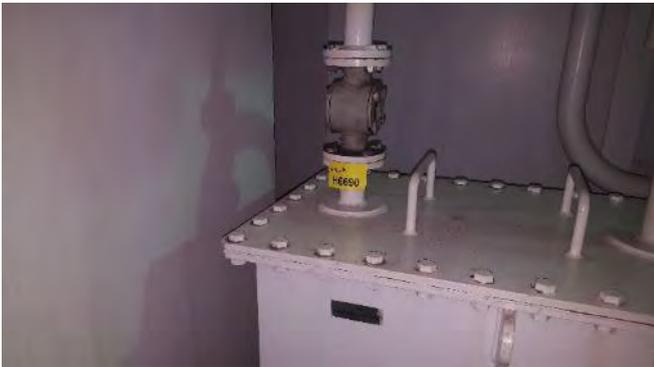
**Photo 53**  
G6690  
3rd Deck, Steering Flat, Overflow Tank Filling Glass Flange, Gasket (Chrysotile)

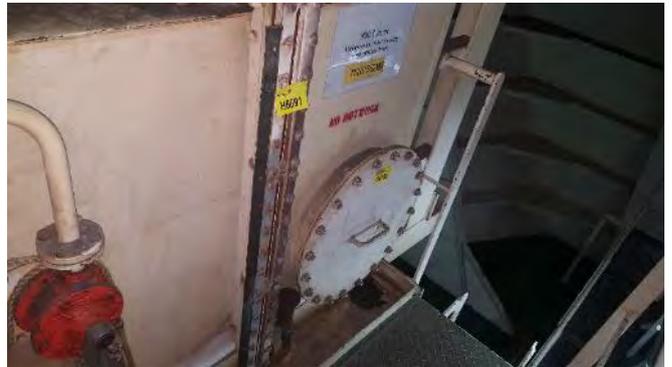
**Photo 54**  
G6691  
3rd Deck, Steering Flat, Storage Tank S2V68 Sight Level Glass, Gasket (Chrysotile)

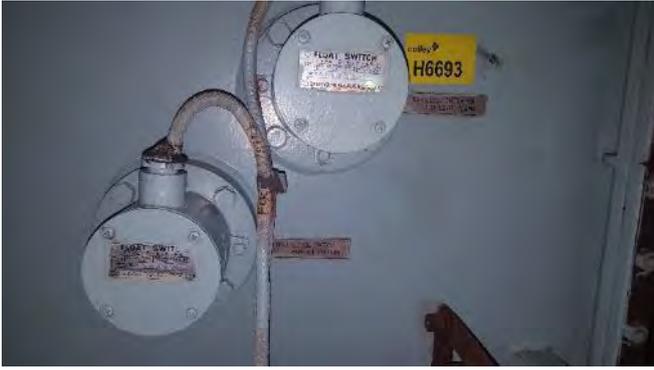
**Photo 55**  
G6693  
3rd Deck, Steering Flat, Starboard Header Tank Level Switch, Gasket (Chrysotile)

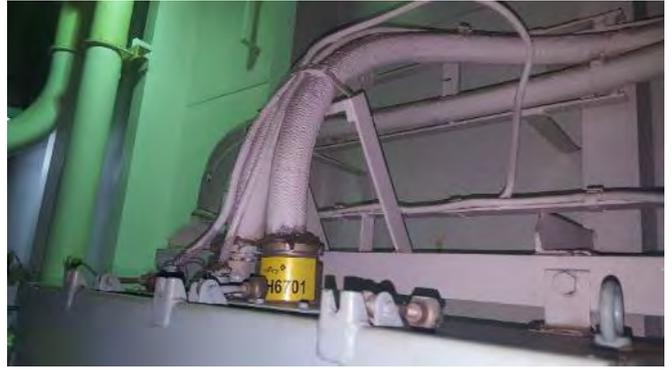
**Photo 56**  
G6701  
3rd Deck, Steering Flat, Power Cable Conduit Aft Winch Electrical Cabinet, Putty (Chrysotile)

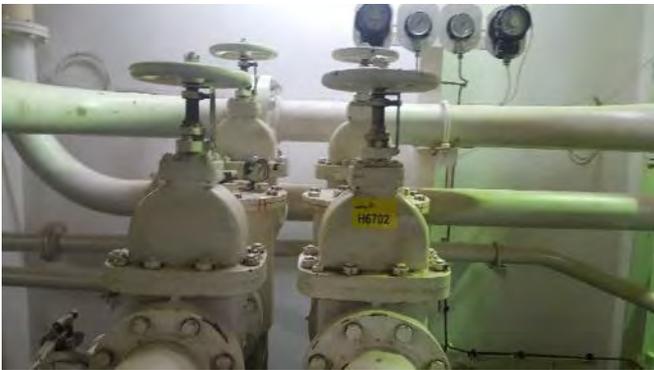
**Photo 57**  
H6702  
3rd Deck, Steering Flat, Hydraulic Valve Bonnet, Gasket (Chrysotile)

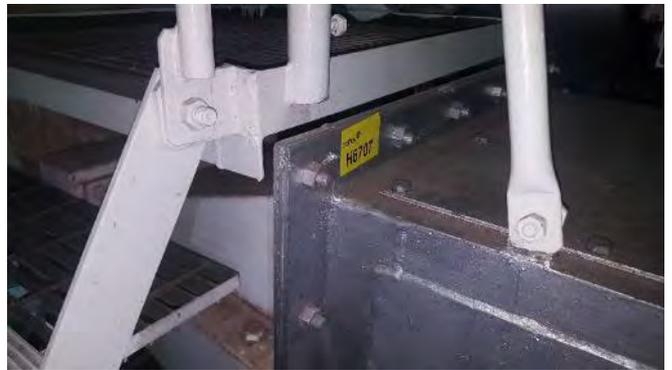
**Photo 58**  
H6707  
3rd Deck, Port Gas Hood, Boiler Gas Valve, Flange, Gasket (Chrysotile)

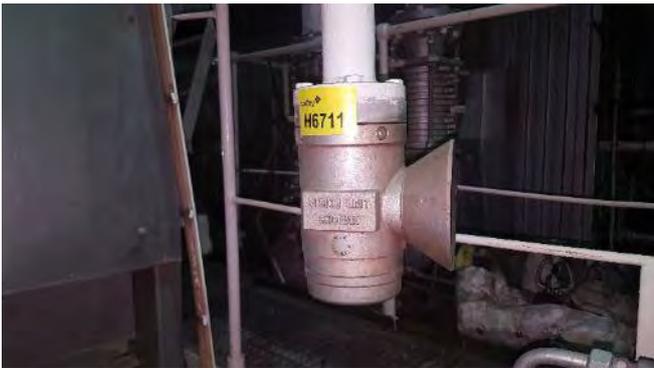
**Photo 59**  
H6711  
3rd Deck, Burner Tops, Starboard Boiler Periscope, Gasket (Chrysotile)

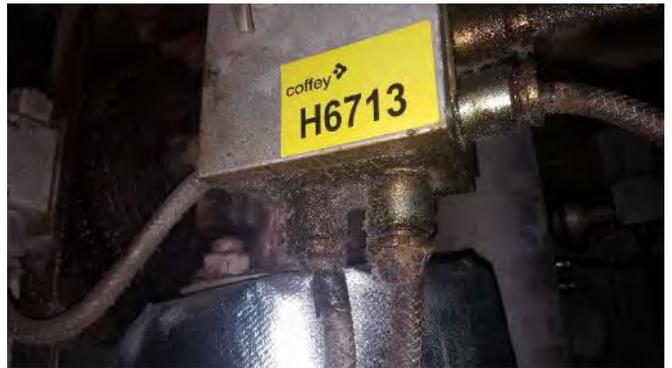
**Photo 60**  
H6713  
3rd Deck, Burner Tops, Starboard Boiler Conduit No.5 Soot Blower Junction Box, Putty (Chrysotile)

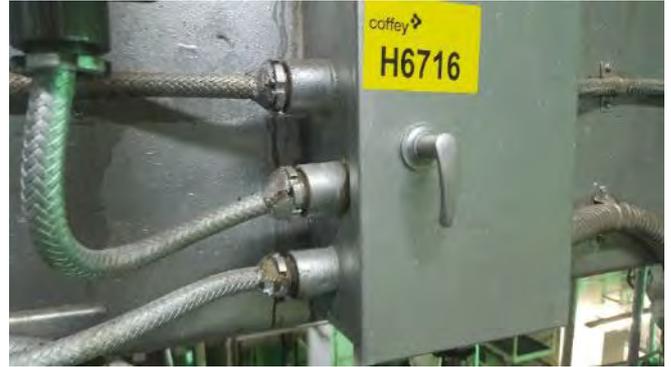
**Photo 61**  
H6714  
2nd Deck, Engine Room, Starboard Boiler No.1 Retractable Soot Blower Power Junction Box, Putty (Chrysotile)

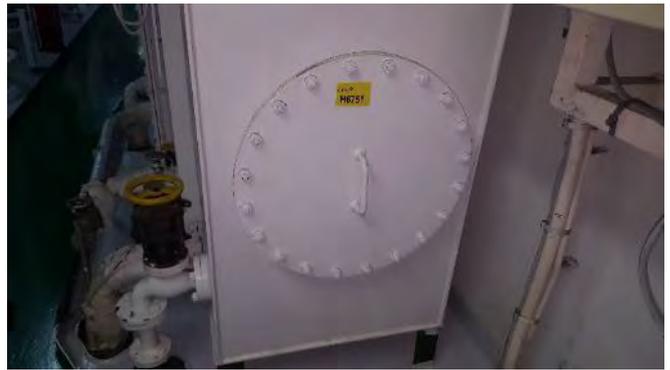
**Photo 73**  
H6750  
2nd Deck, Starboard, L.O. Renovation Tank (Small) Filling Line, Gasket (Chrysotile)

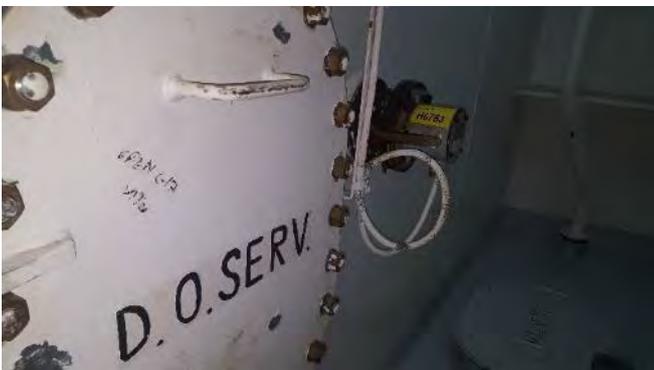
**Photo 74**  
H6751  
2nd Deck, Starboard, L.O. Renovation Tank (Small) Manhole, Gasket (Chrysotile)

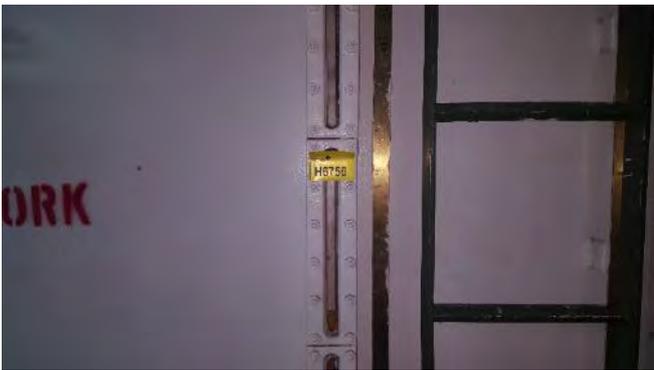
**Photo 76**  
H6754  
2nd Deck, L.O. Storage Tank "F" Level Gauge Glass, Gasket (Chrysotile)

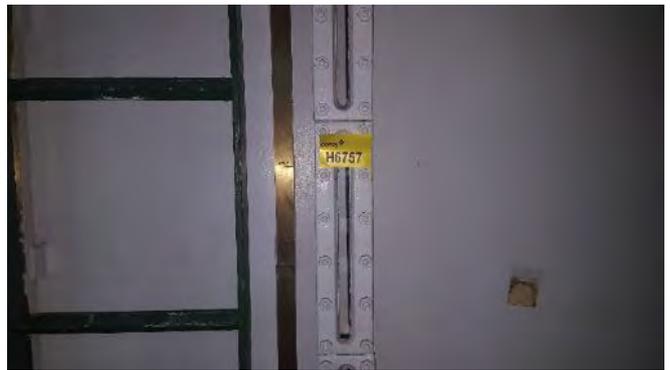
**Photo 77**  
H6756  
2nd Deck, L.O. Storage Tank "A" Level Gauge Glass, Gasket (Chrysotile)

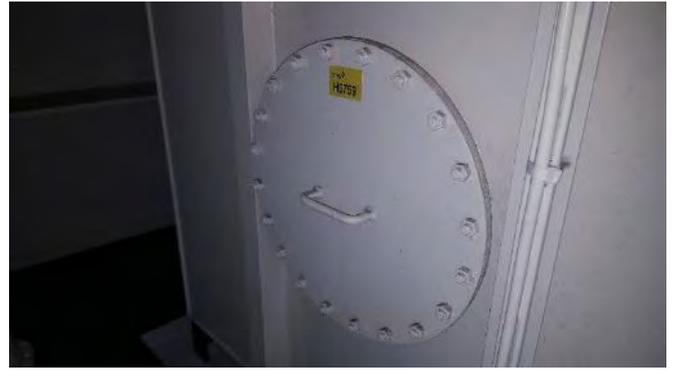
**Photo 79**  
H6758  
2nd Deck, D/G L.O. Storage Tank Filling Valve, Gasket (Chrysotile)

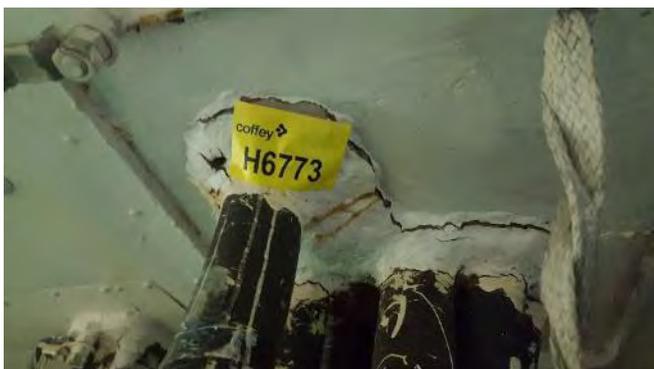
**Photo 84**  
H6769  
2nd Deck, Package Cooler Starboard Cooling Inlet Valve, Gasket (Chrysotile)

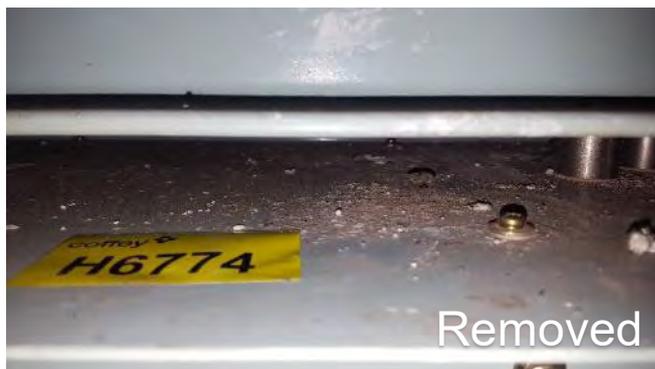
**Photo 85**  
H6773  
2nd Deck, No.2 Main Switchboard Room (O/B) Penetration to Deck Head, Putty (Chrysotile)

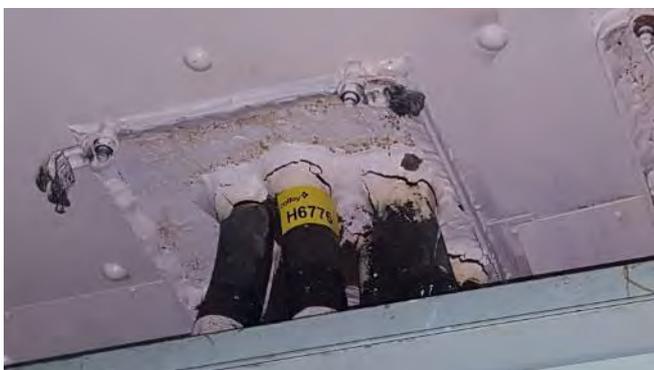
**Photo 86**  
H6774  
2nd Deck, No.2 Main Switchboard Room (O/B) on Top of Electrical Cabinet, Mixed Debris (Chrysotile)

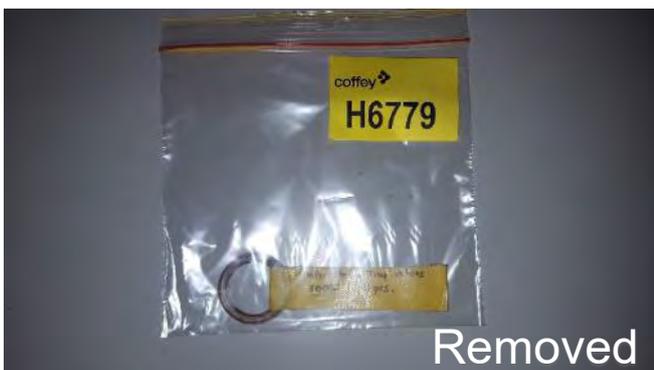
**Photo 88**  
H6778  
2nd Deck, No.1 Main Switchboard Room, Top of Electrical Cabinet, Mixed Debris (Chrysotile)

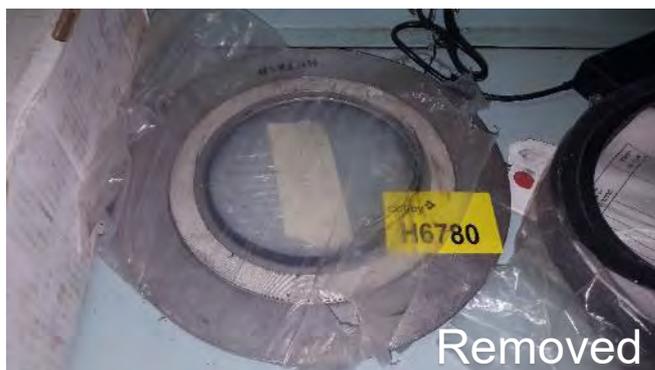
**Photo 89**  
H6779  
2nd Deck, Control Room, Starboard Cupboard to Wooden Cabinet, Small Spiral Wound Gasket (White Sealing Element) '1 Mpa Steam Trap Valves (Chrysotile)

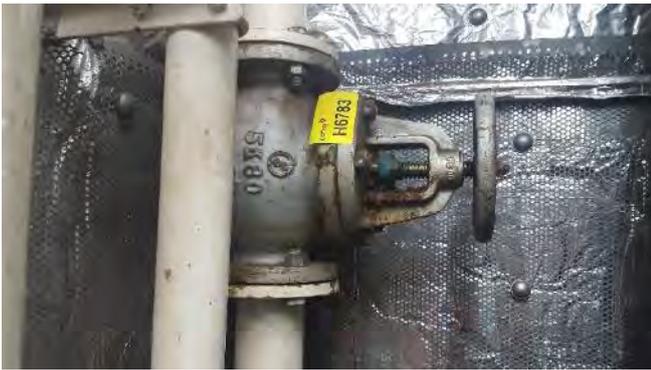
**Photo 90**  
H6780  
2nd Deck, Control Room, Above DB3 Dist. Panel AC100v, Large Spiral Bound Gasket (White Sealing Element) (Chrysotile)

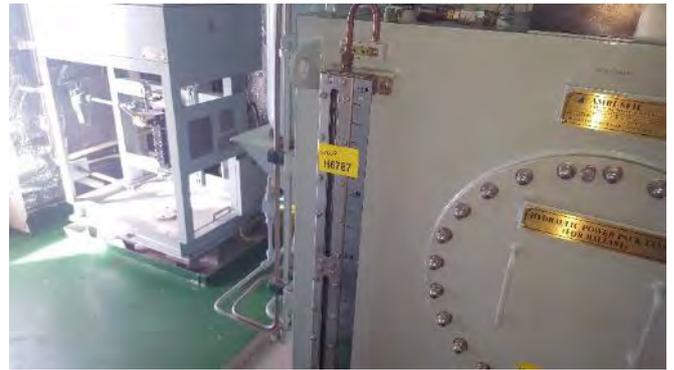
**Photo 91**  
H6783  
Upper Deck, Air Handling Room, Swimming Pool Drain Valve, Gasket (Chrysotile)

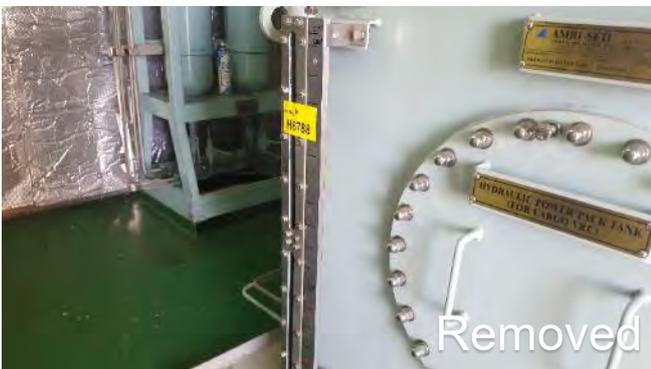
**Photo 92**  
G6787  
Upper Deck, Hydraulic Room, Ballast Power Pack Level Sight Glass, Gasket (Chrysotile)

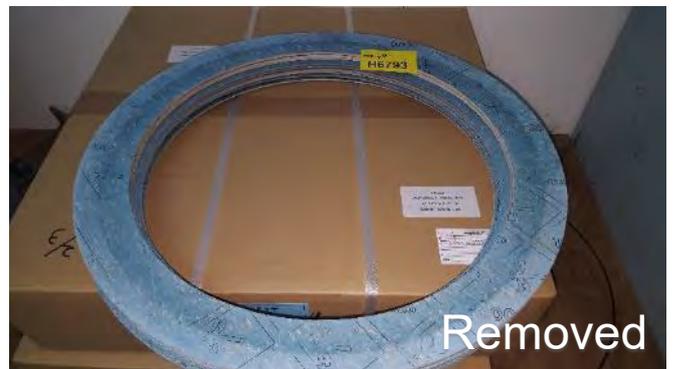
**Photo 93**  
G6788  
Upper Deck, Hydraulic Room, Cargo Power Pack Level Sight Glass, Gasket (Chrysotile)

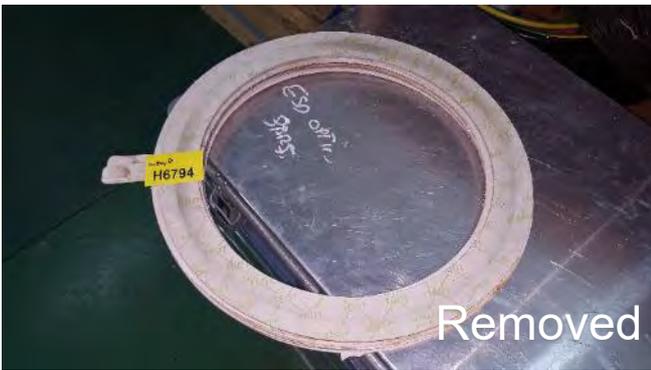
**Photo 94**  
G6793  
Upper Deck, No1 Cargo Room on Storage Rack, Gasket Loose "Tombo 1000" Blue Background Black Font (x16) (Chrysotile)

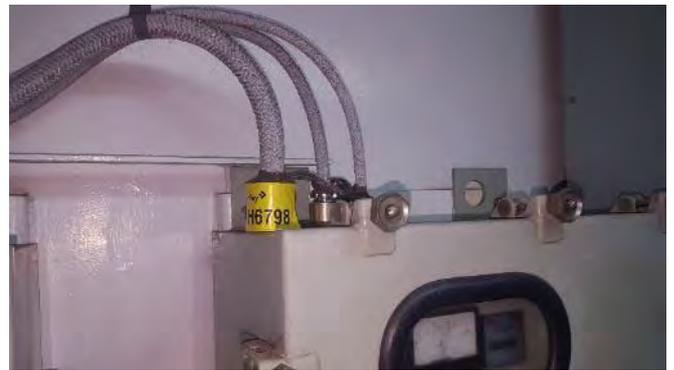
**Photo 95**  
G6794  
Upper Deck, No1 Cargo Room on Storage Rack, Gasket Loose "Valqua 1501" Grey Background Green Font (x14) (Chrysotile)

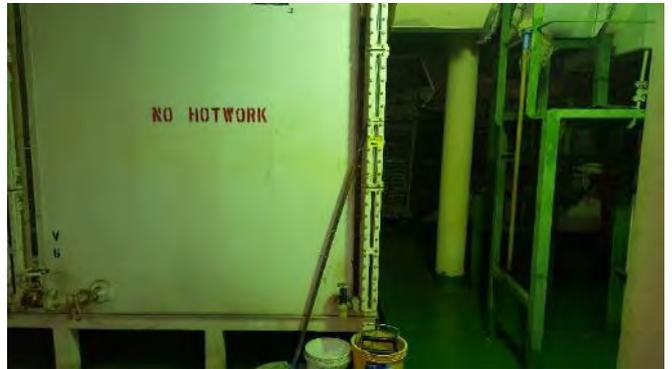
**Photo 105**  
G6831  
Upper Deck, Fo'c'sle/Bosons Store, No.3 Winch & Windlass Starter Box, Putty (Chrysotile)

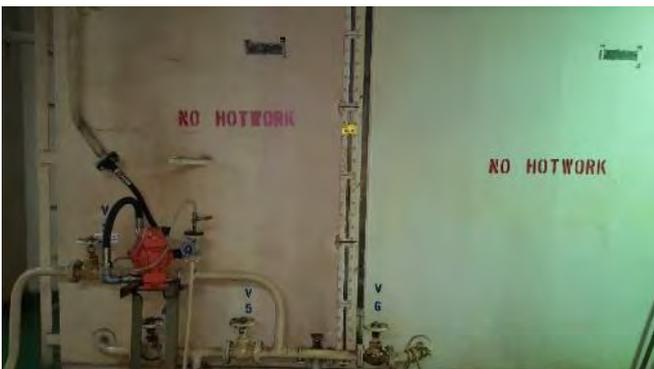
**Photo 106**  
G6832  
Upper Deck, Fo'c'sle/Bosons Store, Transfer Oil Tank Sight Glass, Gasket (Chrysotile)

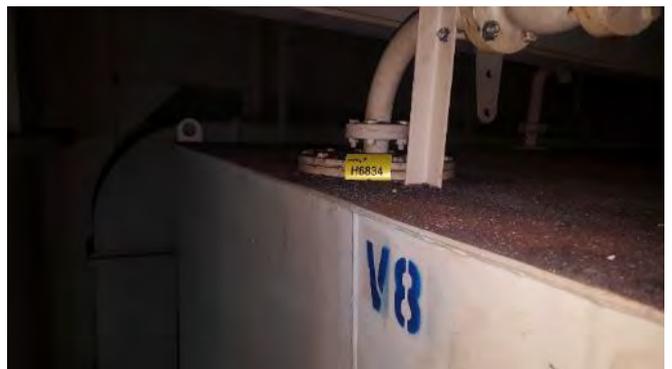
**Photo 107**  
G6833  
Upper Deck, Fo'c'sle/Bosons Store, Storage Oil Tank Sight Glass, Gasket (Chrysotile)

Hazard	Material Description	Location	Photograph No.	Asbestos Fibre Type	Asbestos Fibre Type	Surface Treatment	Product Type	Condition	Likelihood of Disturbance	Risk Score	Action Rating	Comments/Recommendations
ACM	Gasket	Fo'c'sle/Bosons Store, Storage Oil Tank Sight Glass	107	H6833	1	0	2	1	0	5	A4	Manage and remain in situ. Inspect periodically for damage. This item is recommended to be removed by a Licensed Asbestos Removalist Contractor (LARC)
ACM	Gasket	Fo'c'sle/Bosons Store, Transfer Oil Tank Inlet/Inspection Plate	108	H6834	1	0	2	1	0	5	A4	Manage and remain in situ. Inspect periodically for damage. This item is recommended to be removed by a Licensed Asbestos Removalist Contractor (LARC)
ACM	Gasket	Fo'c'sle/Bosons Store, Pipework to Transfer Oil Tank	109	H6835	1	0	2	1	0	5	A4	Manage and remain in situ. Inspect periodically for damage. This item is recommended to be removed by a Licensed Asbestos Removalist Contractor (LARC)

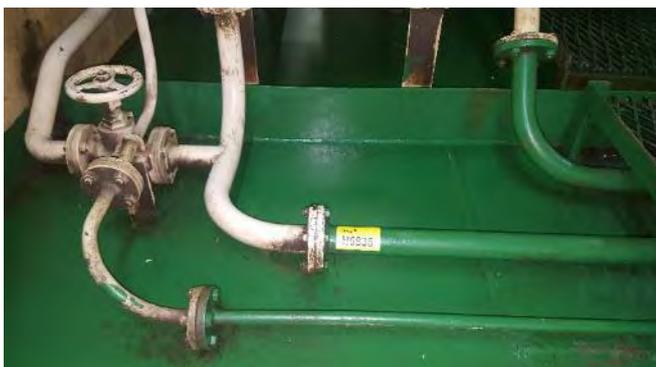
**Photo 108**  
G6834  
Upper Deck, Fo'c'sle/Bosons Store, Transfer Oil Tank Inlet/Inspection Plate, Gasket (Chrysotile)

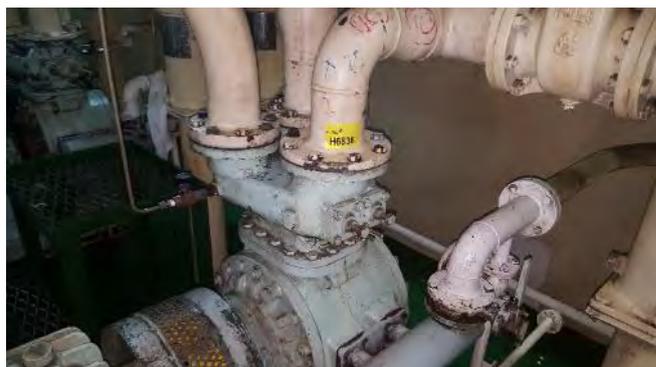
**Photo 109**  
G6835  
Upper Deck, Fo'c'sle/Bosons Store, Pipework to Transfer Oil Tank, Gasket (Chrysotile)

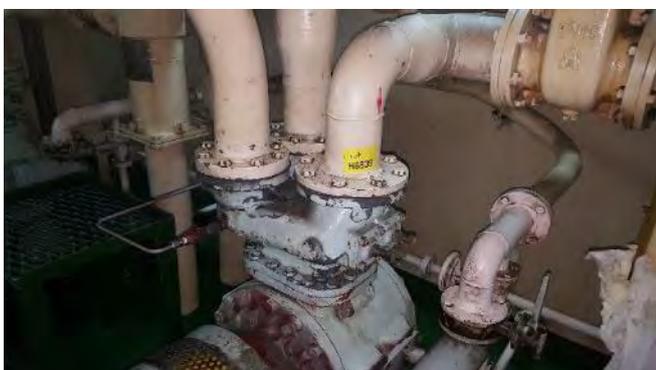
**Photo 110**  
G6838  
Upper Deck, Fo'c'sle/Bosons Store, Hydraulic Pump No.2 Suction Flange, Gasket (Chrysotile)

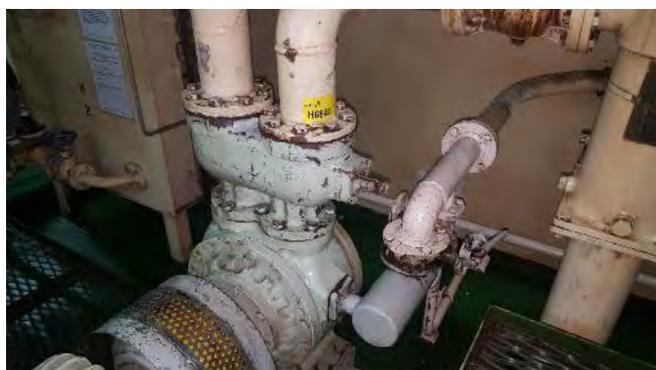
**Photo 111**  
G6839  
Upper Deck, Fo'c'sle/Bosons Store, Hydraulic Pump No.3 Suction Flange, Gasket (Chrysotile)

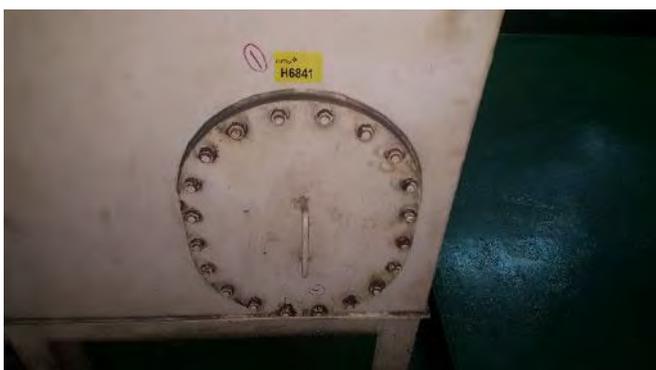
**Photo 112**  
G6840  
Upper Deck, Fo'c'sle/Bosons Store, Hydraulic Pump No.4 Suction Flange, Gasket (Chrysotile)

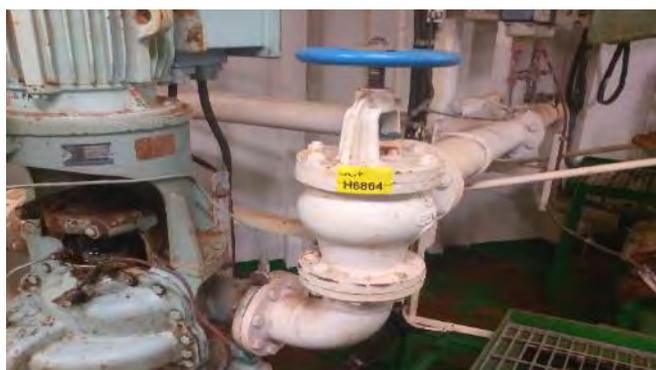
**Photo 113**  
G6841  
Upper Deck, Fo'c'sle/Bosons Store, Hydraulic Pump No.4 Suction Flange, Gasket (Chrysotile)

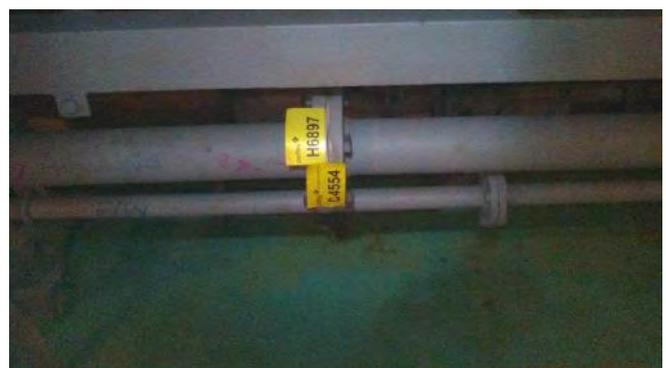
**Photo 125**  
G6894  
Upper Deck, Port Passage, Electrical Cabinet JCM-20 Frame 87, Putty (Chrysotile)

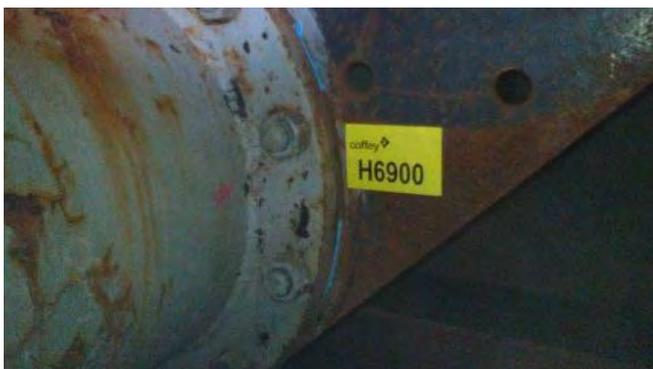
**Photo 126**  
H6897  
Upper Deck, Port Passage, Pipework Air Line Frame 66, Gasket (Chrysotile)

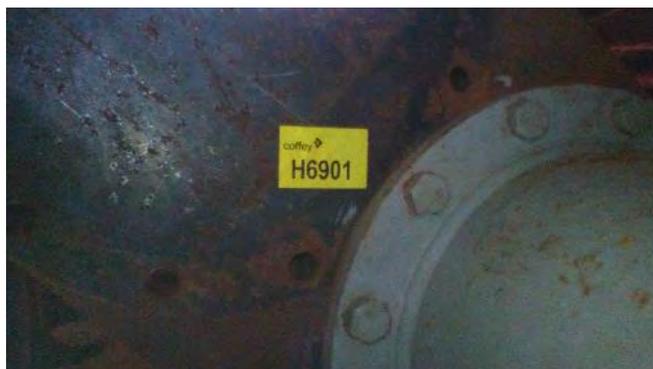
**Photo 127**  
H6900  
Upper Deck, Port Passage, Spectacle Piece Port Frame 65, Gasket (UMF)

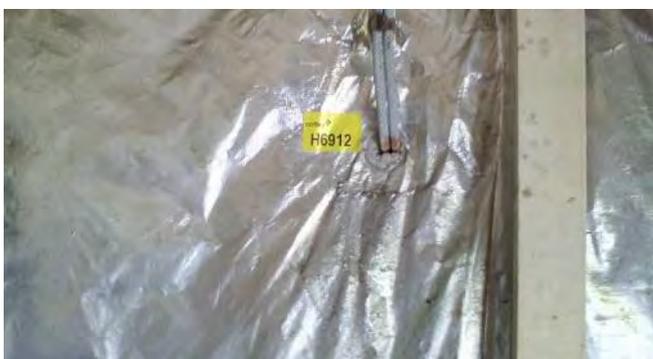
**Photo 128**  
H6901  
Upper Deck, Port Passage, Spectacle Piece Starboard Frame 66, Gasket (UMF)

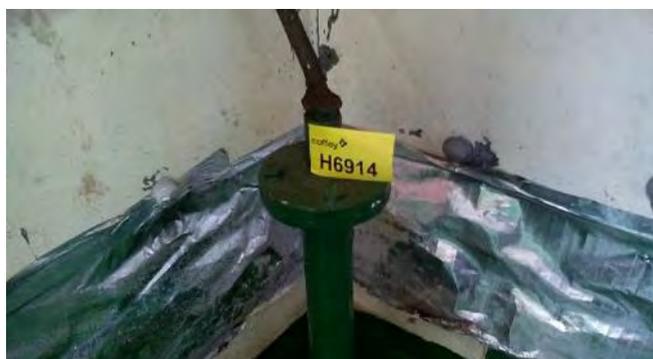
**Photo 129**  
H6912  
Upper Deck, Deck Rope Store (Starboard Aft), Packing (Chrysotile)

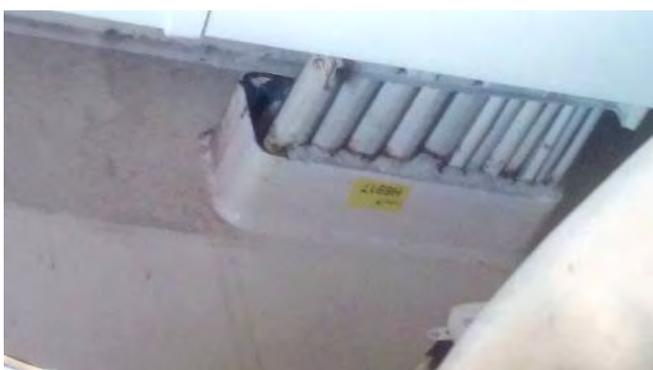
**Photo 130**  
G6914  
Upper Deck, B.A. Locker (Starboard Aft) Cable Conduit Pipe to Deck, Putty (Chrysotile)

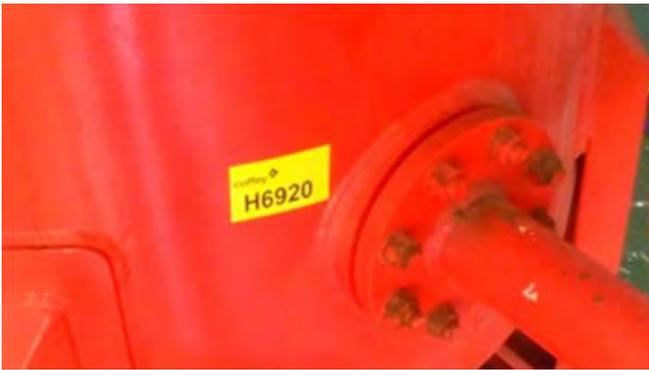
**Photo 132**  
H6918  
Upper Deck, Boat Gear Locker, Cable Penetration to Deck via Steel Conduit, Putty (Chrysotile)

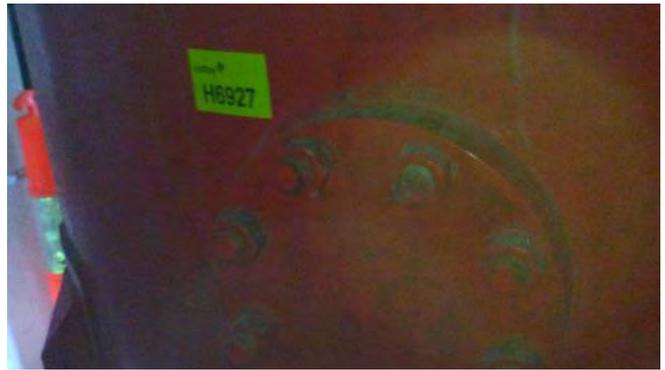
**Photo 133**  
H6920  
Upper Deck, No.3 Dry Chemical Powder Room Vessel Pipework Outlet Flange to Manifold, Gasket

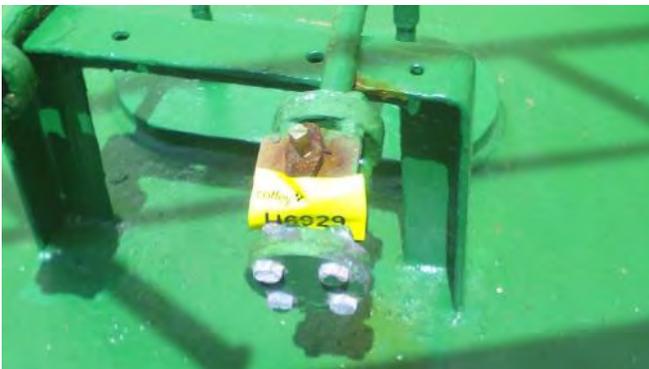
**Photo 134**  
H6927  
Upper Deck, No.1 Dry Chemical Powder Room, Vessel Inboard Blank, Gasket

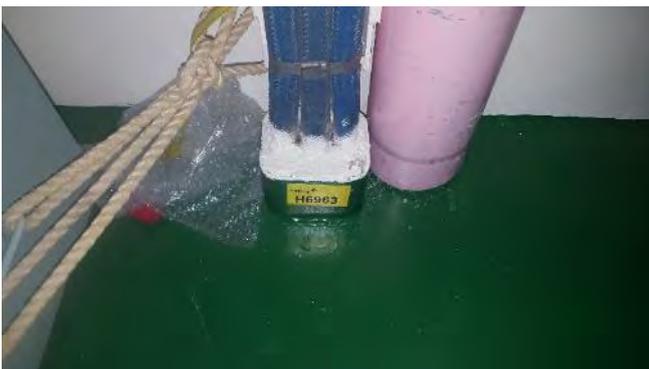
**Photo 136**  
G6962  
G Deck, Cable Trunk Room (CRYOS) FWD Bulkhead Penetration, Packing (Chrysotile)

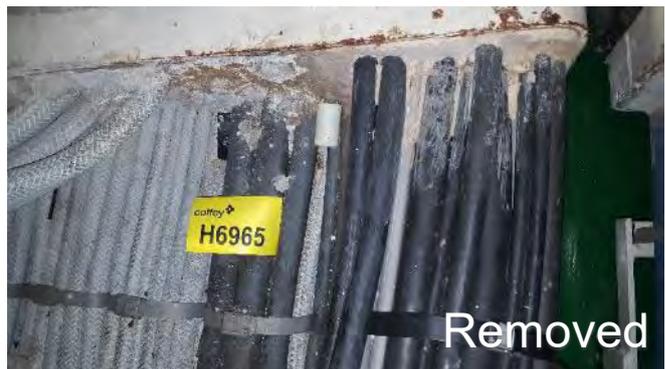
**Photo 137**  
H6963  
Nav. Bridge, Cable Trunk Room (CRYOS) Deck Penetration, Packing (Chrysotile)

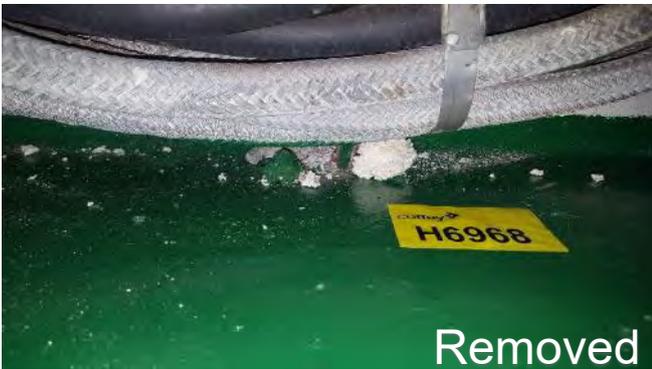
**Photo 140**  
H6967  
F Deck, Electric Cable Space, Inboard Deck Head, Packing (Chrysotile)

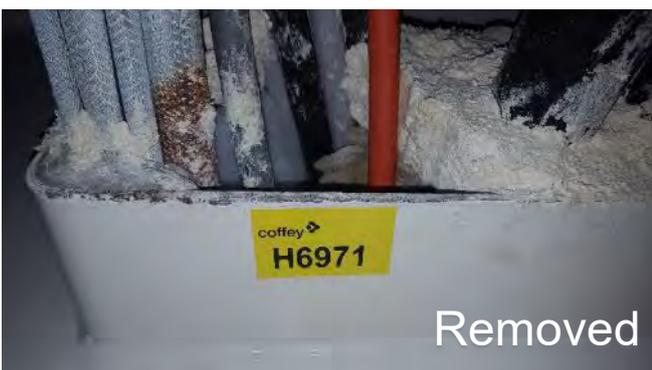
**Photo 143**  
H6971  
F Deck, Electrical Cable Trunking, Inboard Deck Head, Debris (Chrysotile)

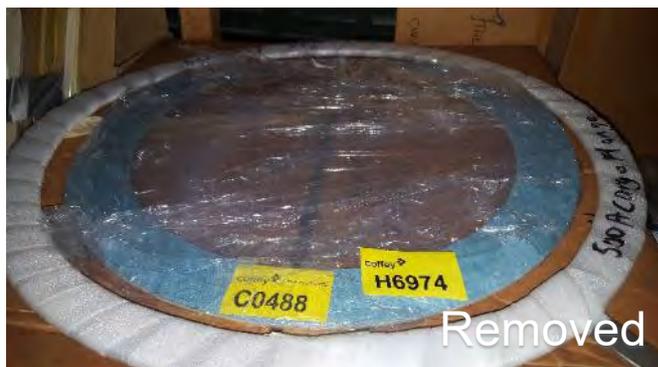
**Photo 146**  
H6974  
F Deck, No.2 Equipment Room, Shelf CA2, Gasket "Tombo 1000" Blue Backing Black Font (Chrysotile)

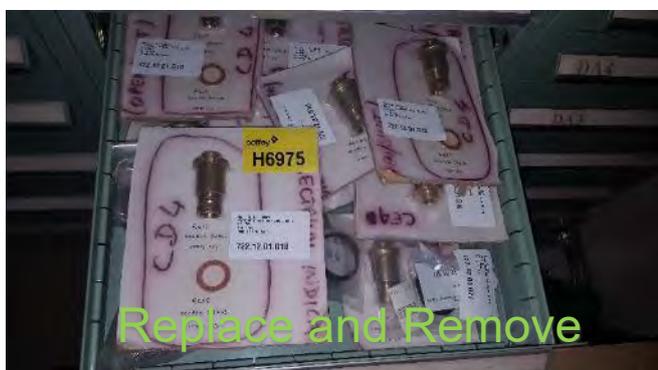
**Photo 147**  
H6975  
F Deck, No.2 Equipment Room, F3 DB4 722.12.01.G10 Boil Off Gas Valves, Gasket (Pink Backing Black Cursive Font) (Chrysotile)

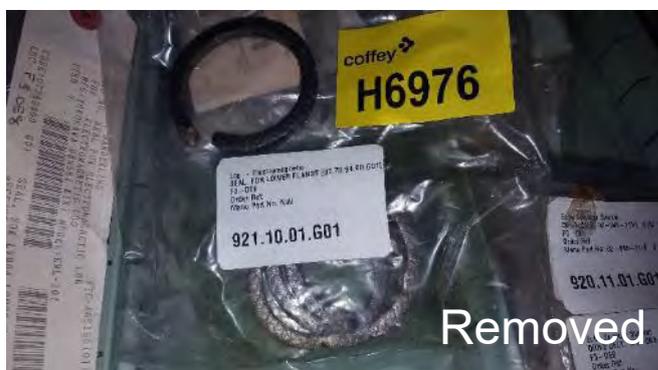
**Photo 148**  
H6976  
F Deck, No.2 Equipment Room, F3 DE8 921. 10.01.G01, Electromagnetic Seal, Packing Gland (Chrysotile)

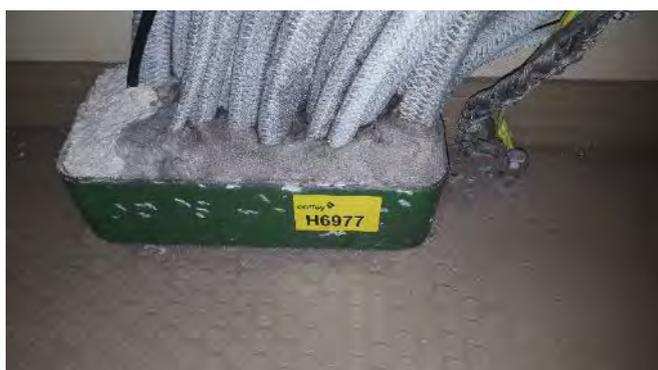
**Photo 149**  
H6977  
F Deck, No.2 Equipment Room, Penetration Through Deck, Packing (Grey) (Chrysotile)

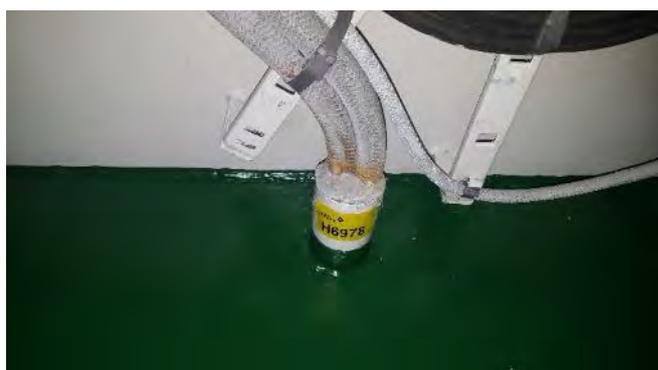
**Photo 150**  
H6978  
E Deck, Electrical Cable Trunk Room, Inboard Deck Penetration, Packing (Grey) (Chrysotile)

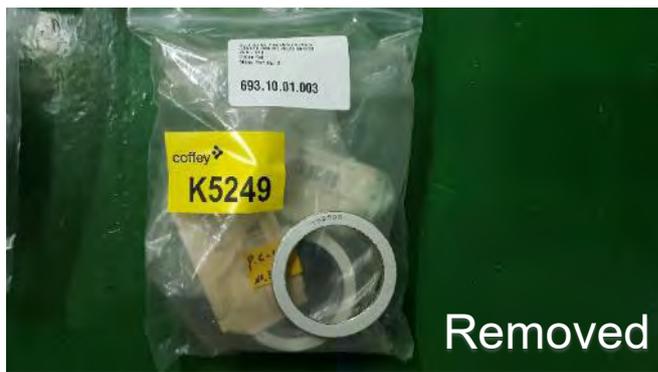
**Photo 158**  
K5249  
2nd Deck, 2SA, BF1 693.10.01.003 Soot Blower, Spiral Wound  
Gasket (Chrysotile)
