# Asbestos Materials Refit survey and partial reinspection

## NW Sanderling

Shell Tankers Australia Pty Ltd

Reference: 754-PEREN324141

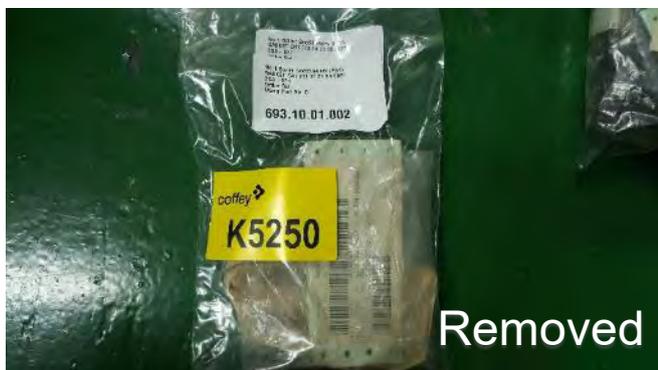
**Photo 159**  
K5250  
2nd Deck, 2SA, BF1 693.10.01.002 Soot Blower, Gasket Metal  
(Chrysotile)

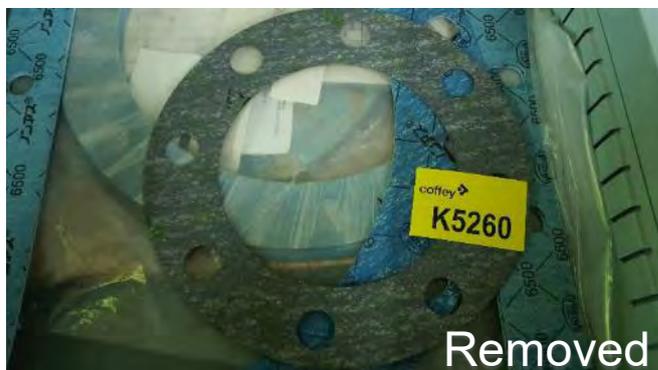
**Photo 160**  
K5260  
2nd Deck, 2SA, BJ3 708.10.01.024 Manoeuvring Valves, Gasket  
"Valqua 1500" Black Backing with Green Font (Chrysotile)

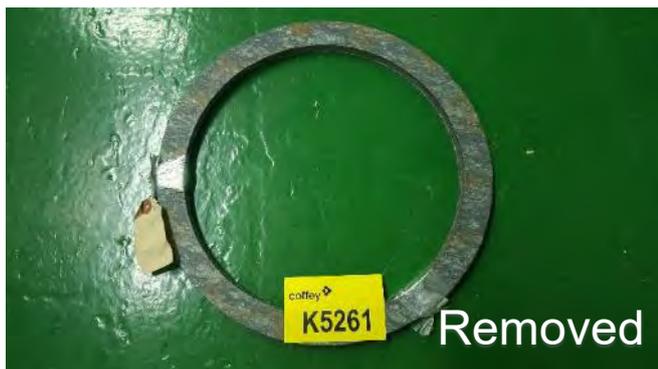
**Photo 161**  
K5261  
2nd Deck, 2SA, BJ2, Gasket "Valqua" (Chrysotile)

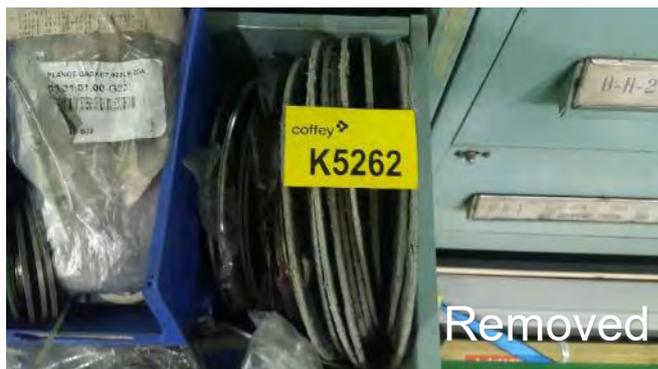
**Photo 162**  
K5262  
2nd Deck, 2SA, BJ2, Gaskets Loose (Various Grey Sizes)  
(Chrysotile)

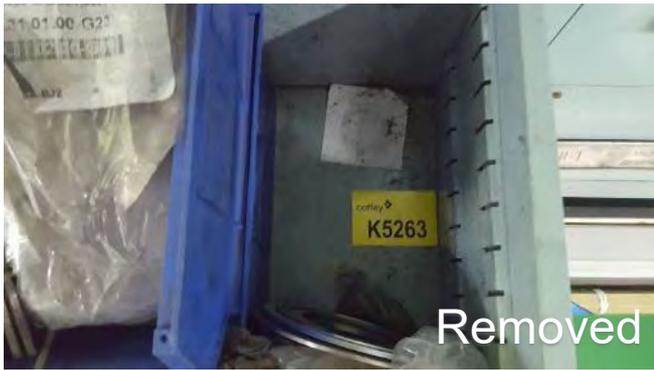
**Photo 163**

2nd Deck, 2SA, BJ2 Drawer, Debris (Chrysotile)

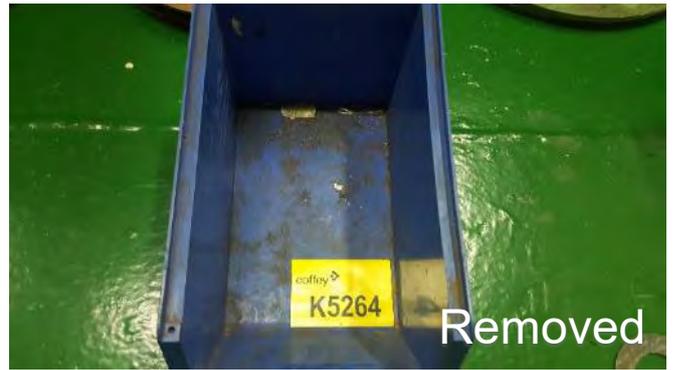
**Photo 164**

2nd Deck, 2SA, BJ2 Blue Plastic Container, Debris (Chrysotile)

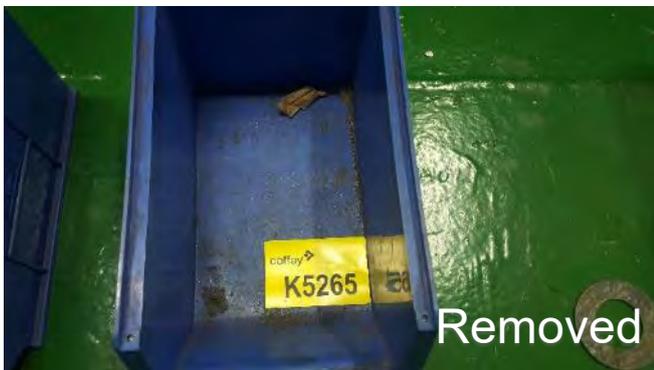
**Photo 165**

2nd Deck, 2SA, BJ2 Blue Plastic Container, Debris (Chrysotile)

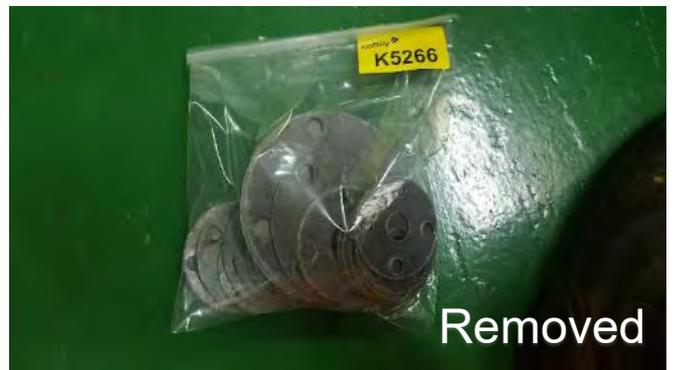
**Photo 166**

2nd Deck, 2SA, BJ2, Gaskets Loose (Various Sizes of Graphite Material) (Chrysotile)

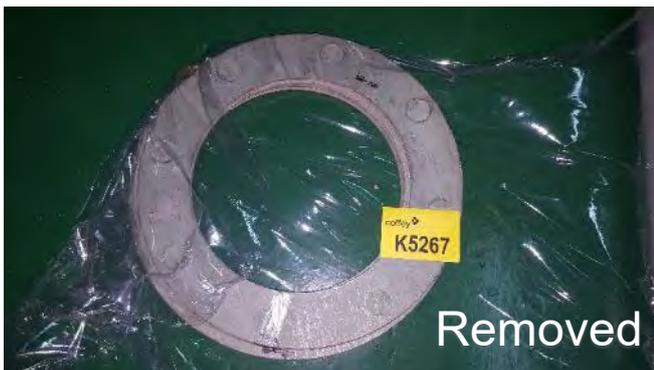
**Photo 167**

2nd Deck, 2SA, BJ2, Gaskets Loose (Green with White Speckles 5K200A) (Chrysotile)

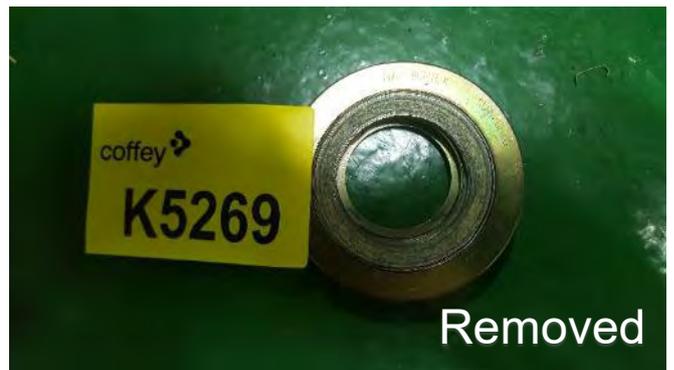
**Photo 168**

2nd Deck, 2SA, BJ2, Spiral Wound Loose Gaskets Vortex C20 K25,D 20K 25 (Chrysotile)

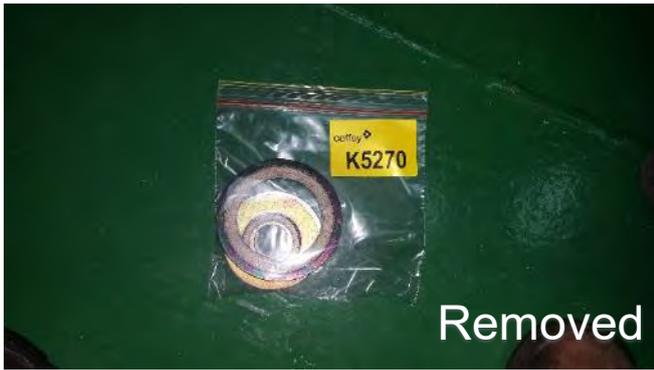
**Photo 169**

2nd Deck, 2SA, BJ2, Spiral Wound Medium Size Loose No Brand (Various Makes) (Chrysotile)

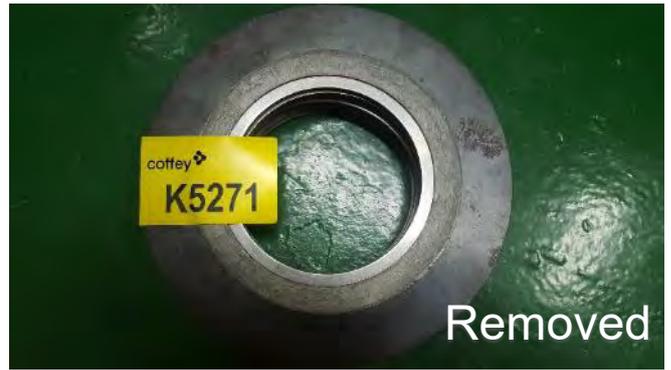
**Photo 170**

2nd Deck, 2SA, BJ2, Spiral Wound Medium Size Loose No Brand (Various Makes) (Chrysotile)

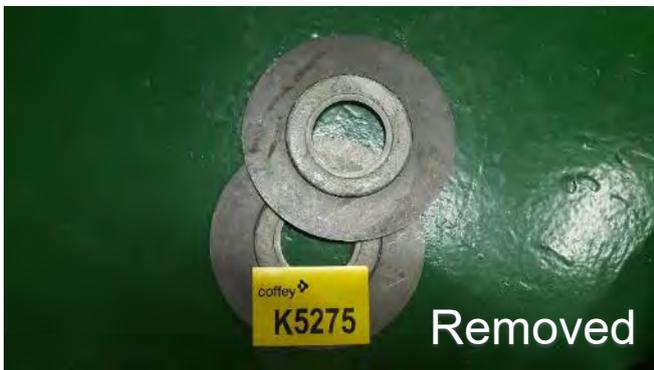
**Photo 171**

2nd Deck, 2SA, BJ2, Spiral Wound Gasket White Sealing Element (No Brand) 9 lb's – 58 (Chrysotile)

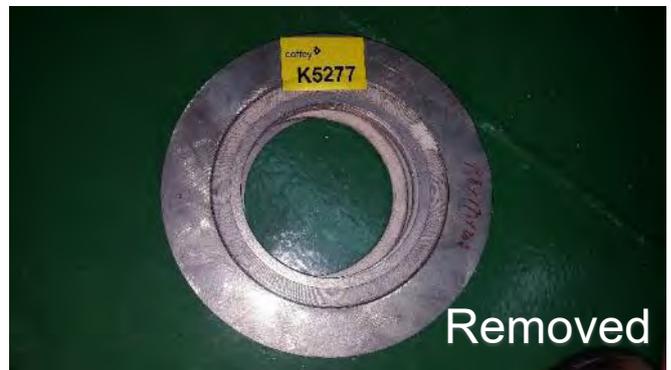
**Photo 172**

2nd Deck, 2SA, BJ2, Spiral Wound Gaskets Large Size (158x173x203 JPI900-6) (Chrysotile)

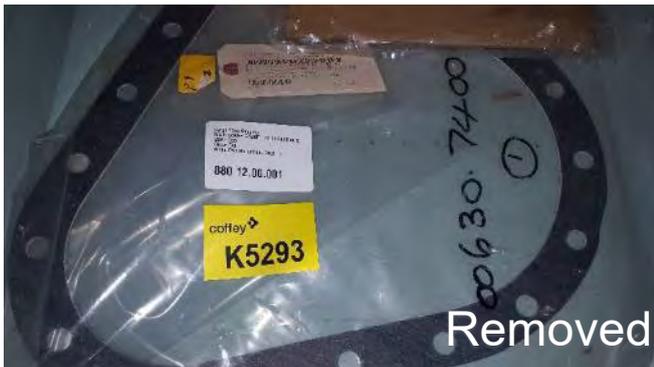
**Photo 173**

2nd Deck, 2SA, CB5 Cargo Tank Gauging 880.12.00.001, Gasket Loose "Permanite G" (Black Backing with White Speckles and Blue Font) (Chrysotile)

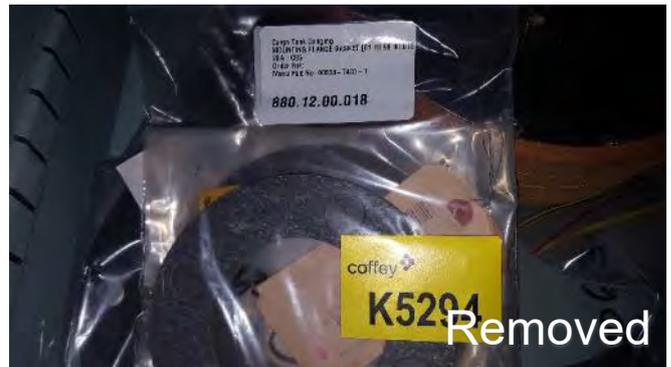
**Photo 174**

2nd Deck, 2SA, CB5 Cargo Tank Gauging 880.12.00.018, Gasket (Black with White Speckles) (Chrysotile)

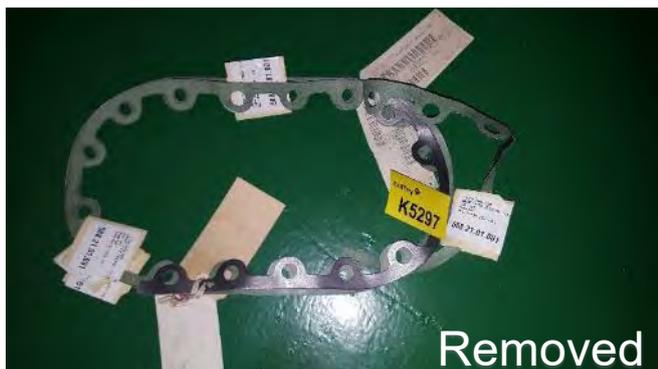
**Photo 175**

2nd Deck, 2SA, HC2 I.G. Ref Comp. 568.21.01.001 F/Top Cover, Gasket (Chrysotile)

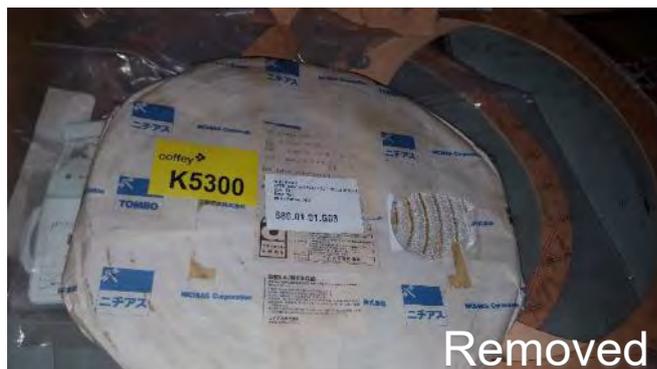
**Photo 176**

2nd Deck, 2SA, BF7 Main Boilers Door Joint (Furnace Out) 680.01.01.G01, Lagging "Tombo" (Chrysotile)

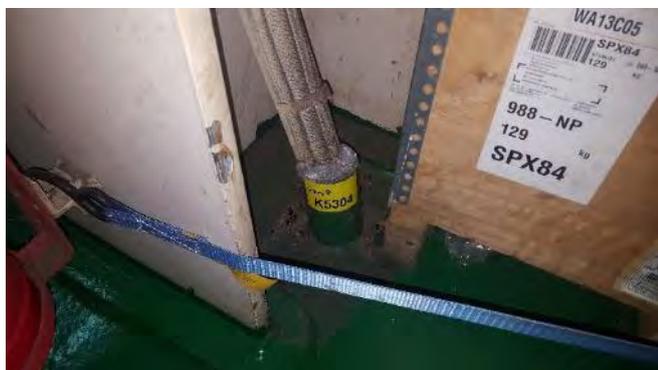
**Photo 177**

2nd Deck, 2SA, Below Gas Alarm Motor Penetration, Packing (Chrysotile)

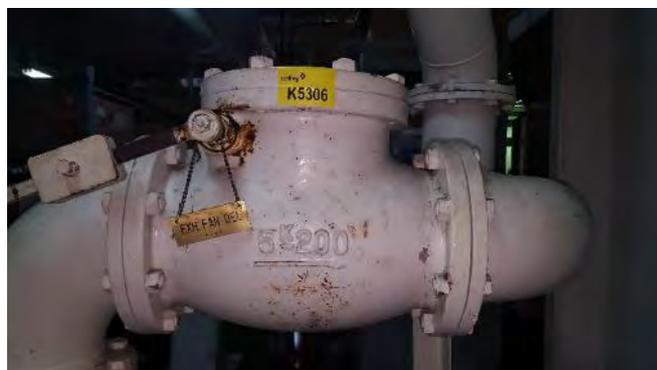
**Photo 178**

2nd Deck, 2SA, No.1 Exhaust Fane Valve, Gasket (Chrysotile)

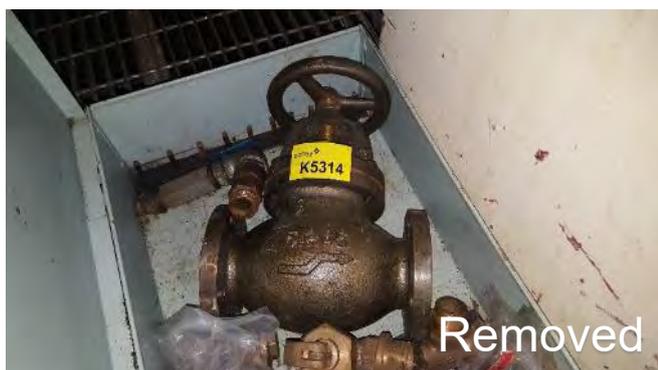
**Photo 179**

2nd Deck, Workshop Loft, Small Grey Metal Box Beneath Black Crate Containing Brass Valves, Gasket (Bonnet) (Chrysotile)

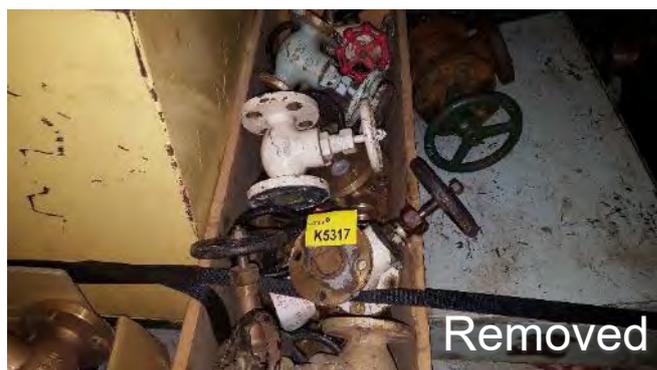
**Photo 180**

2nd Deck, Workshop Loft, Small Wooden Crate, Gasket Adhered to White Valve (Chrysotile)

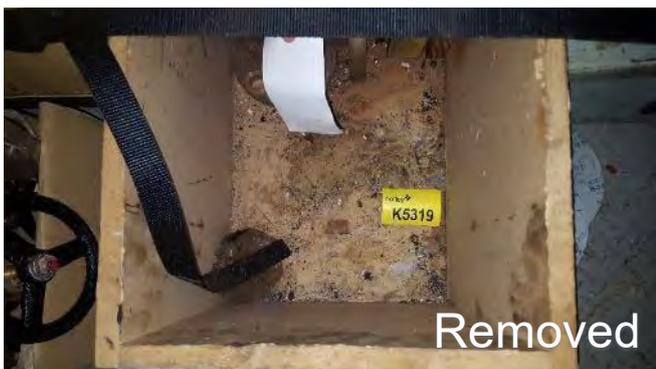
**Photo 181**  
K5319  
2nd Deck, Workshop Loft, Small Wooden Crate, Debris (Mixed) (Chrysotile)

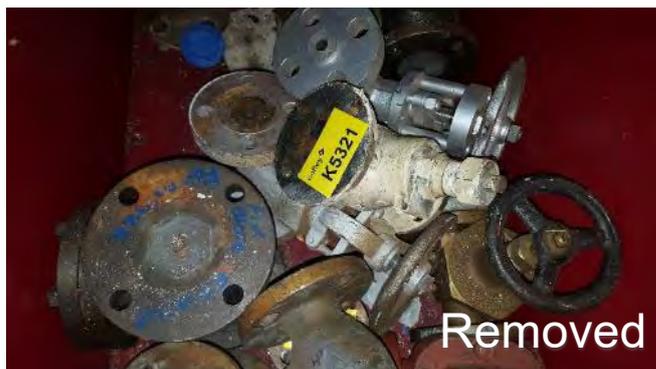
**Photo 182**  
K5321  
2nd Deck, Workshop Loft, Large Yellow Metal Box White Valve, Gasket Adhered to Valve (Chrysotile)

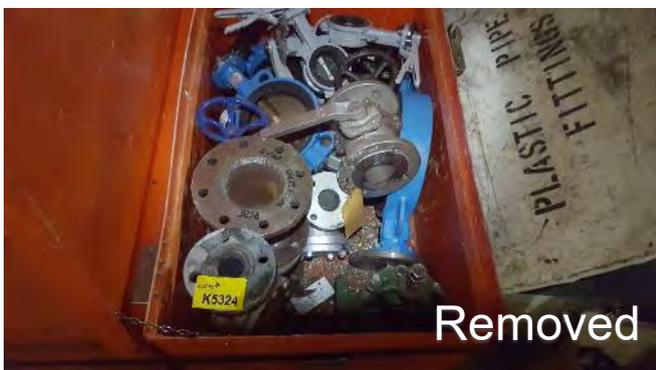
**Photo 183**  
K5324  
2nd Deck, Workshop Loft, Small Red Metal Box, Gasket Adhered to Silver Valve (Chrysotile)

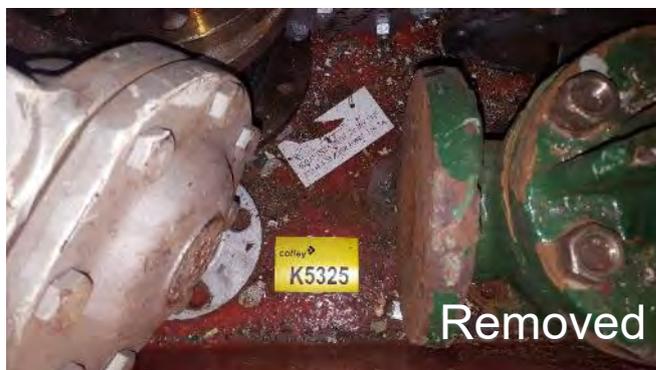
**Photo 184**  
K5325  
2nd Deck, Workshop Loft, Small Red Metal Box, Debris (Mixed) (Chrysotile)

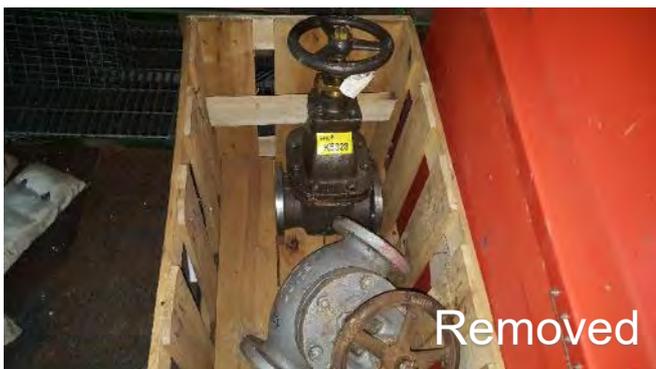
**Photo 185**  
K5328  
3rd Deck, Workshop Mezzanine, Large Wooden Crate Stored Large Valves, Brass Valve Bonnet, Gasket (Chrysotile)

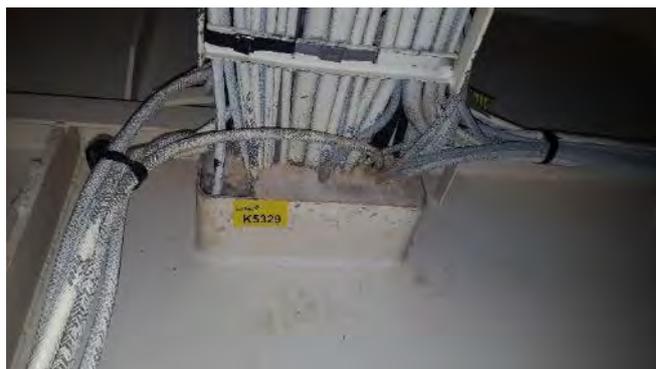
**Photo 186**  
K5329  
3rd Deck, Workshop Mezzanine, Port Aft Penetration, Packing (Grey/Cream) (Chrysotile)

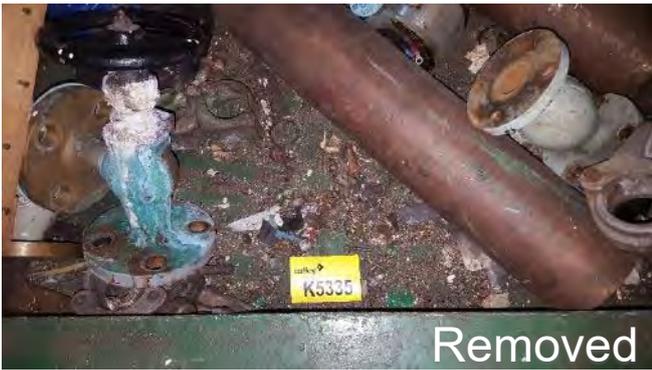
**Photo 187**  
K5335  
3rd Deck, Workshop, Work Bench Adjacent Wooden Block, Caged Floor Area (Aft), Debris (Mixed) (Chrysotile)

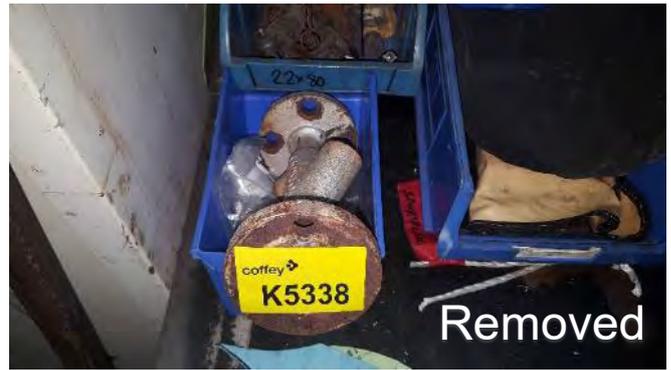
**Photo 188**  
K5338  
3rd Deck, Workshop, Gasket Drawer Bench Top, Stored Valve, Gasket Adhered to Valve (Chrysotile)

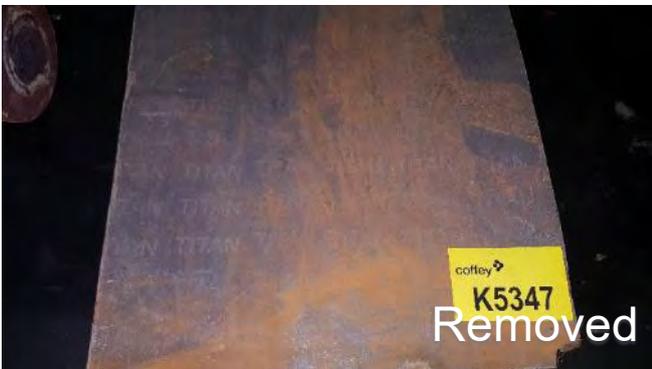
**Photo 189**  
K5347  
3rd Deck, Workshop, Storage Rack, Gasket Sheet "Titan" (Grey Backing Silver Font) (Chrysotile)

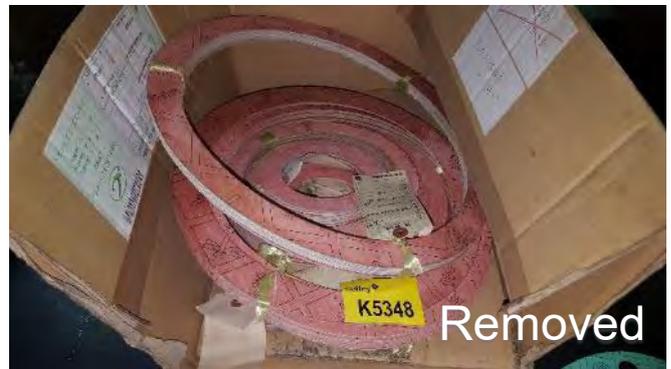
**Photo 190**  
K5348  
3rd Deck, Workshop, Storage Rack, Gaskets Loose "Tombo 1000" Tan Backing Black Font (Chrysotile)

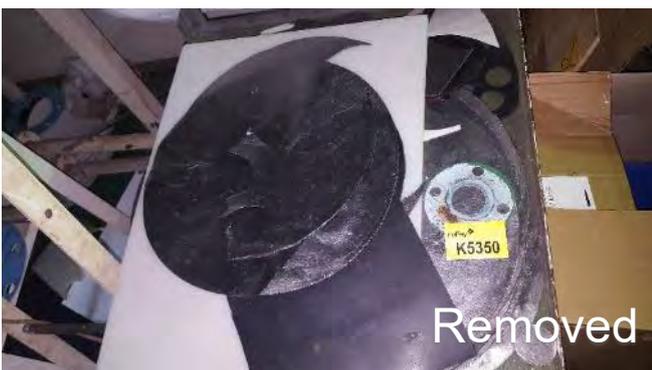
**Photo 191**  
K5350  
3rd Deck, Workshop, Graphite Stand, Gasket Loose "Tombo" (Blue Backing White Specks Black Font) (Chrysotile)

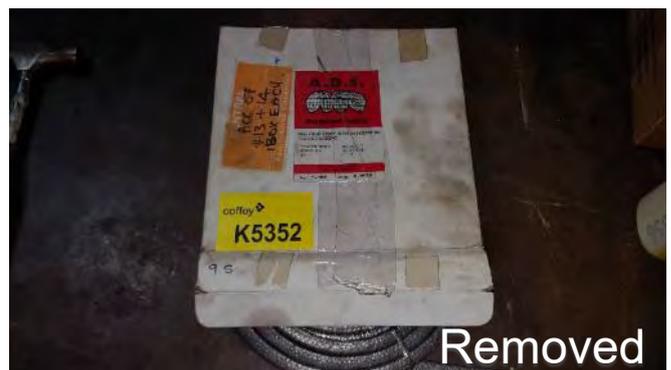
**Photo 192**  
K5352  
3rd Deck, Workshop, Packing Cabinet 4th Shelf, Packing "ADJ" #183 (Chrysotile)

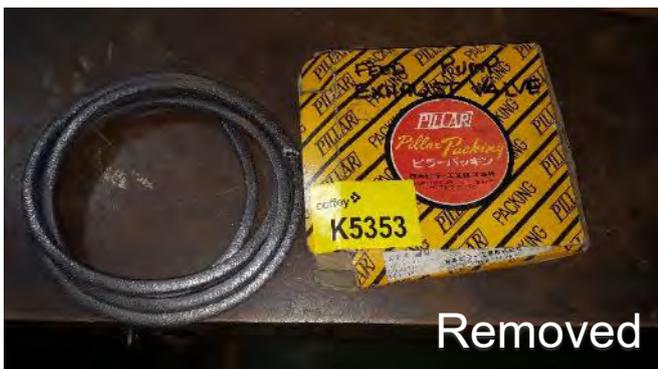
**Photo 193**

3rd Deck, Workshop, Packing Cabinet 4th Shelf, Packing "Pillar Packing" Feed Pump Exhaust Valve (Chrysotile)

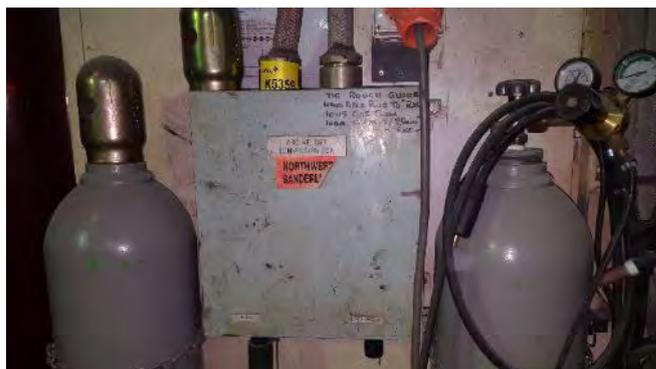
**Photo 194**

3rd Deck, Workshop, ARC Welder Connection Box Power Inlet (Welding Booth), Putty (Chrysotile)

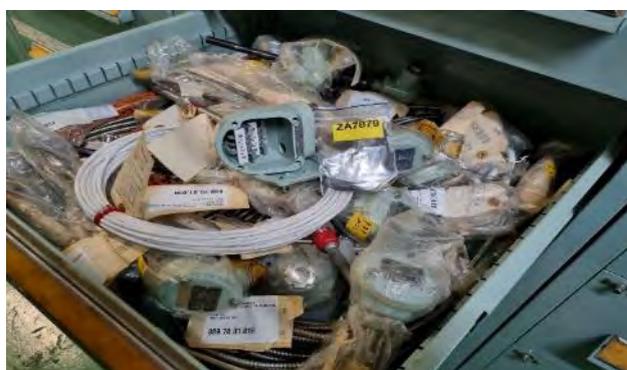
**Photo 194**

2nd Deck, Gasket - 2SA - DE3 - Temperature prob (Chrysotile)

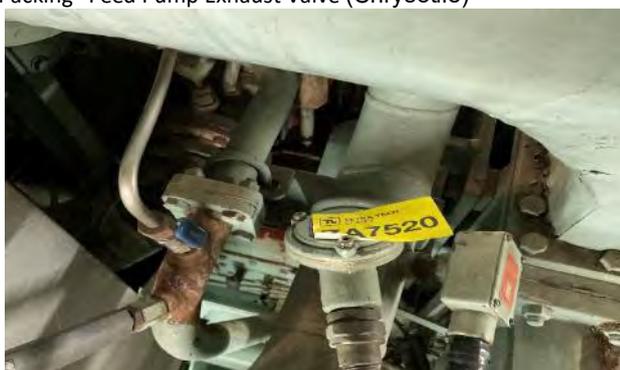
**Photo 195**

3rd Deck, No.2 Diesel Generator Temp Guage Gasket (Chrysotile)

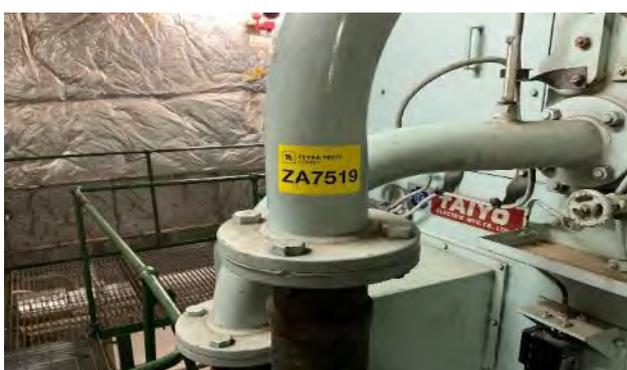
**Photo 196**

No.2 Diesel Generator Air Cooler Water Gasket (Chrysotile)

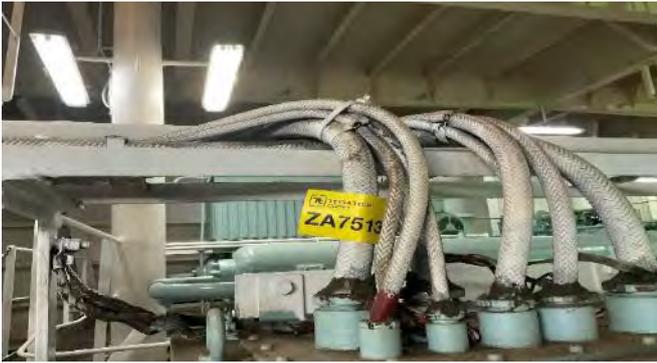
**Photo 197**  
ZA7513  
3rd Deck, No.3 Steering Gear Pump Fwd , Putty (Chrysotile)

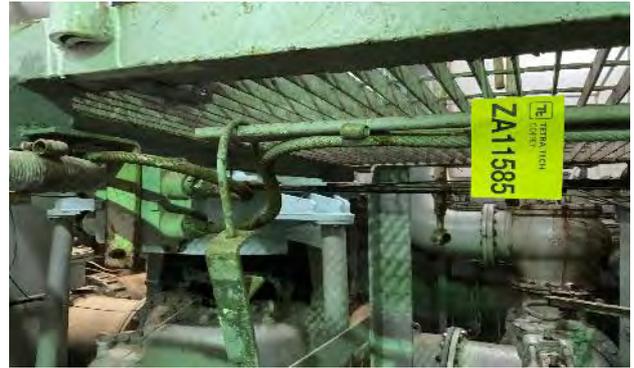
**Photo 198**  
ZA11585  
Tank Top, Penetration to Cables Adjacent Atmospheric Drains, Putty (Chrysotile)

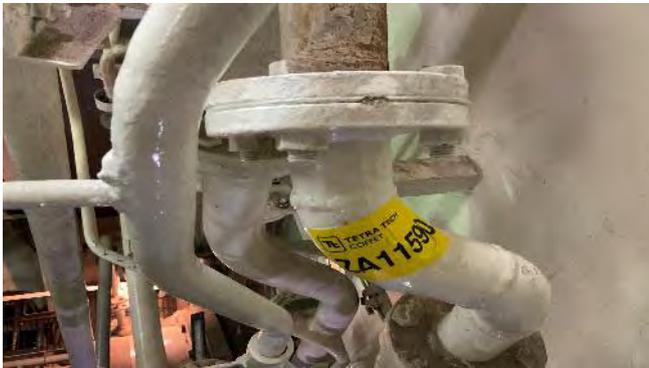
**Photo 199**  
ZA11590  
Tank Top, Engine Room, Stern Tune Berance Line, Gasket (Chrysotile)

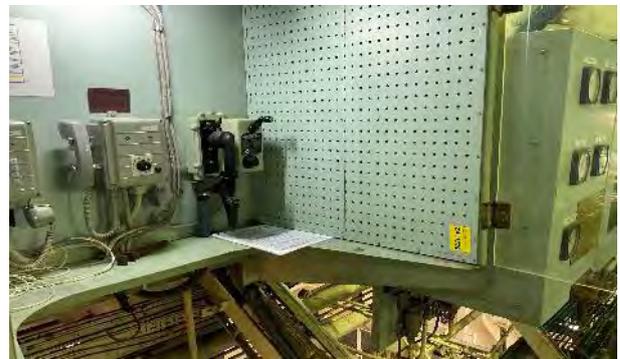
**Photo 200**  
ZA11579  
Tank Top, Telephone Booth Adjacent Stairs to 4th Deck – Fibre Board (Chrysotile)

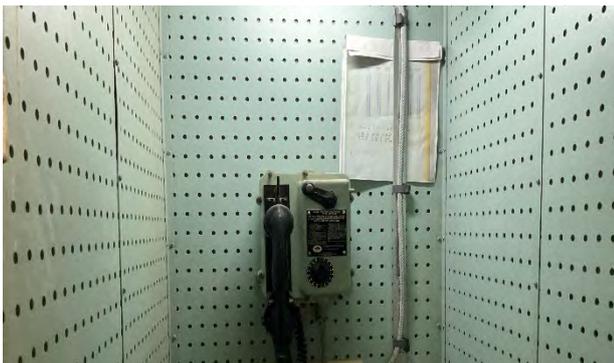
**Photo 201**  
ZA11574  
3rd Deck, Workshop Phonebooth Sheeting (Chrysotile)
