# Maritime Asbestos Materials Post Re-Fit Assessment

Post Re-Fit Survey - Northwest Sandpiper (IMO: 8913150)

Shell Tankers Australia Pty Ltd

**Report reference number: 754-PEREN310903**

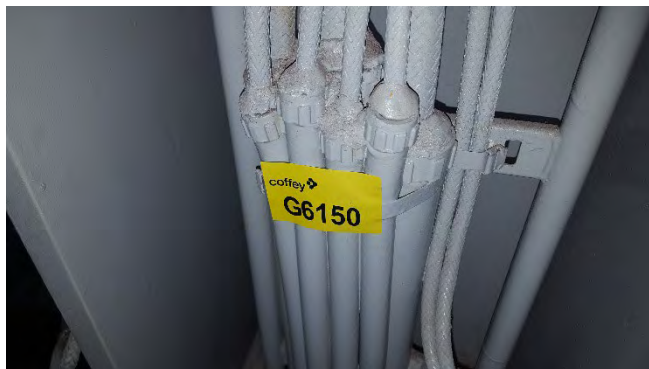
**Photo 3**

G6147  
Tank Top Engine Room, No.2 PP Power Cable Conduit – Putty (Chrysotile)

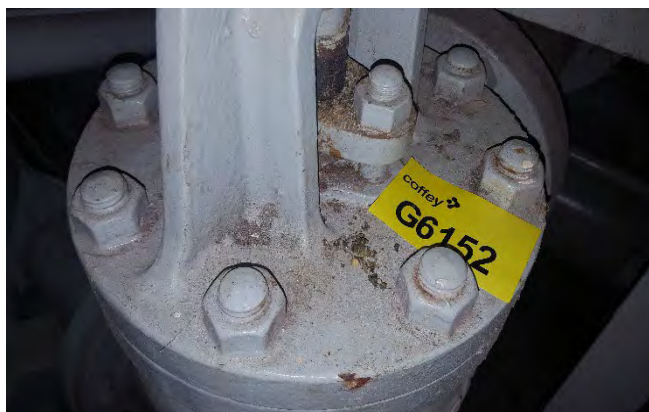
**Photo 5**

G6151  
Tank Top Engine Room, Auxiliary Circuit, PP Inlet Flange, Lower Walkway – Gasket (UMF)

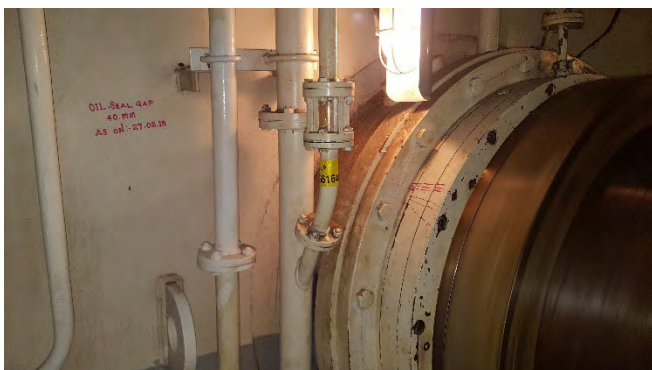
**Photo 6**

G6152  
Tank Top - Engine Room, Condensate Outlet V/V Flange - Gasket

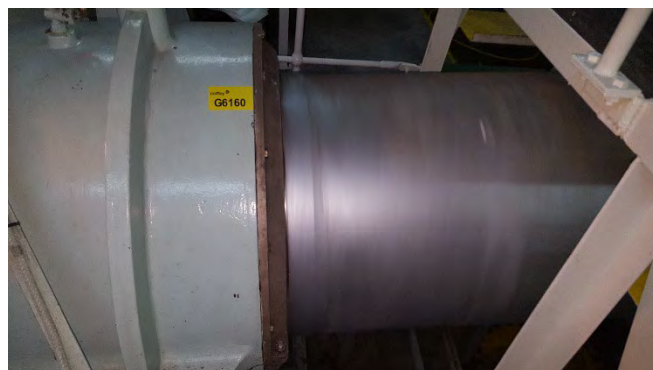
**Photo 7**  
G6164  
Lower Deck - Engine Room, Aft Midship, Sight Glass, Stern Tube to Lube Oil Overflow- Gasket (UMF)

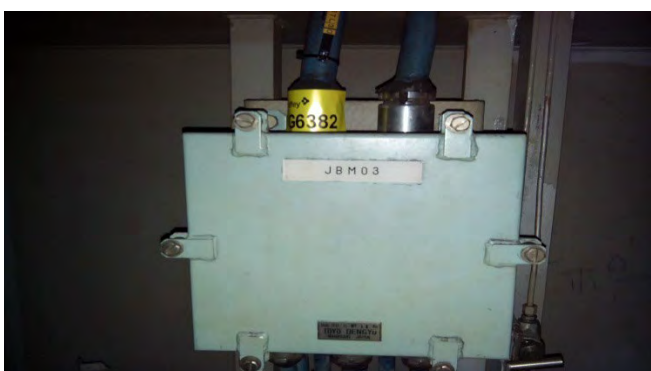
**Photo 116**  
G6380  
Upper Deck Pipe Passage Starboard, Valve to Sampling Line) - Gasket (UMF)

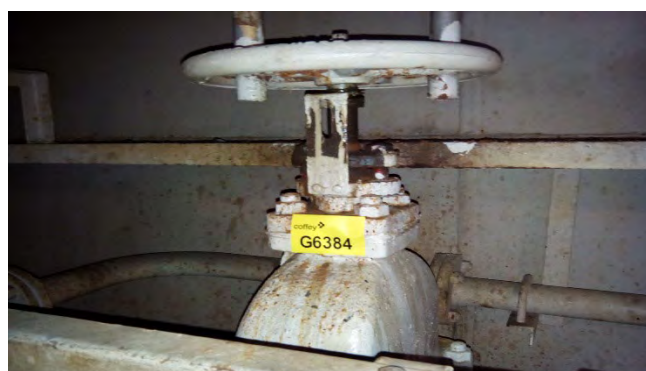
**Photo 117**  
G6382  
Upper Deck Pipe Passage Starboard, JB M03 Cabinet, Conduit – Putty (Chrysotile)
