Asbestos Materials Refit survey and partial reinspection

NW Snipe

Shell Tankers Australia Pty Ltd

Report reference number: 754-PEREN324142

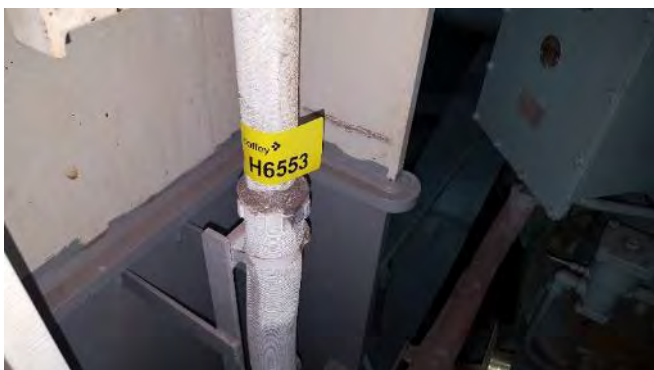
Photo 7

H6553

Tank Top/Lower Deck, Engine Room, Bilge and General Service Pump – Conduit, Putty (Chrysotile)

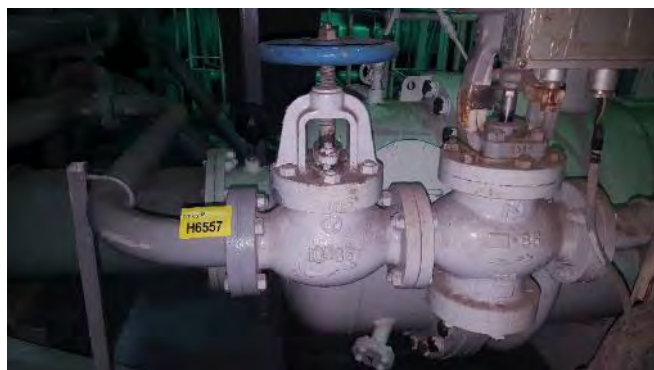
Photo 8

H6557

Tank Top/Lower Deck, Engine Room, Controller Isolation V-PF168 Dump STM Water Spray Inlet Valve, Gasket (Chrysotile)

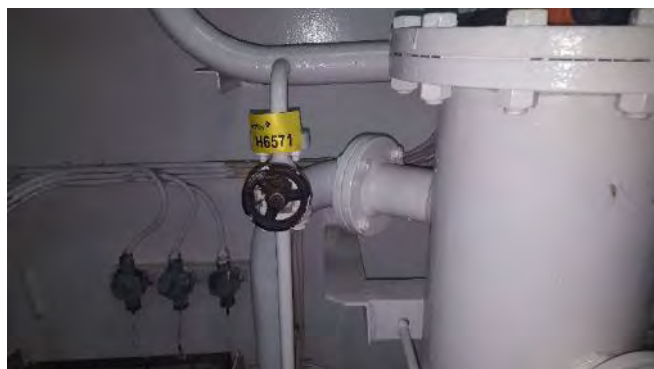
Photo 10

H6571

Tank Top/Lower Deck, Engine Room, Stern Tube Filling Line Valve Flange, Gasket (Chrysotile)

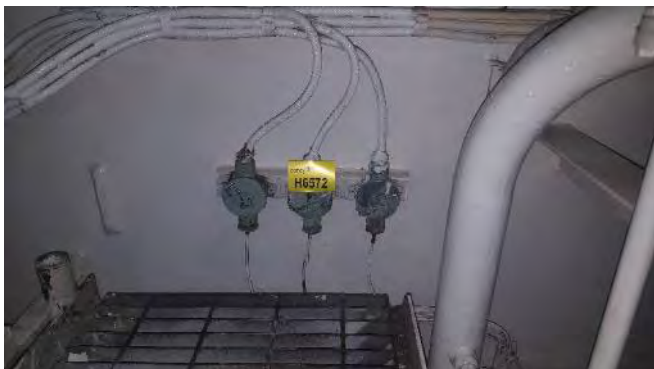
Photo 11

H6572

Tank Top/Lower Deck, Engine Room, Junction Box - Aft Bulkhead, Putty (Chrysotile)

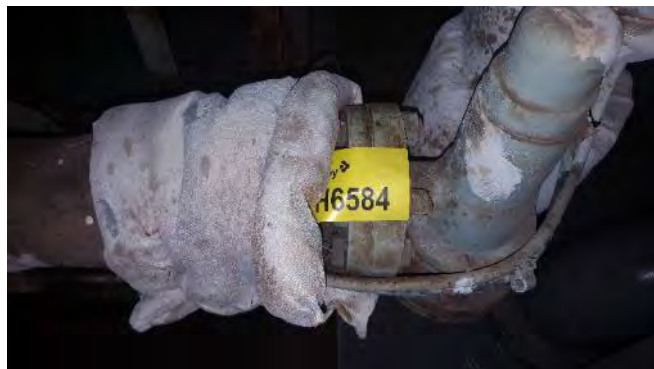
Photo 12

H6584

Tank Top/Lower Deck, Engine Room, Sludge Oil Transfer Pump Flange Relief Valve, Gasket (Chrysotile)

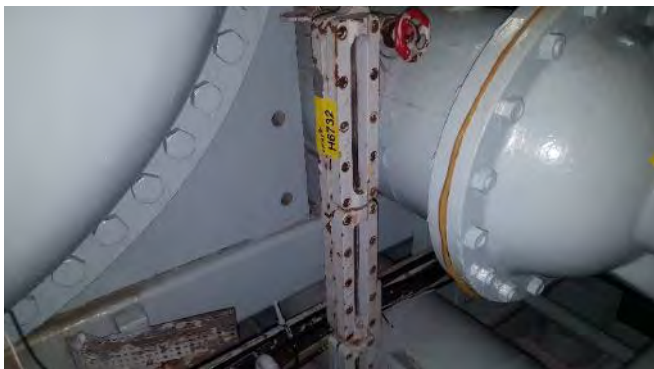
Photo 67
H6732
2nd Deck, IGG Room, Sight Glass Level, Gasket (Chrysotile)

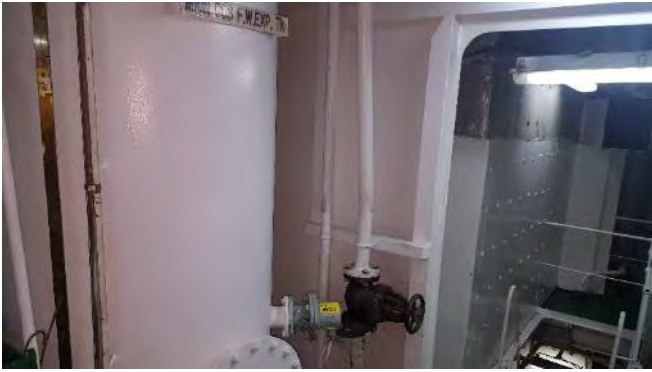
Photo 102
G6819
B Deck, Engine Room, Incinerator Exhaust Trunking (Adj. No.1 Fan Room Exhaust), Gasket (Chrysotile)

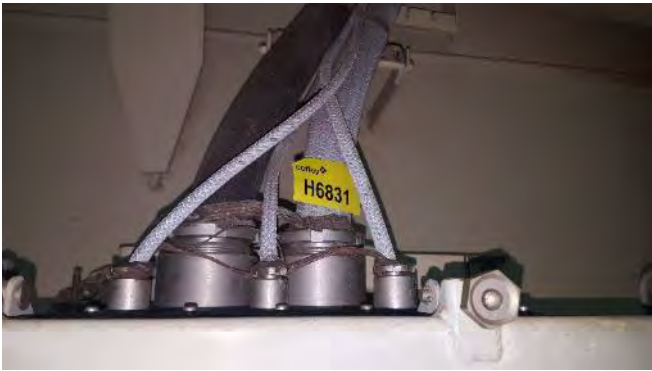
G6830

Upper Deck, Fo'c'sle/Bosons Store, Hydraulic Oil Header/Tank Overflow Level Sight Glass, Gasket (Chrysotile)

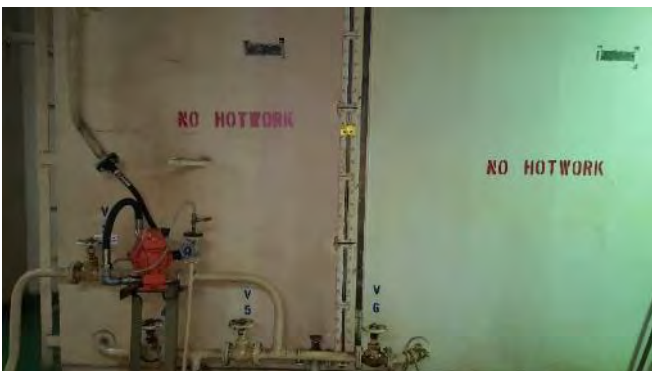
G6832

Upper Deck, Fo'c'sle/Bosons Store, Transfer Oil Tank Sight Glass, Gasket (Chrysotile)

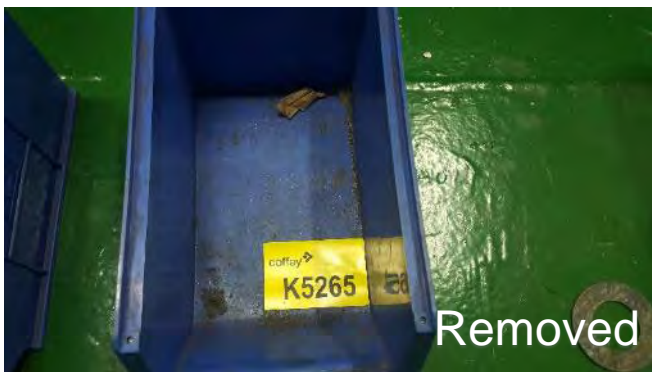
K5264

2nd Deck, 2SA, BJ2 Blue Plastic Container, Debris (Chrysotile)

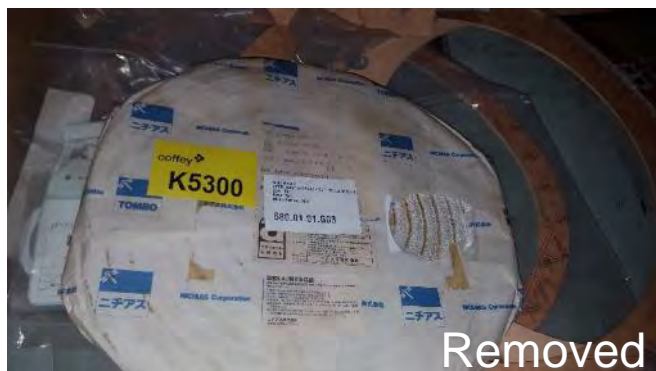
K5297

2nd Deck, 2SA, HC2 I.G. Ref Comp. 568.21.01.001 F/Top Cover, Gasket (Chrysotile)

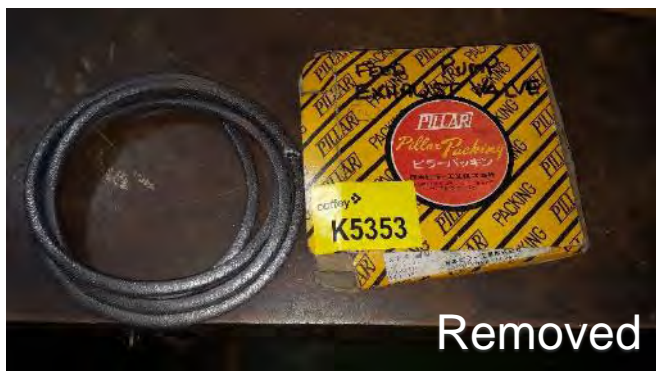
Photo 192
K5352
3rd Deck, Workshop, Packing Cabinet 4th Shelf, Packing "ADJ" #183 (Chrysotile)

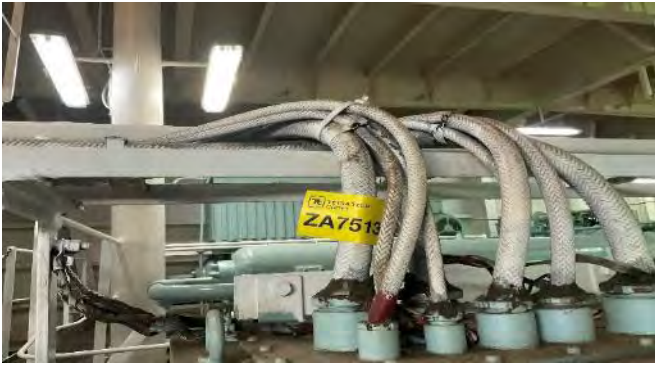
Photo 196

No.2 Diesel Generator Air Cooler Water Gasket (Chrysotile)

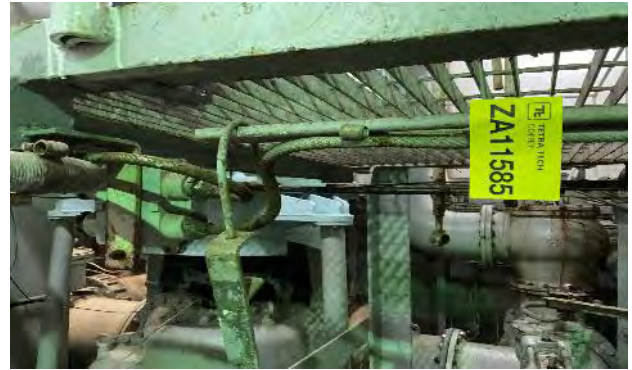
Photo 197

3rd Deck, No.3 Steering Gear Pump Fwd , Putty (Chrysotile)

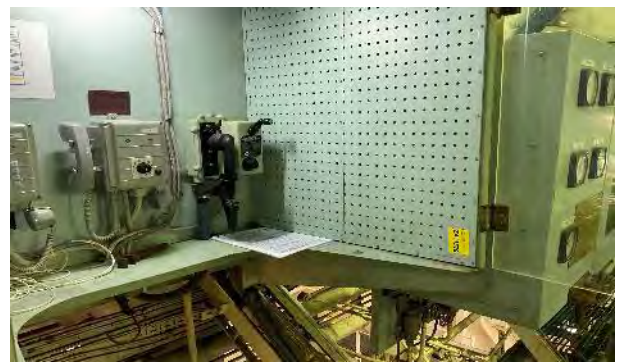
Photo 200

Tank Top, Engine Room, Stern Tune Berance Line, Gasket (Chrysotile)

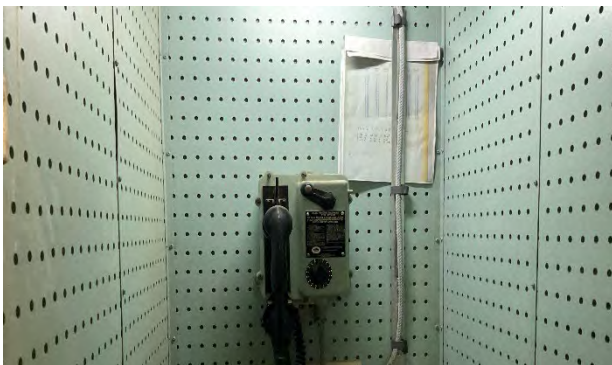
Photo 201

Tank Top, Telephone Booth Adjacent Stairs to 4th Deck – Fibre Board (Chrysotile)
