Asbestos Materials Refit survey and partial reinspection

NW Stormpetrel

Shell Tankers Australia Pty Ltd

Report reference number: 754-PEREN324141

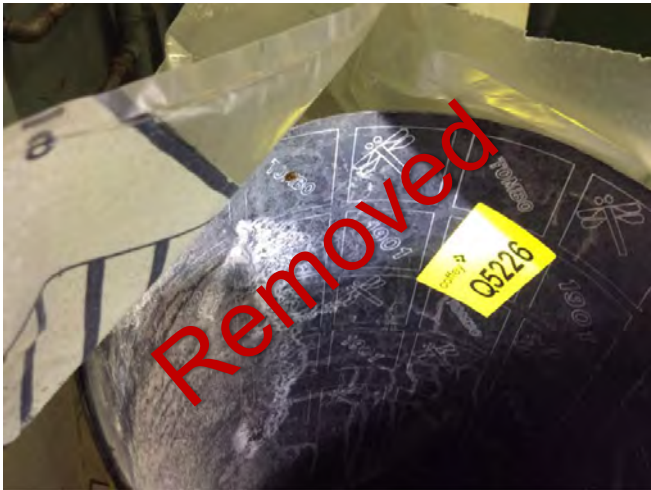
Photo 5
Q5226
3rd deck - IG room - Portside ships frame
Black sheet gasket - Tombo 1901

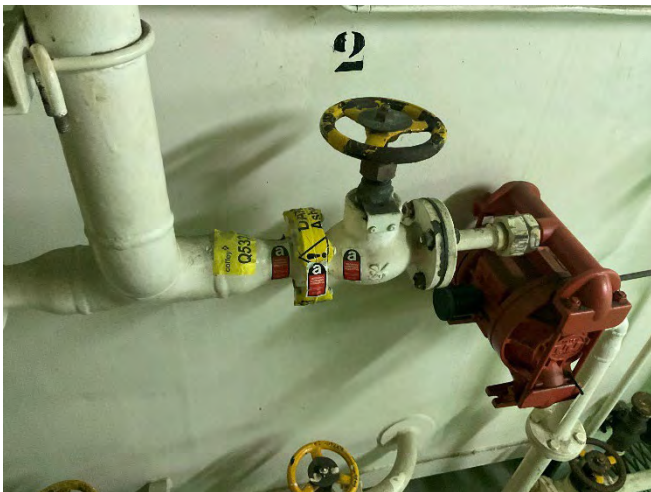
Photo 7
Q5337
3rd deck - steering flat - aft Winch hydraulic tank
Gasket filling pump flange

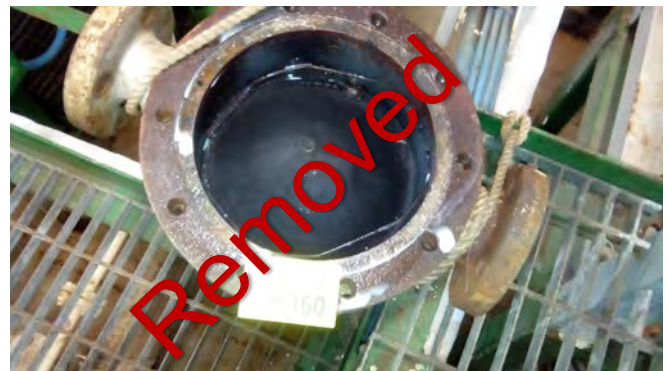
Photo 35
Q5426
2nd Deck – 2SA – Starboard Aft – Sanderling Spares Cardboard Box
Loose Tombo Branded Gasket – Assumed 1903

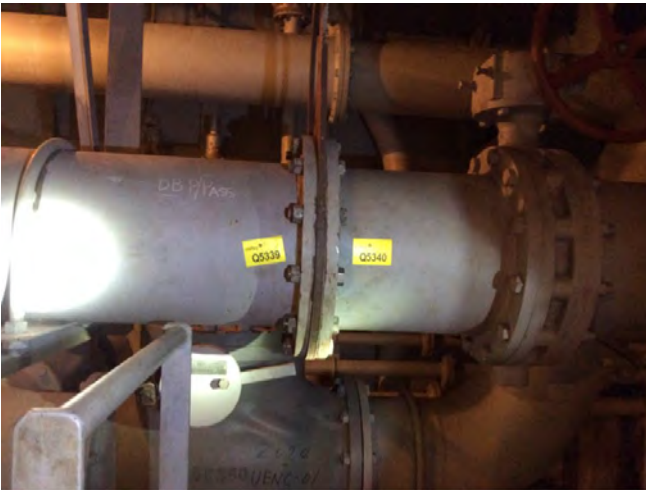
Photo 43
Q5339
Port UDPP- IG 2 Dbpp
Spectacle piece downstream Gasket

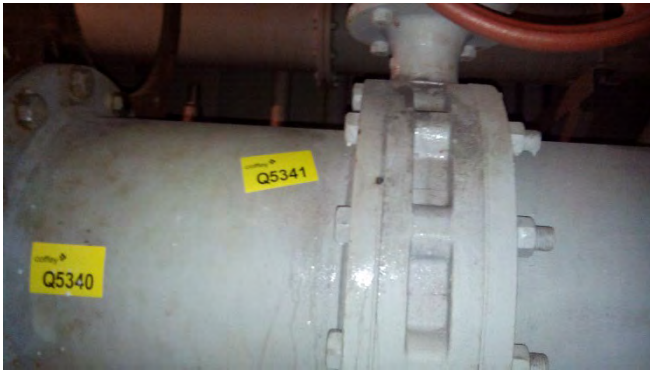
Photo 45
Q5341
Port UDPP IG to ebpp Valve Gasket
